Water enters the vehicle interior. The headliner and/or footwell is wet.

Water enters the dry area of the wind deflector storage compartment.

Modification(s) on panoramic sliding sunroof.

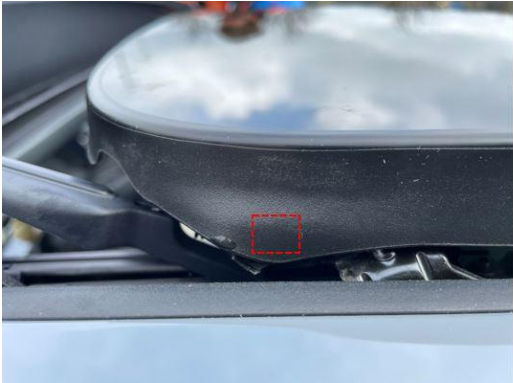
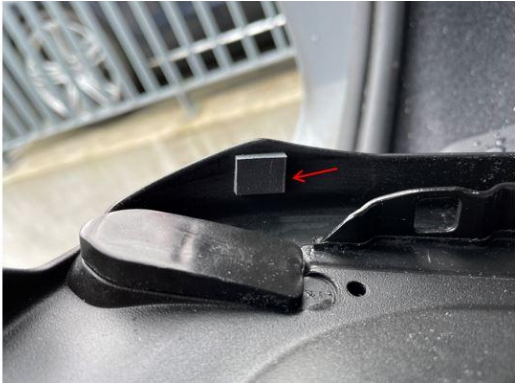
**Figure 49.**

Remove rubber buffers on glass panel with **long** PU trim.

If fitted, remove rubber buffers on inside of glass panel with **long** PU trim (see Figure 49).
