| <b>HYUNDAI</b><br><b>Technical Service Bulletin</b> | GROUP<br><b>FUEL SYSTEM</b> | NUMBER<br><b>26-FL-003H</b> |
| | DATE<br><b>JUNE 2026</b> | MODEL(S)<br><b>KONA (SX2)</b> |
| <b>SUBJECT:</b> FALSE “ENGINE LEFT IDLING” MYHYUNDAI NOTIFICATIONS - ECM SOFTWARE UPDATE - DTC P223700 | | |

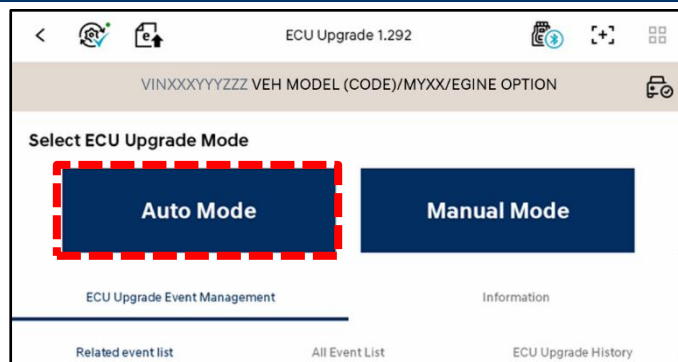
2. Verify the ROM ID by selecting the **Engine** system to scan the vehicle's current ROM ID.

Check the current ROM ID version and compare it to the ROM ID Information table before attempting to perform the software update.

If the update fails, remove the power connector from the in-cabin fuse box for at least **5 seconds**. Alternatively, disconnect the negative (–) **12V** battery terminal and wait at least **5 seconds**. Reassemble and retry the update.
