**HYUNDAI**  
**Technical Service Bulletin**

| GROUP<br><b>CAMPAIGN</b> | NUMBER<br><b>26-01-055H</b> |
| DATE<br><b>JULY 2026</b> | MODEL(S)<br><b>PALISADE HYBRID (LX3 HEV)</b> |

**SUBJECT:** VPC SOFTWARE UPDATE  
(LIMITED COVERAGE CAMPAIGN LA28)

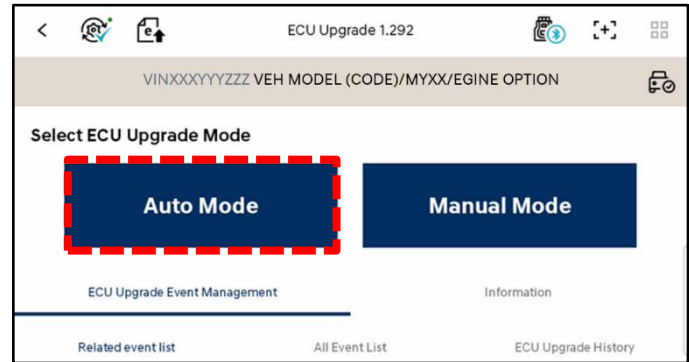
2. Verify the ROM ID by selecting the **VPC** system to scan the vehicle's current ROM ID.

Check the current ROM ID version and compare it to the ROM ID Information table before attempting to perform the software update.

If the update fails, remove the power connector from the in-cabin fuse box for at least **5 seconds**. Alternatively, disconnect the negative (–) **12V** battery terminal and wait at least **5 seconds**. Reassemble and retry the update.
