| | ELE | 2027MY<br>Telluride Hybrid<br>(LQ2AH) |
| | 267 | July 2026 |
| SUBJECT: <b>CRANKCASE EJECTOR<br/>INSPECTION/REPLACEMENT (SA650)</b> | | |

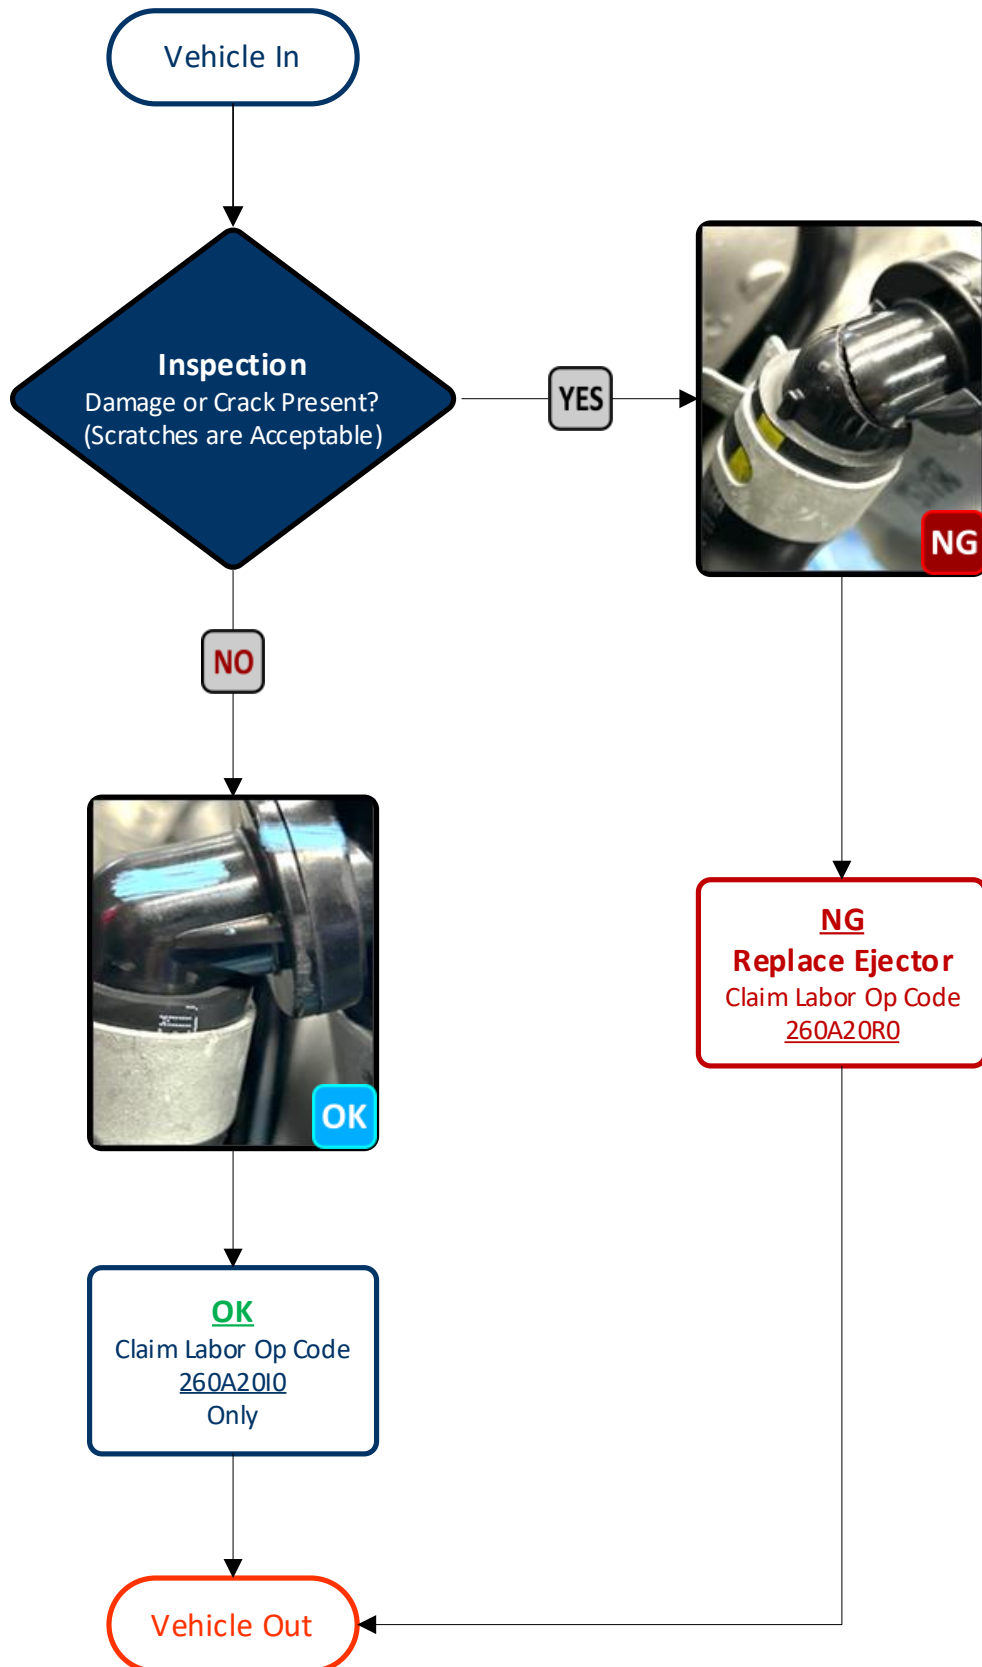
## Flowchart:

This bulletin provides instructions to inspect and, if necessary, replace the PCV ejector on certain 2027MY Telluride Hybrid (LQ2AH) vehicles produced from December 4, 2025, through March 20, 2026. Affected vehicles may display an illuminated Malfunction Indicator Lamp (MIL) with Diagnostic Trouble Code (DTC) P04DB00 due to damage to the ejector assembly. No drivability issues are associated with this condition. Before performing the procedure, verify that the vehicle’s VIN is included in the affected VIN list/range. If applicable, follow the inspection and replacement procedure outlined in this bulletin.

**DTC Description:**  
**P04DB00 - Crankcase Ventilation System Disconnected**
