## Technical product information

| <b>Topic</b> | Window Drop Glass Operation Continental GT/GTC 25-26MY |
| <b>Transaction No.</b> | 2080372/4 |

Window Drop Glass Operation | Continental GT/GTC | 25-26MY

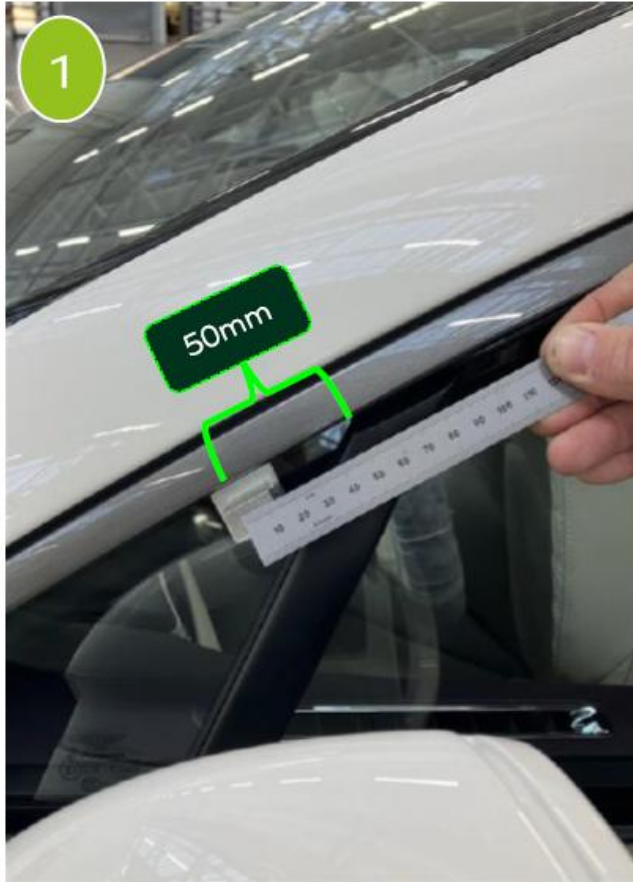
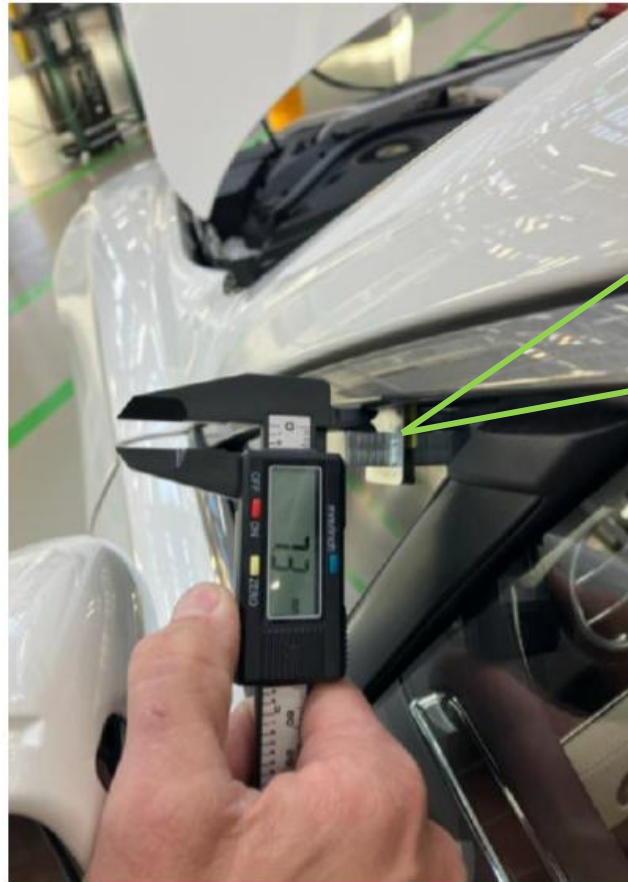
# INTERLOCK POINT 1

Place block 50mm in front of front div bar

Record measurement for all interlock points

From block to bright ware for all interlock points

If the measurement is out of specification refer to ElsaPro Repair Group 64 'Front door quarter glass – To adjust'

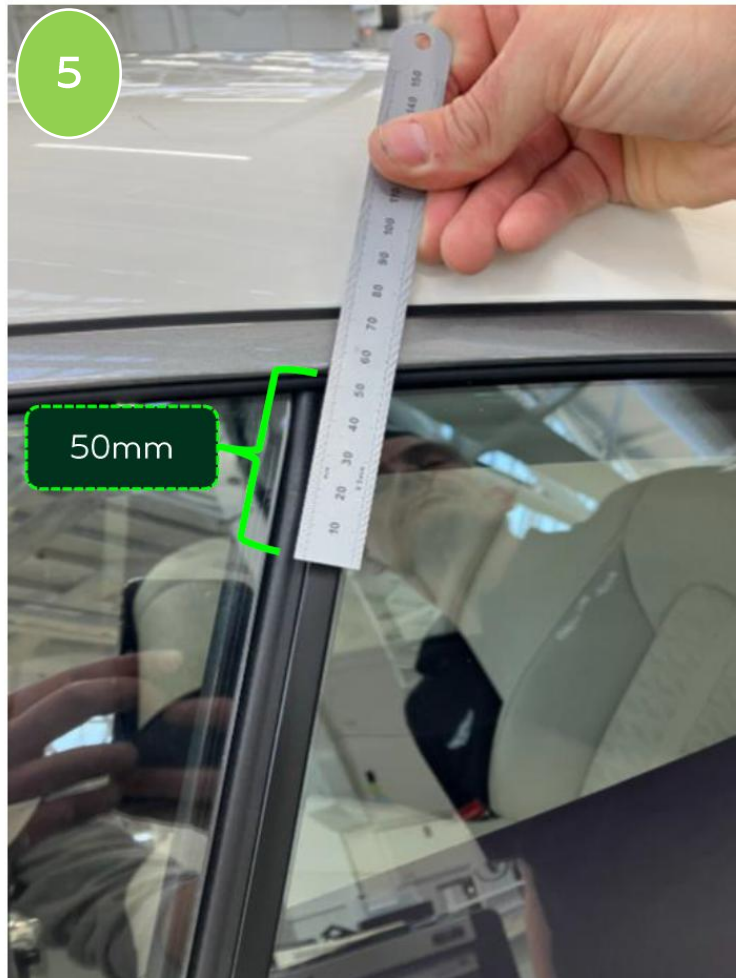
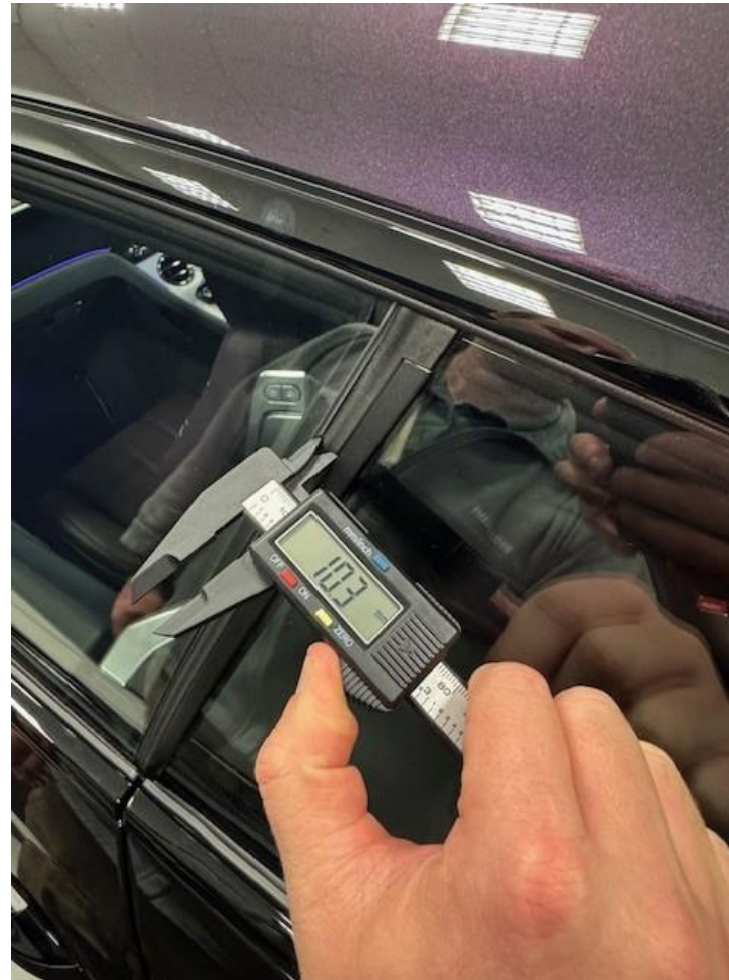
# INTERLOCK POINT 5

50mm from seal

Record measurement

**Specification**  
11mm  $\pm$  1mm  
(Ruler/vernier)

**Repair Group 64 'Slide  
glass checking and  
adjusting'**

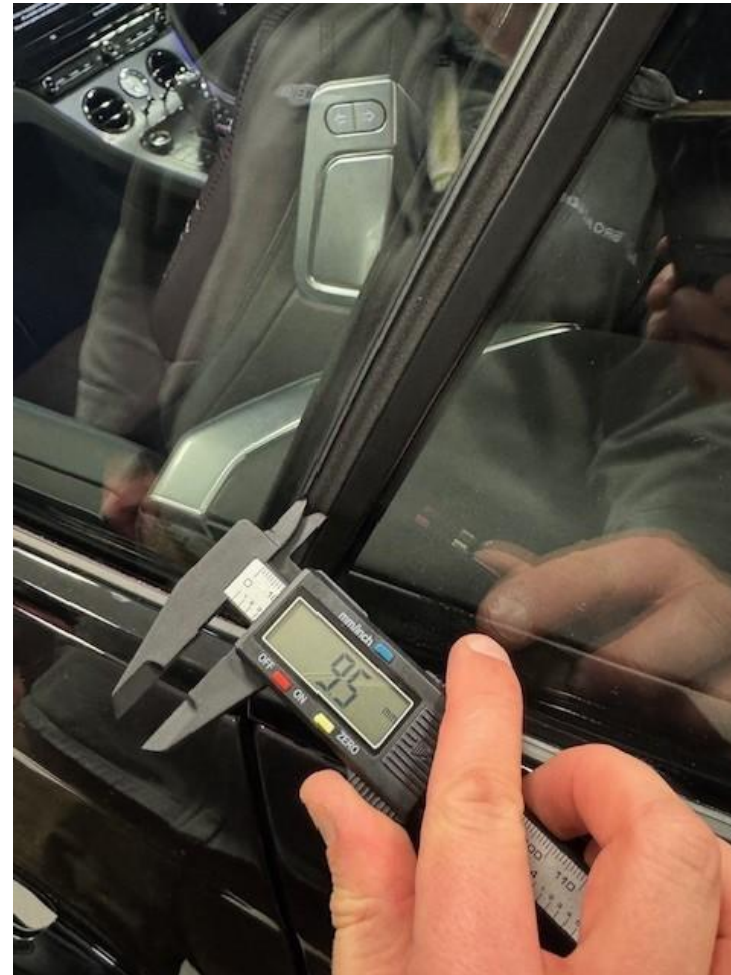
# INTERLOCK POINT 7

50mm from seal

Record measurement

**Repair Group 64 'Slide  
glass checking and  
adjusting'**

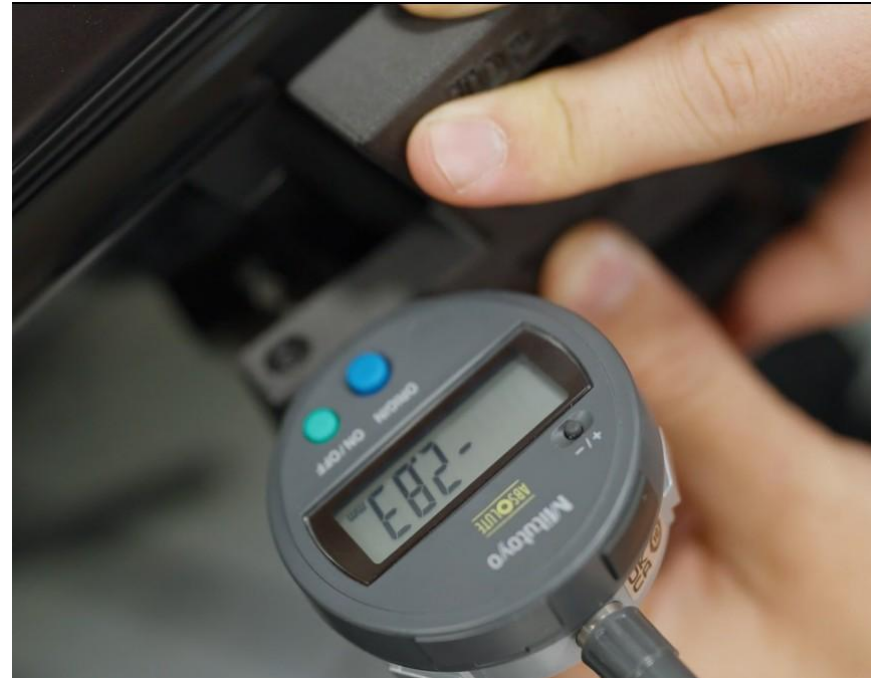
# PROFILE POINT 6 (DIGITAL DTI GAUGE - LATEST TOOL)

Align and position the tool on the front window so that its contact face rests flat against the upper bright ware trim, zero the tool.

Then slide it along the surface until it makes full, even contact with the rear glass.  
Record the measurement.

**Specification**  
0mm +0 / -3mm

**Repair Group 64**  
**'Slide glass checking and adjusting'**
