# RCA-78-26-001-1: Loose or Cross-Threaded Instrument Panel Ground Nut

| Document Type | Customer Satisfaction Campaign Bulletin |
| Affected Model(s) | R1T, R1S |
| Vehicle System | 78 - Low Voltage Electrical |

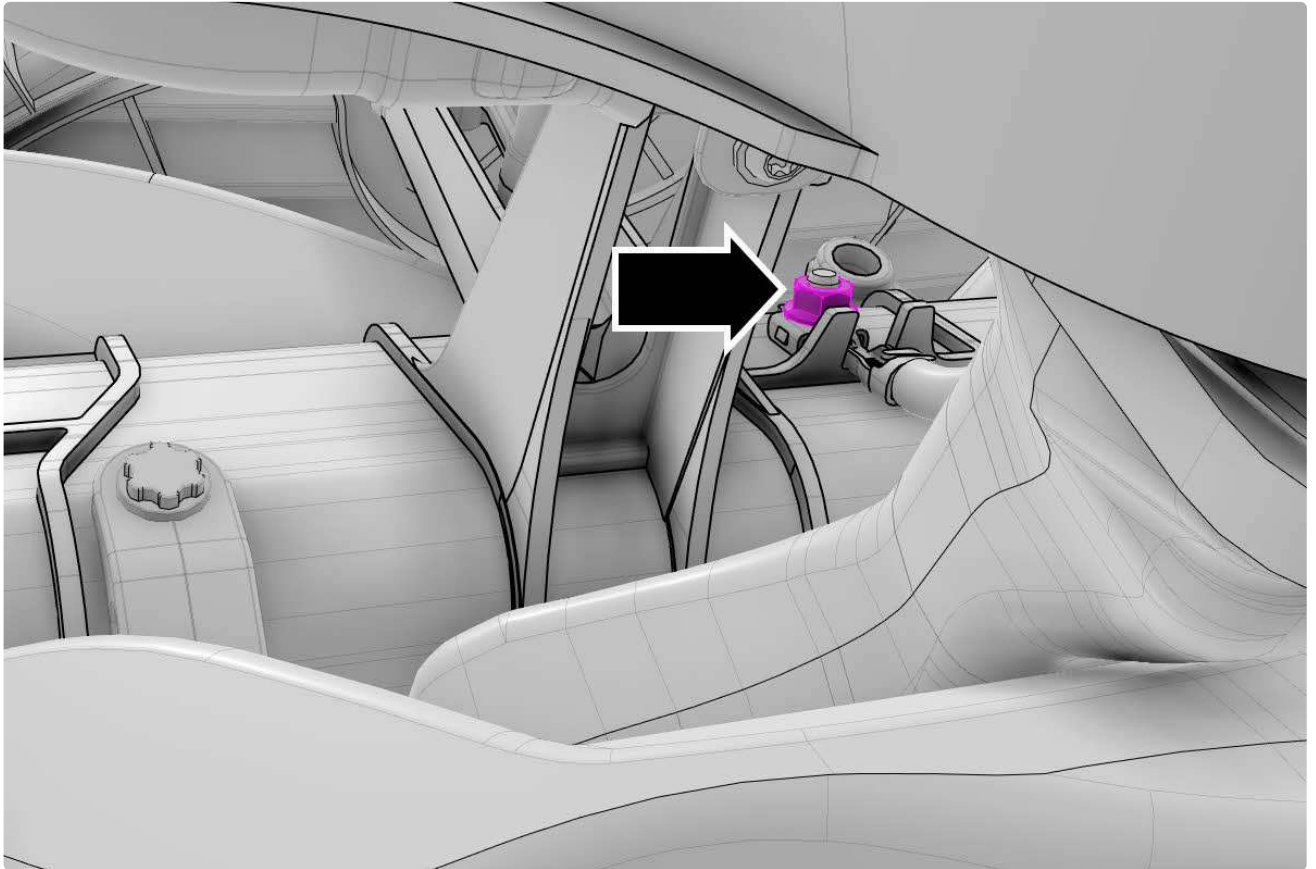
4.

5. Inspect the threads on the stud for damage.

- 6.
- If there is no thread damage: Continue to the next step.
  - If the threads are damaged and appear to be repairable: Skip to the [Repair Threads](#) section.
  - If the threads are damaged and do not appear to be repairable: Skip to the [Replace Stud](#) section.
