# Head Unit Software Update Version 8612G42397 via OTA and USB (Panasonic)

| YEAR(S) | MODEL(S) | ADDITIONAL INFORMATION |
|---|---|---|
| 2026 | RAV4 HV, RAV4 PHV | |

A head unit software update (version 8612G42397) is now available for 2026 model year RAV4 Hybrid, and RAV4 Plug-in Hybrid vehicles via OTA or USB.

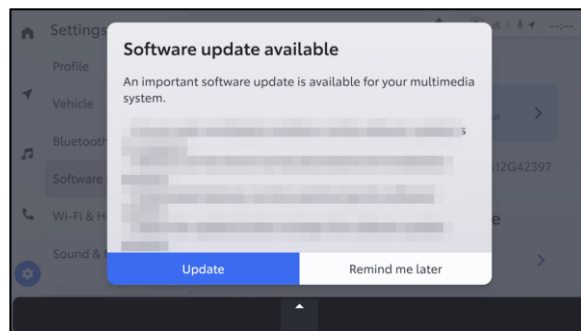
**Figure 1.**

Vehicle operators can perform this update directly by accepting the on-screen notification (see Figure 1) advising the software update is available, or by locating the software update from the Settings menu and initiating the available update (see Figure 2).

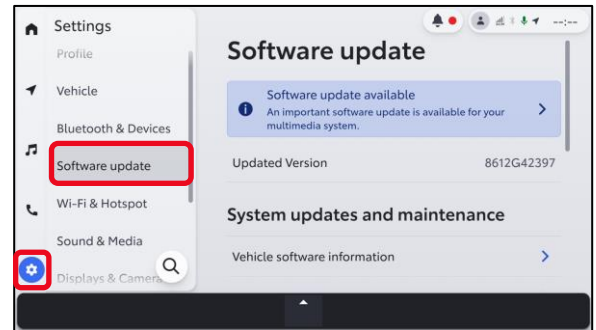
**Figure 3.**

Does the Software update menu open as seen in Figure 3?

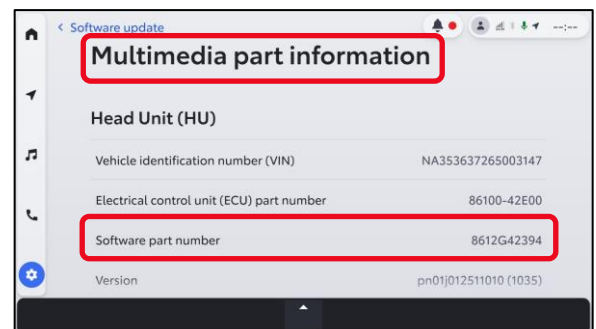
**Figure 5.**

3. Scroll down and select Multimedia part information and confirm the Software part number as shown in Figure 5.
