Altec Industries, Inc. has issued a **customer satisfaction campaign** as described in the included Service Information Letter (SIL). According to our records, you own one or more units this applies to.

## Bolt Contacting Chassis U-Bolt Inspection

**Units Affected:** Certain AT37/41/48 units on small duty Ford and Dodge chassis, built from December 2017 to May 2025. Verify your unit is affected by reviewing the attached list or accessing Altec Connect.

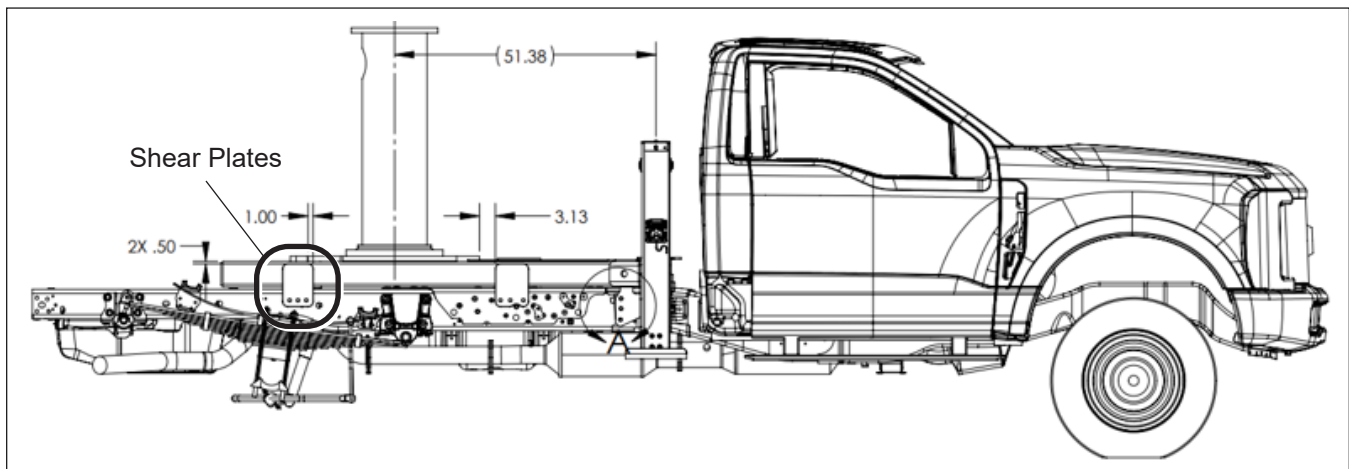
**Figure 1 — Subbase Shear Plates**

1. Read and understand all steps of the instructions before beginning the procedure. Wear appropriate personal protective equipment (PPE) following your employer's requirements.
2. Position the unit on a level surface, apply the parking brake, and turn off the engine. Remove the key from the ignition, and secure it following your employer's vehicle lockout/tagout (LOTO) procedure. Chock the wheels.
3. Begin the inspection on the curb side of the chassis and complete all inspection steps on that side only. Do not inspect the street side at this time; a later step will direct you to return and repeat the entire inspection on the street side. Locate the shear plate above the rear axle suspension. Shear plates over the suspensions could be subbase shear plates or could be boom rest crossmember shear plates (refer to Figures 1 and 2).

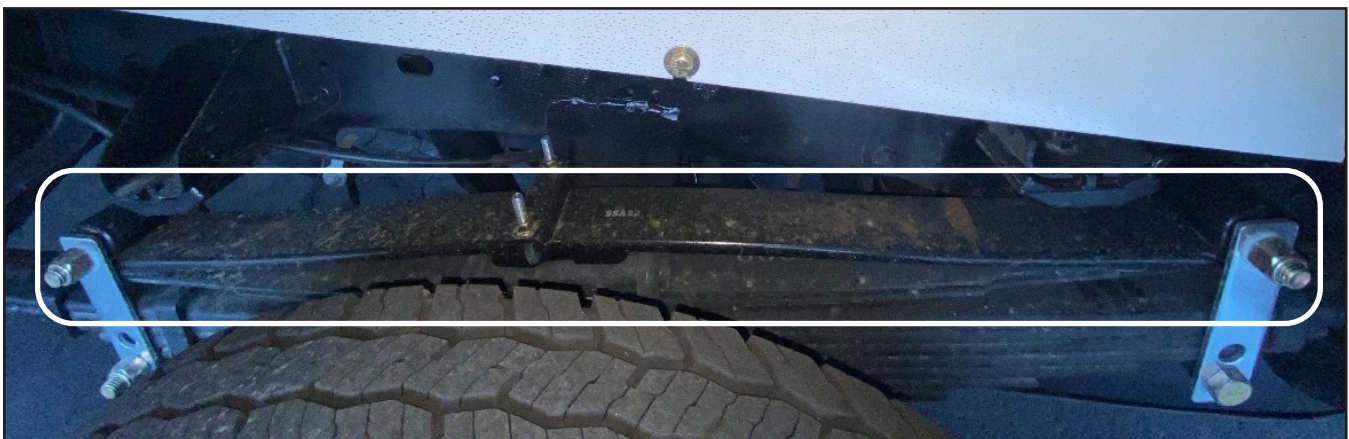
**Figure 7 — Dodge SuperSpring**

6. Determine if a SuperSpring® has been installed on the rear axle suspension. A SuperSpring has different appearances depending on the make of the chassis. Refer to Figures 7 and 8 for examples.
- If a SuperSpring has been installed, continue to step 7.
  - If a SuperSpring has not been installed, proceed to step 8.

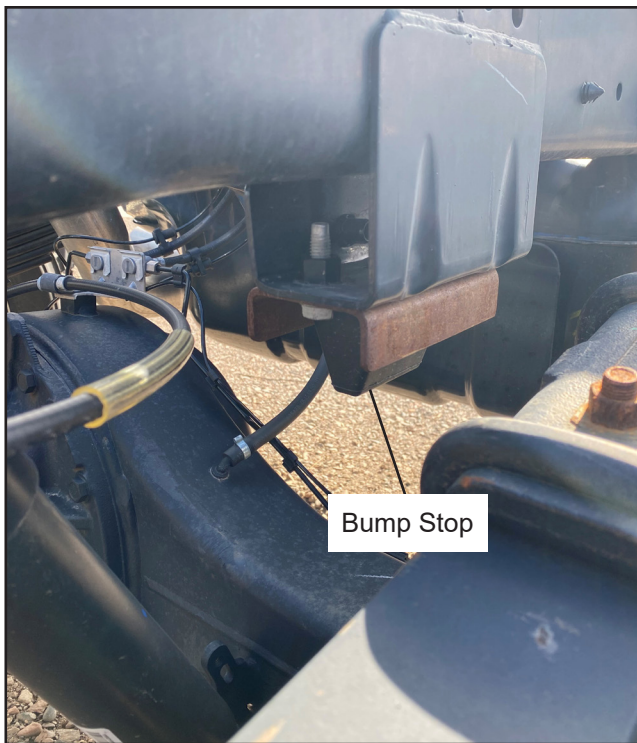
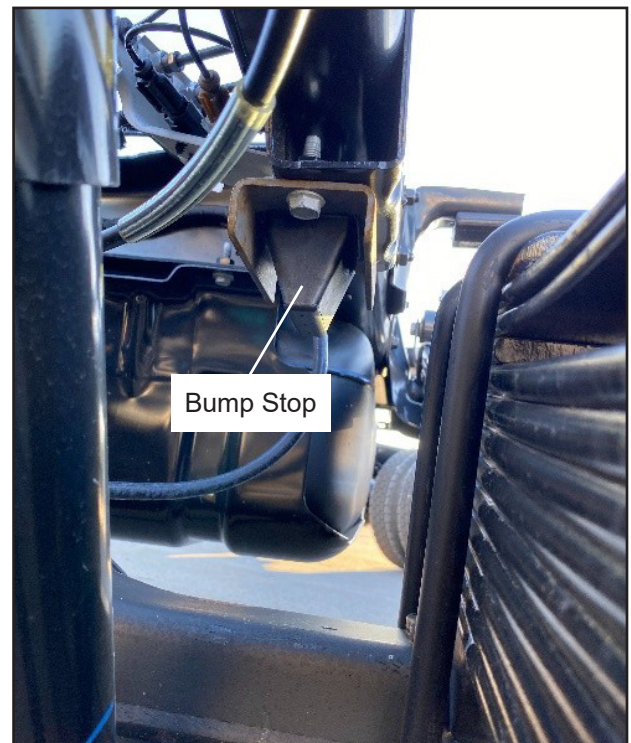
**Figure 15 — Dodge Rear Suspension Bump Stop**

10. Find the rear suspension bump stop located above the rear axle on the street side of the chassis (refer to Figures 15 and 16).

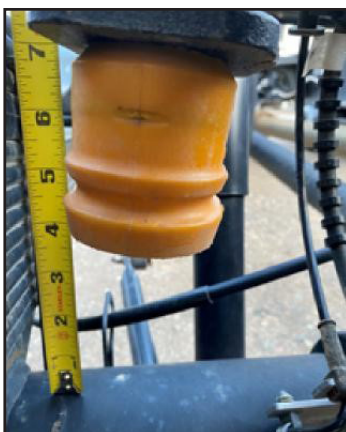
**Figure 17 — Ford or Dodge Measuring for Suspension Travel Number**

11. Calculate the suspension travel number by measuring the vertical distance from the top of the rear axle to the bottom of the bump stop on the street side of the chassis (refer to Figure 17). Enter this number in column A of the table in Figure 18 in the row of the chassis side currently being inspected.
