PRODUCT CAMPAIGN BULLETIN

APPLICABILITY: 2003-2005 Subaru Legacy and Outback**
 2003-2005 Subaru Baja
 2004-2005 Subaru Impreza**
 (including WRX and STI)

NUMBER: WQP-51R
DATE: January 2015
NHTSA ID: 14V-763
REVISED: December 21, 2022

SUBJECT: Regional Front Passenger Air Bag Inflator Replacement

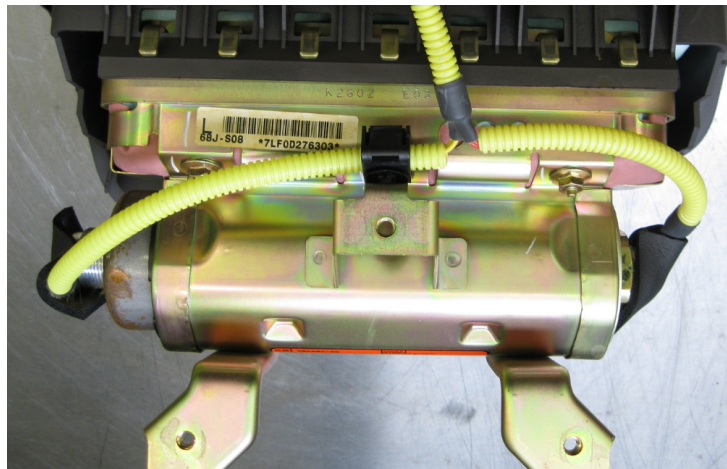
Inflator WITHOUT Ammonium Nitrate- Serial Number Label Location (2003 Legacy, Outback and Baja models only): Record this 12-digit number for claims purposes.

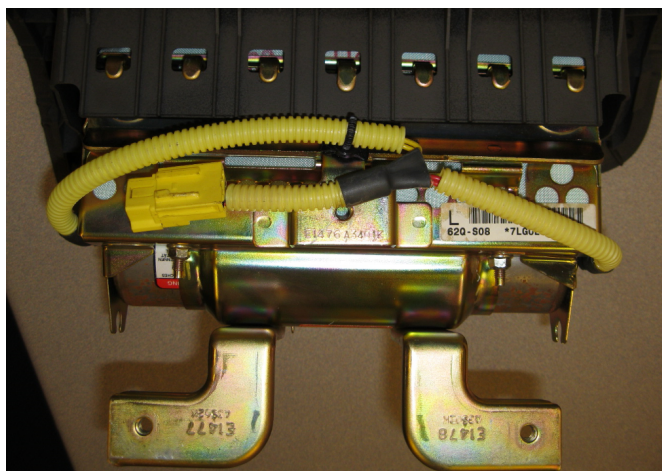
Inflator WITH Ammonium Nitrate- Serial Number Label Location
