**PRODUCT CAMPAIGN BULLETIN**

**APPLICABILITY:** 2003-2005 Subaru Legacy and Outback\*\*  
 2003-2005 Subaru Baja  
 2004-2005 Subaru Impreza\*\*  
 (including WRX and STI)

**NUMBER:** WQP-51R  
**DATE:** January 2015  
**NHTSA ID:** 14V-763  
**REVISED:** December 7, 2017

**SUBJECT:** Regional Front Passenger Air Bag Inflator Replacement

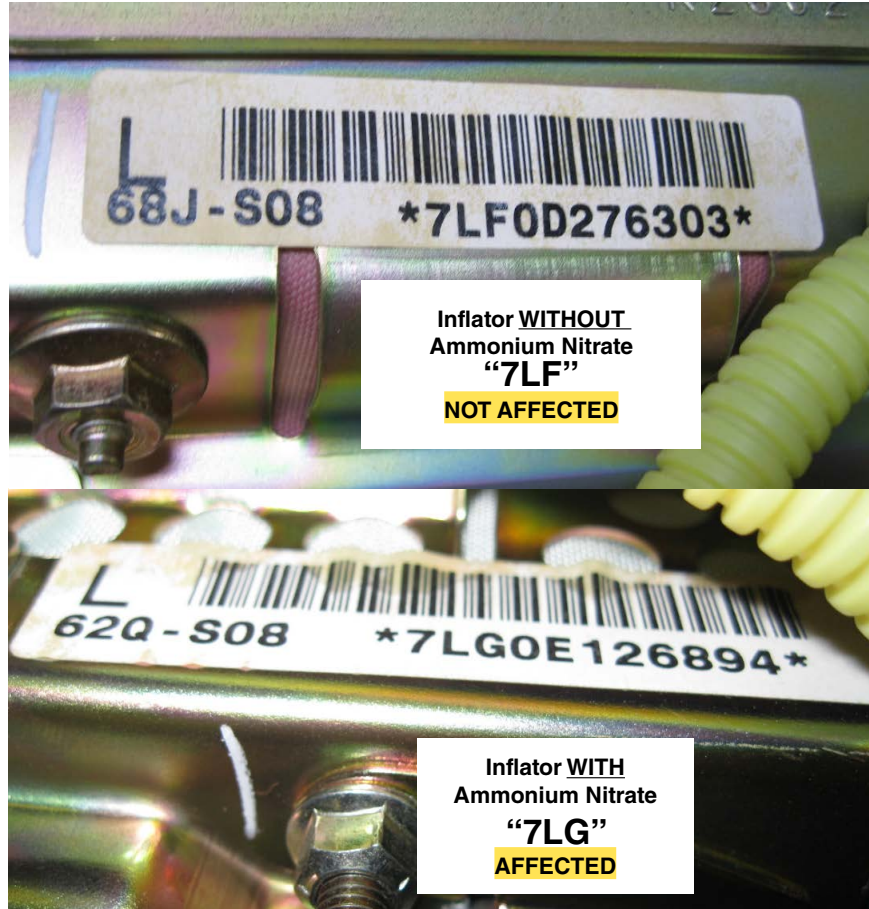
### Label Detail

If the serial number label is missing, illegible or if there is any uncertainty if the airbag module is affected by this Recall Campaign, follow the Counterfeit / Non-Genuine airbag inspection process provided above. Always take photos of the module showing the entire inflator along with an additional photo showing the area where the label should be as seen in the photos below. Next, submit a Quality Monitoring Report (QMR) requesting SOA review. A member of the Claims Team will contact the Retailer following review of the QMR submission with information on how to proceed.

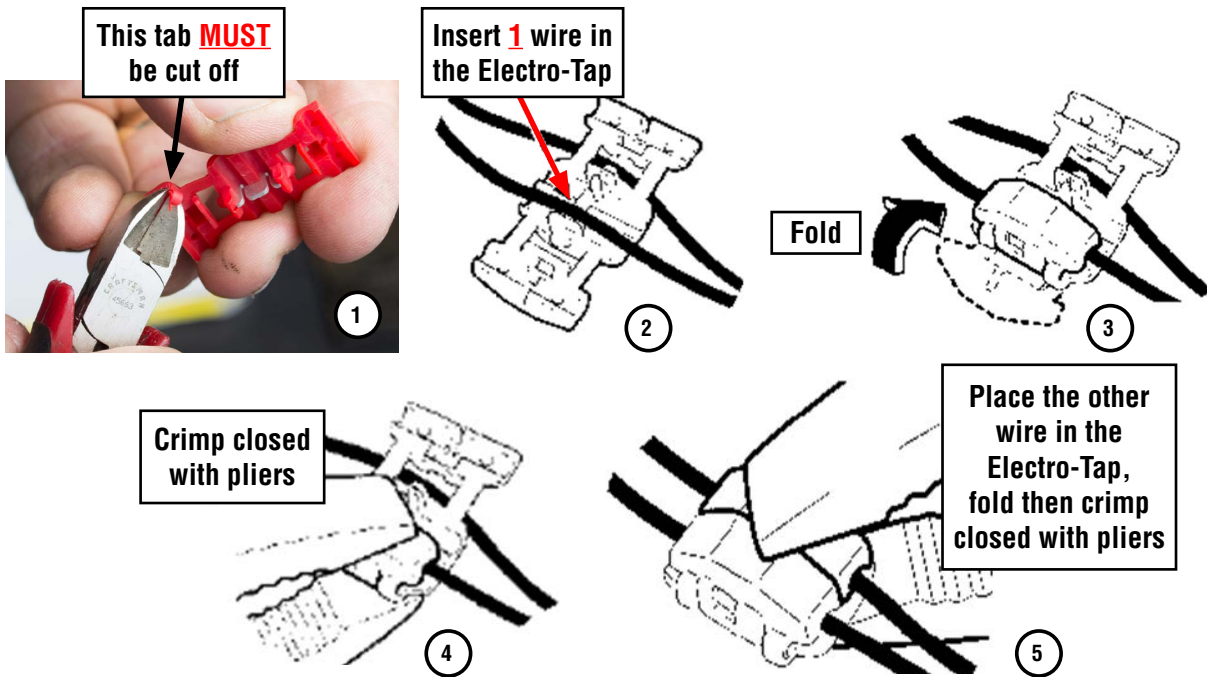
**STEP 4-** Short the 2 yellow wires together by installing the Electro-Tap connector. The connector creates a short circuit which acts as a safeguard to prevent against static discharge that may deploy the removed inflator. The tab portion of the Electro-Tap connector **MUST** be cut off prior to use to insure a good short-circuit is made as shown in the illustration below. **Follow the sequence below** for installing the Electro-Tap connector. Use pliers to squeeze closed the two sections of the connector together, **one section at a time**.

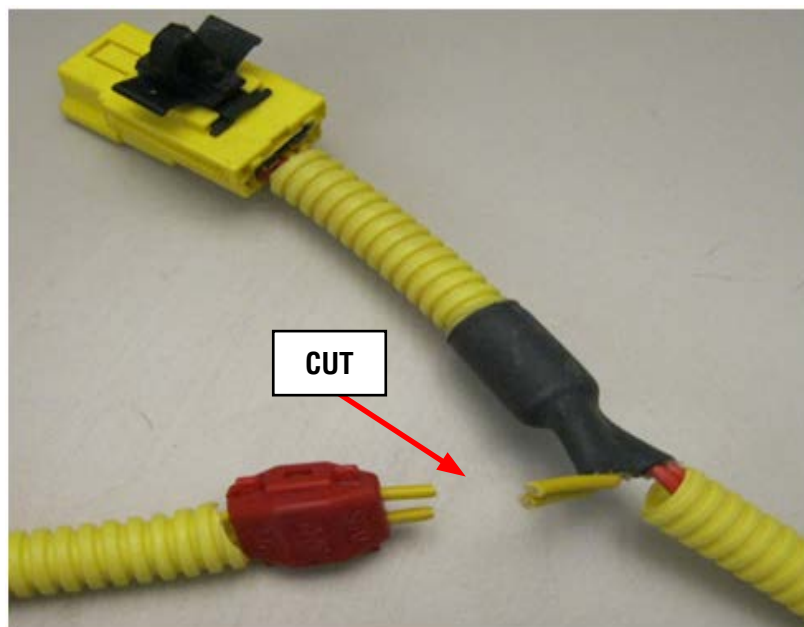
**STEP 5-** Once the Electro-Tap connector is fully crimped in place, cut the 2 yellow wires on the **body harness connector side** of the Electro-Tap connector.

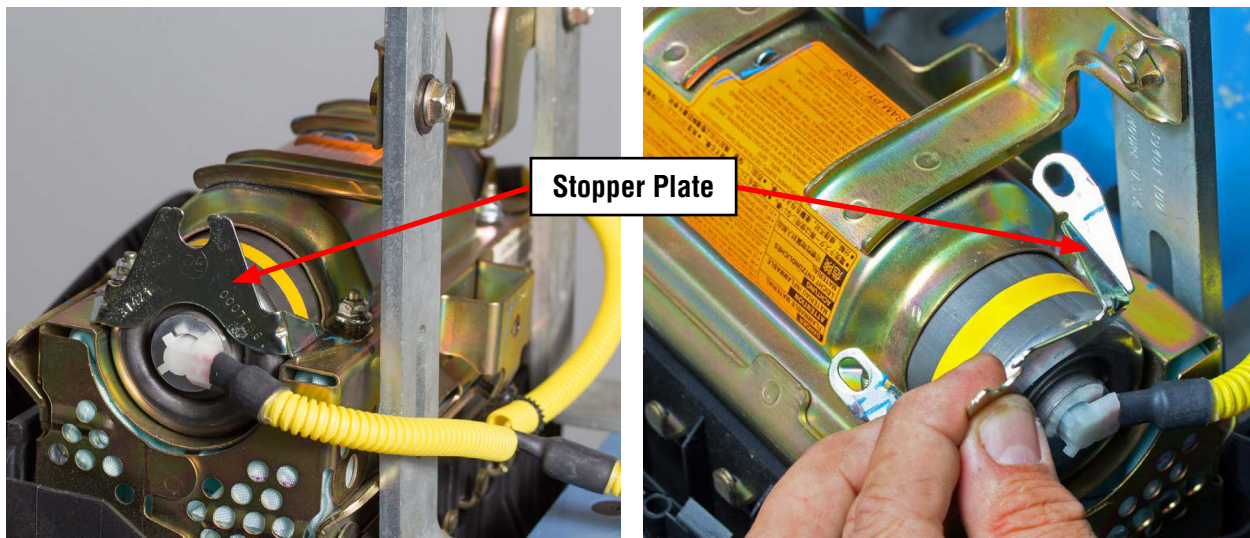
**STEP 6-** Remove the two 8mm self-locking nuts securing the stopper plate. Loosen but **do not remove** the other two nuts on the mounting bracket as leaving them in place will help keep the airbag assembly together.

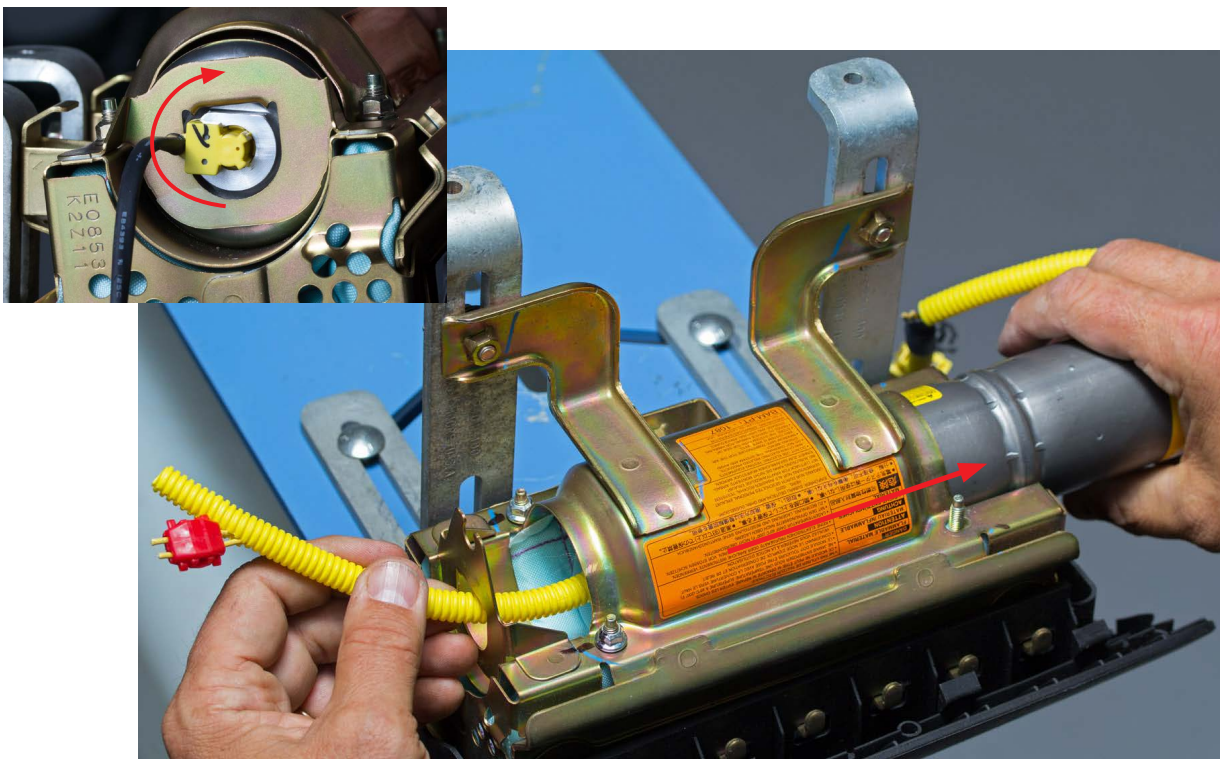
**STEP 7-** With the stopper plate removed and the other 2 self-locking nuts loosened, unseat the inflator off the mounting bracket end plate then rotate it slightly **CLOCKWISE** to make it easier to remove as shown below. Slide the original inflator out of the mounting bracket while feeding the cut off portion of the wiring harness through the “D-Shaped” hole in the end plate.

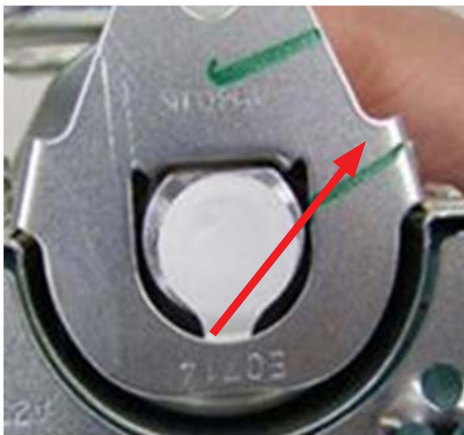
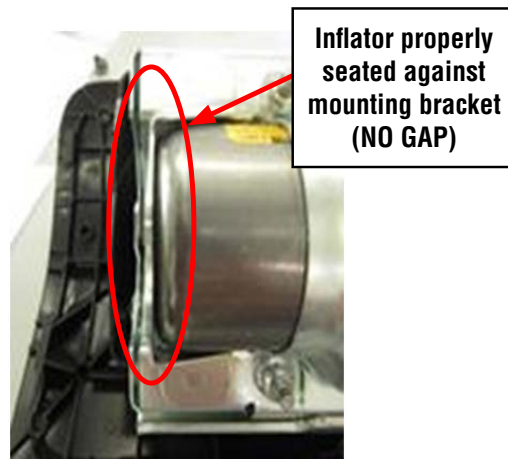
**STEP 9-** Install the new inflator into the mounting bracket so the yellow taped end aligns with the removed stopper plate. Make sure the “D-shaped” portion of the inflator harness connector boss aligns with the “D-shaped” portion of the hole in the end of the mounting bracket as shown below. When properly installed, the end of the inflator will be seated tight against the mounting bracket. Do not peel the white harness connection dust cover at this time.

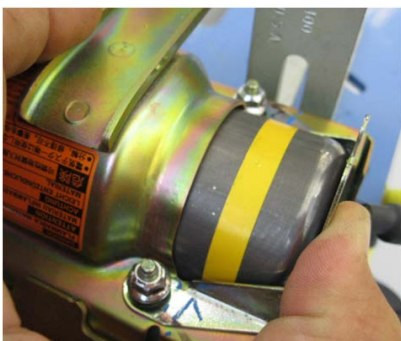
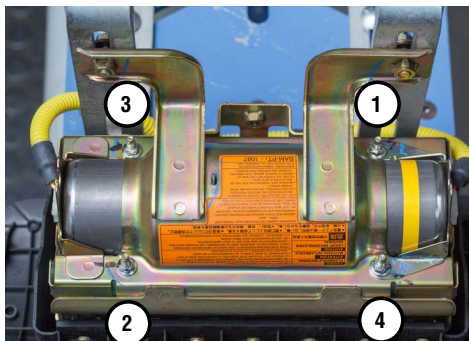
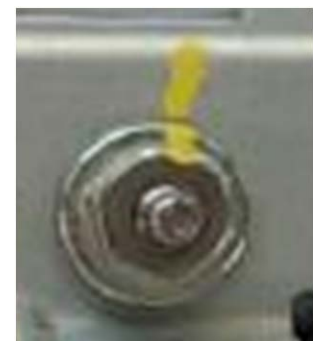
**STEP 10-** As shown below, install but **do not fully tighten** 2 of the NEW self-locking nuts while holding the stopper plate tight against the inflator. Remove the nuts still installed on the mounting bracket and replace them with 2 NEW self-locking nuts. Once all 4 NEW nuts are in place, **torque to 31 - 38 inch pounds in the sequence shown below**. Use a marker to mark the nuts after torquing to indicate they have been fully tightened.

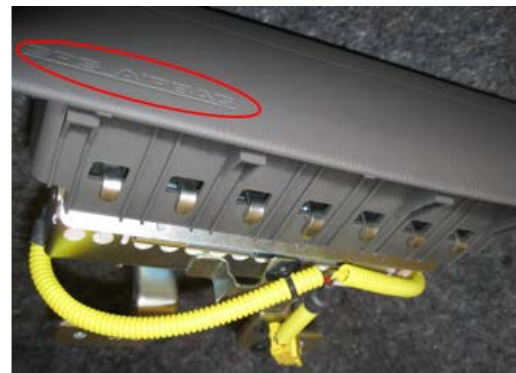
**VERY IMPORTANT:** Before removing the original trim cover / lid from the module, note the orientation of the cover in relation to the module as the module can be installed upside down in the cover. (TIP: The bottom or harness side goes toward the “SRS AIRBAG” side of the cover as shown.)  
**CAUTION:** During cold temperatures always let the cover warm to room temperature before attempting claw removal. In all cases, limit any distortion of the airbag cover to avoid damaging it.

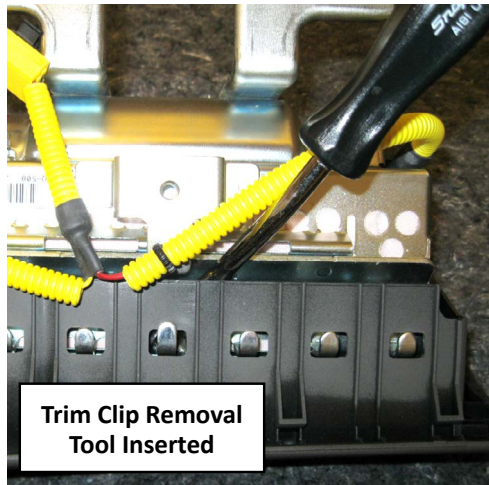
Trim Clip Removal  
Tool Inserted

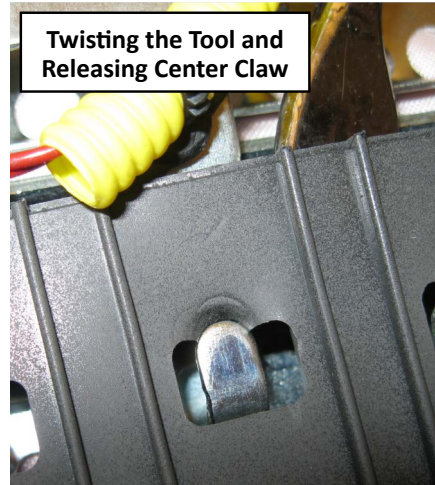
Twisting the Tool and  
Releasing Center Claw

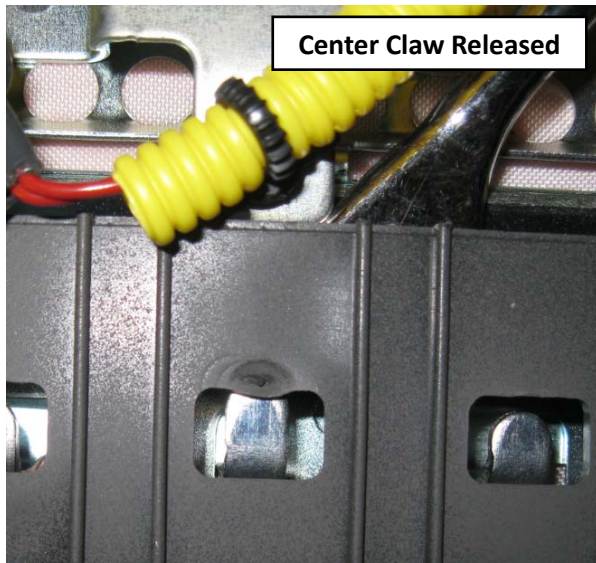
Center Claw Released

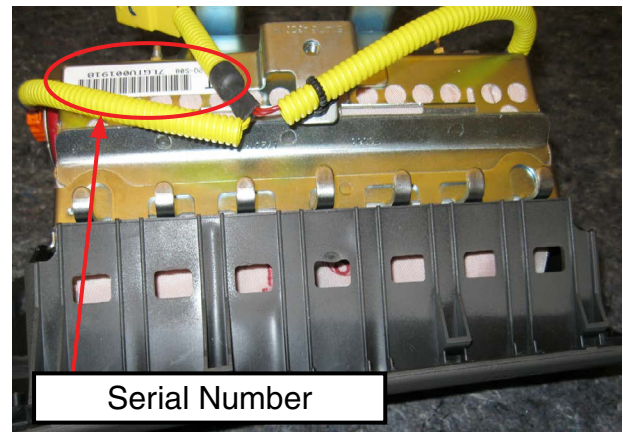
All Harness-Side Claws Released
