**SERVICE INFORMATION BULLETIN**

**NUMBER:** 07-116-16R

**SUBJECT:** Supplemental Service Procedure Information to be Used in Conjunction with Campaigns WQP-51, WQR-53R and TKA, B, C-16R

**DATE:** 11/11/16

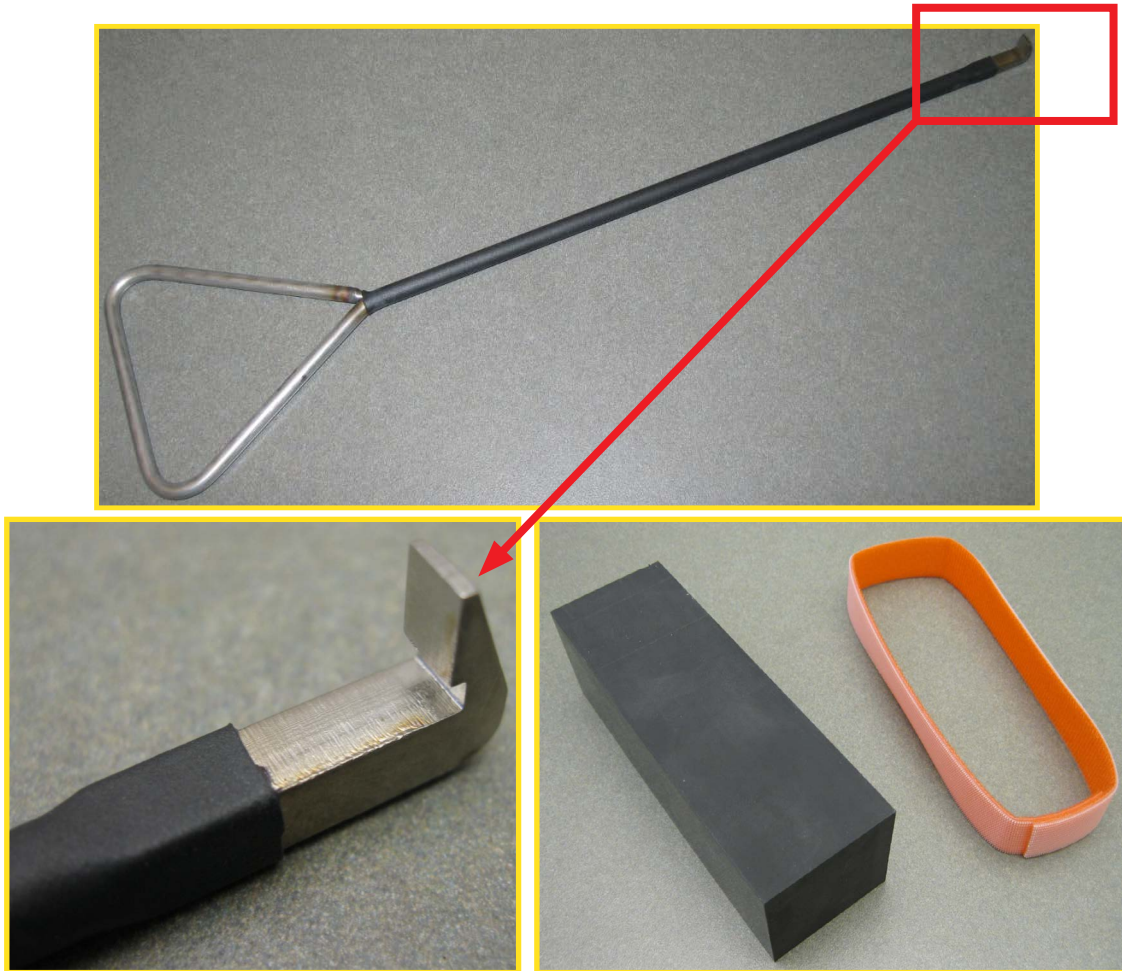
- To help make these repairs easier, two new tools as shown below have been developed and sent to Retailers automatically. Each retailer will be supplied two sets of these tools at no charge. A new removal tool, p.n. SOA635145 for removing the IP's outside and center vent assemblies and, a resin block to support the IP on 2005-2009 Legacy and Outback models, p.n. SOA635146. There is also a velcro strap supplied along with the resin block to help hold it in position if needed when supporting the IP.

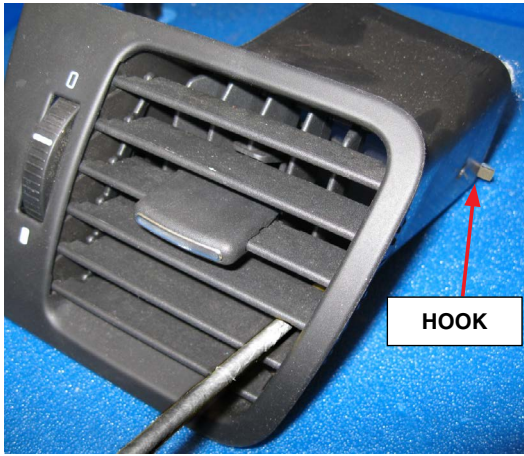
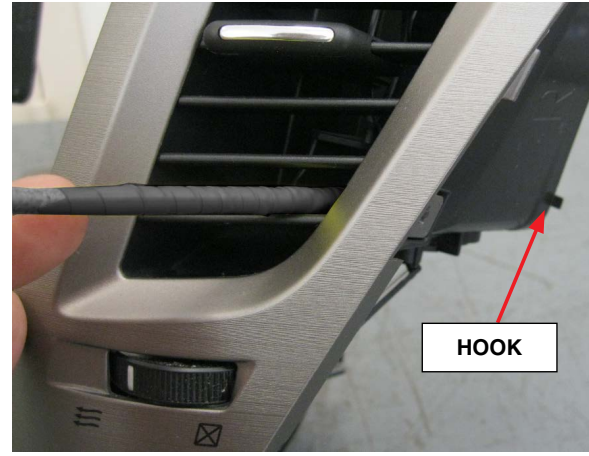
There will be some trial and error involved when learning how to use the **new removal** tool and getting the “feel” of it but, once proficient with the tool’s use, the effort will be well worth it in undamaged vent assemblies. Insert the **removal** tool into the vent being released and “feel” for the lip / edge where it fits inside the air supply duct.

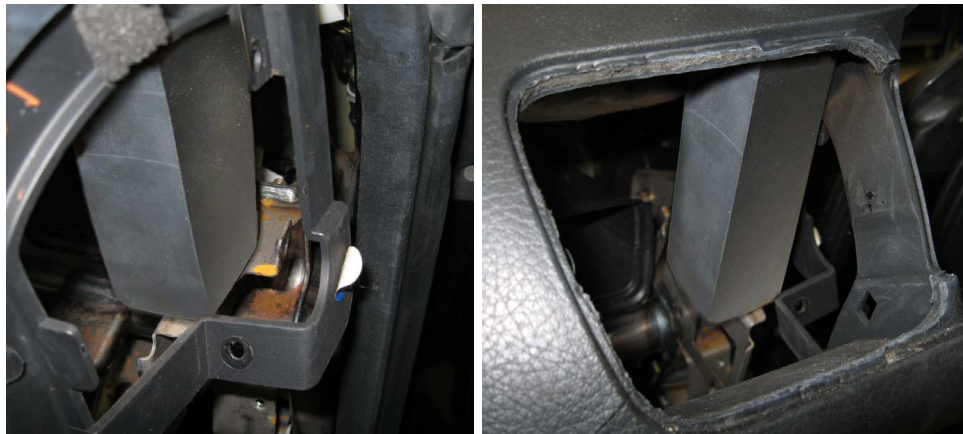
- Follow the Service Manual procedures for removing the IP but, once the IP is loose and moveable, support the passenger’s side end with **the resin block as shown** below. **Use the velcro strap to hold the resin block in place if necessary.**
- Lift the IP **only as much as is needed** to insert the **resin** block between the underside of the IP and the support brace on the steering column support bar as shown below.

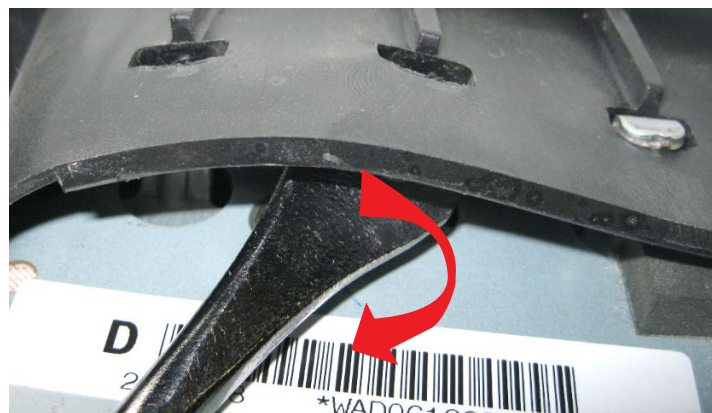
- While pushing upward on the airbag module, insert a trim clip removal tool (or large flat-blade) screwdriver in between the module and the IP and twist enough to **CAREFULLY** release the 6 “bottom” (easiest to see / access) claws as shown in the photo sequence below. It is not necessary to release the other 6 “top” side claws. Once the bottom claws are free, “rotate” the module downward and the rest will release on their own enabling it to be removed from the vehicle.

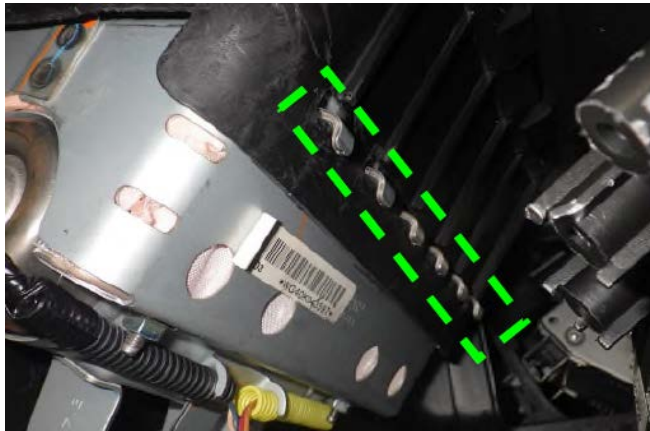
Module in position, retaining claws engaged.

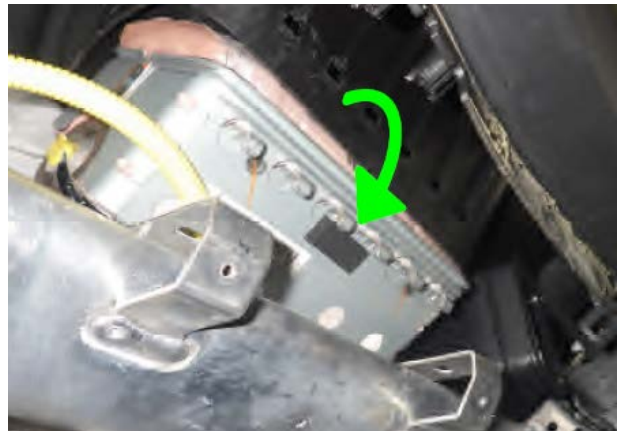
Retaining claws released and module rotated downward to release / remove.

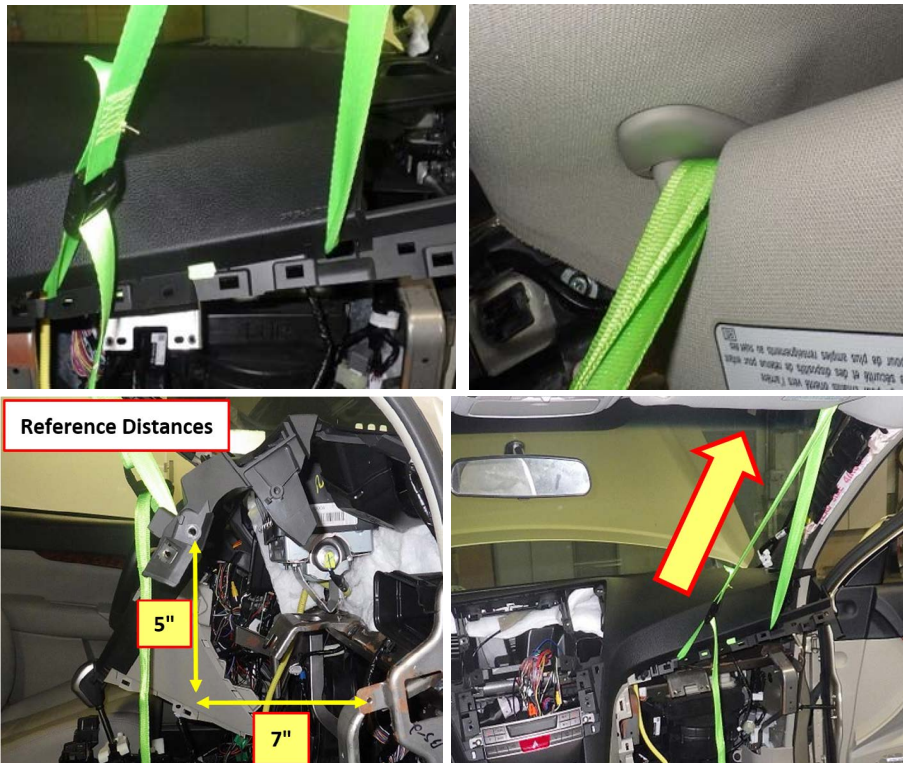
Use the photos below as a guide for positioning the support strap on the IP along with the upper securing point which is the mounting point for the sun visor.

- To avoid damaging the visor, always make sure the opposite end of the visor closest to the rear view mirror is securely clipped into place before adding any load from the IP to it.
- The dimensions shown in the photos are the **maximums** needed to access and remove the module. To avoid damaging the IP, **DO NOT EXCEED** these dimensions.

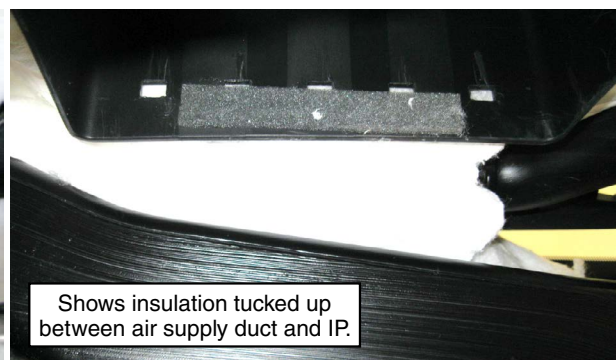
**TIP:** As shown in the photo below, there is a substantial amount of white poly-fill / insulation material around the airbag module location. Before reinstalling the module, **CAREFULLY** tuck the material up into the gap between the air supply duct and underside of the IP to get it out of the way of the “front” retaining claws. Once the module is locked back into position, reach up behind (ahead of) it, **CAREFULLY** pull the insulation back out and put it back into its original position.

Shows insulation tucked up between air supply duct and IP.

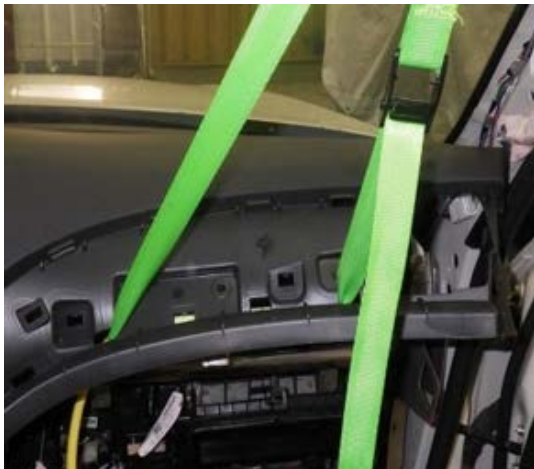
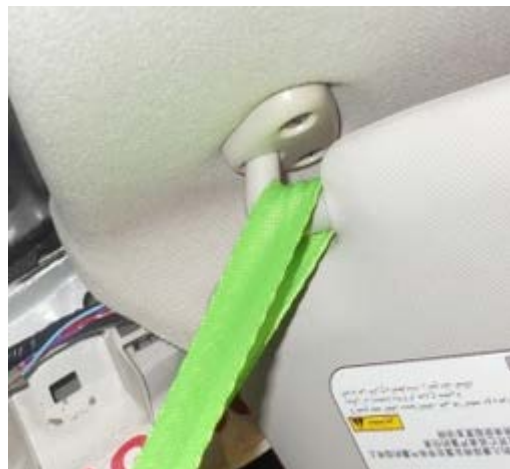
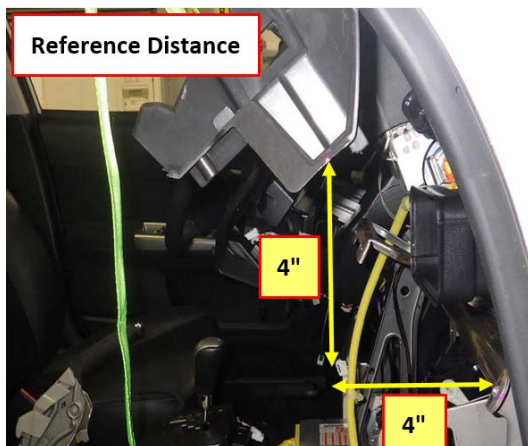
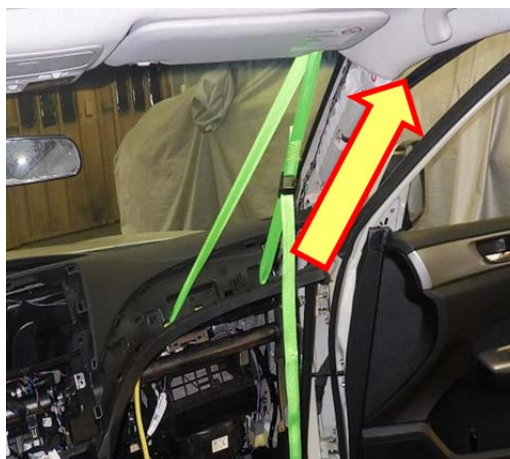
- Once the support strap is installed through the holes on the IP, lift the end of the IP only as much as is needed **without exceeding the Reference Distances** as shown below.
