PRODUCT CAMPAIGN BULLETIN

APPLICABILITY: 2003-2004 Baja
 2003-2008 Legacy and Outback
 2004-2005 Impreza, WRX, STI

SUBJECT: Takata Front Passenger Air Bag Inflator Replacement

NUMBER: WQR-53R
DATE: June 2, 2015
REVISED: April 12, 2016
NHTSA ID: 15V-323

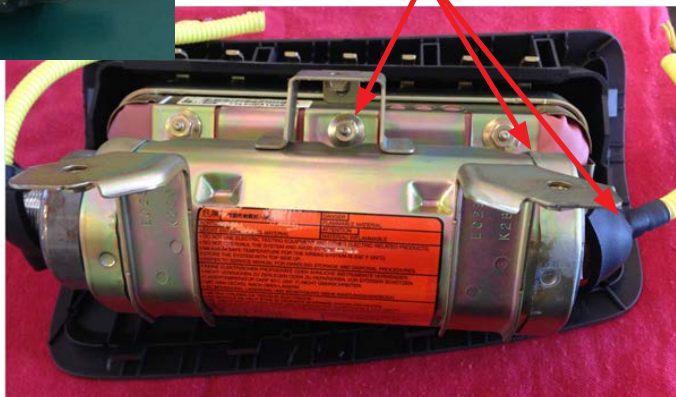
No visible stopper plates, a 6-nut configuration and rubber harness boots are other examples to indicate this is not a Genuine Subaru airbag module.

The shape, holes, and copper-colored stud indicate this not a Genuine Subaru inflator.

- Document the presence of the aftermarket or counterfeit device on the repair order and with photos. Report this information immediately on a Quality Monitoring Report (QMR).
- Once the QMR has been submitted, contact the Subaru Claims Helpline to discuss the details. They will advise you on how to proceed with treatment of the open campaign.
