PRODUCT CAMPAIGN BULLETIN

APPLICABILITY: 2003-2004 Baja
 2003-2008 Legacy and Outback
 2004-2005 Impreza, WRX, STI

NUMBER: WQR-53R
DATE: June 2, 2015
REVISED: December 7, 2017
NHTSA ID: 15V-323

SUBJECT: Takata Front Passenger Air Bag
 Inflator Replacement

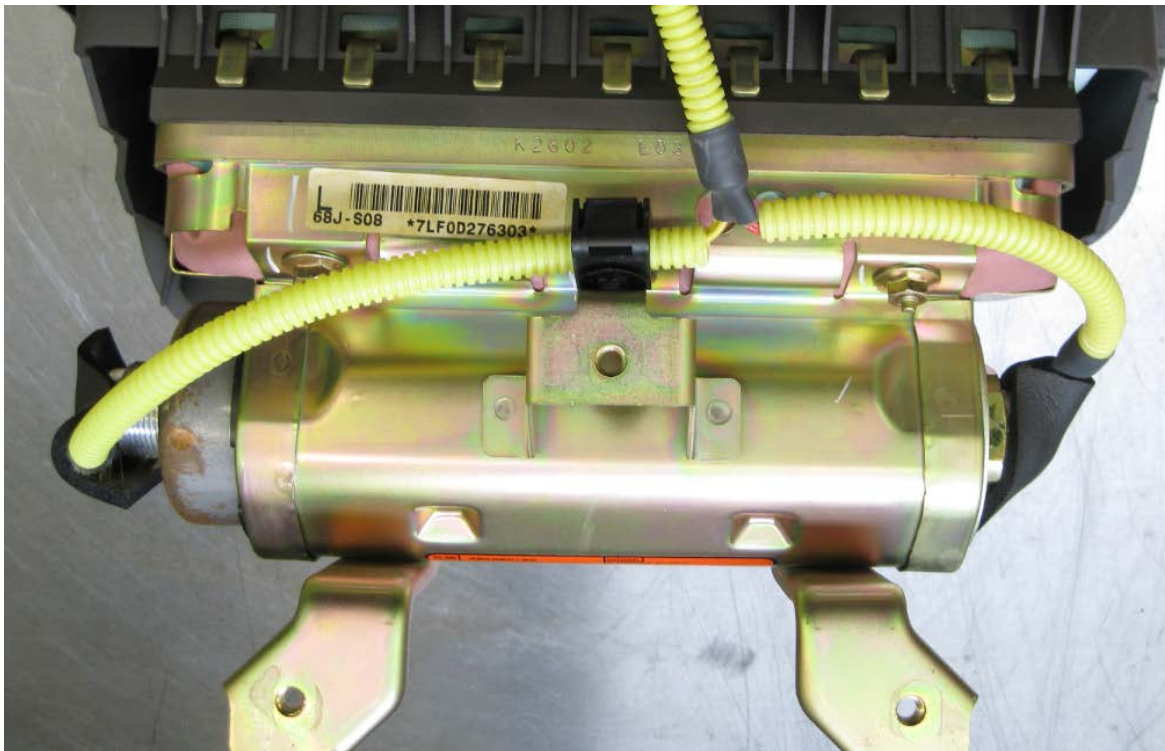
Inflator WITHOUT Ammonium Nitrate- Serial Number Label Location (2003 Legacy, Outback and Baja models only): Record this 12-digit number for claims purposes.

- These early production 2003 MY vehicles (77,000) were equipped with inflators which do not contain ammonium nitrate.
- These inflators which do not contain ammonium nitrate do not require replacement as part of any Subaru airbag recall.

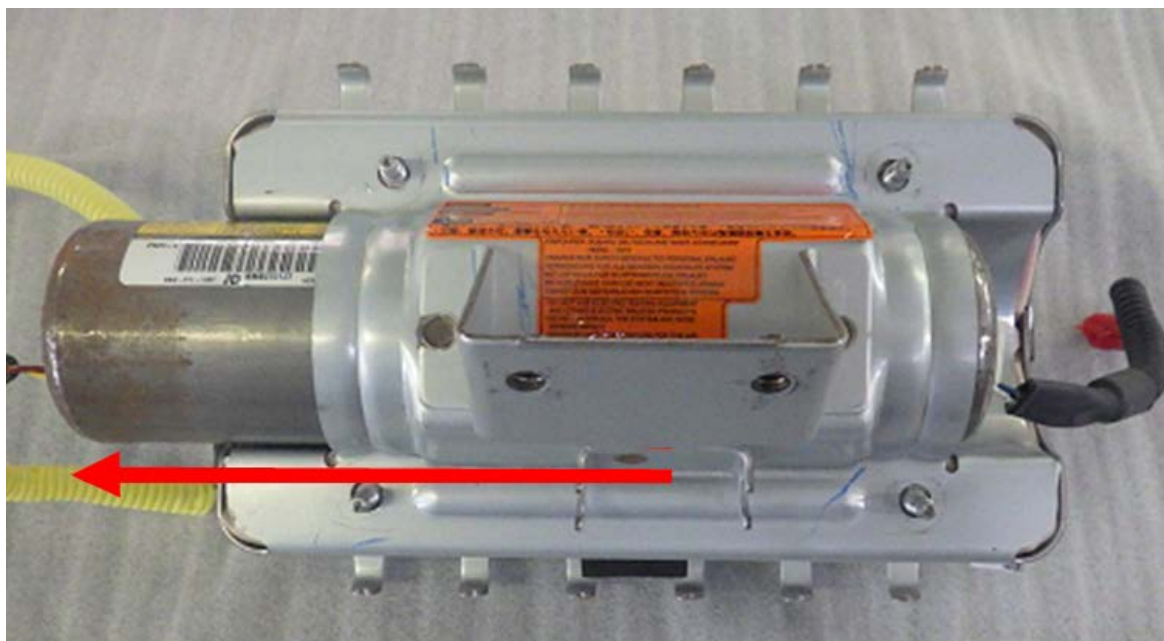
STEP 8- With the self-locking nuts removed, slide the original inflator out of the mounting bracket. Place the removed original air bag inflator back into the “cradle” of the Kit Box insert.

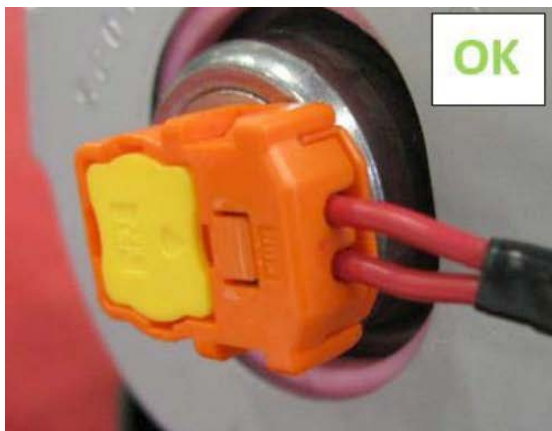
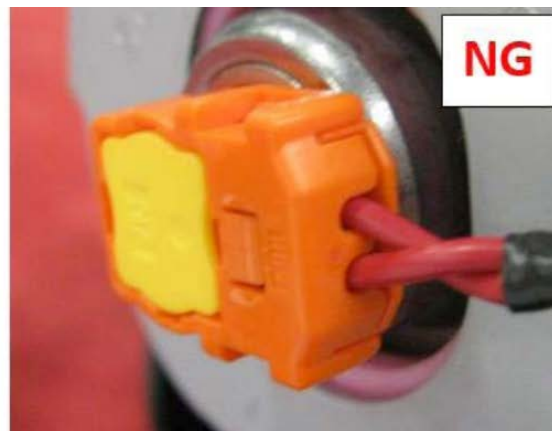
BEFORE connecting the harness to the inflator, make sure the harness is not twisted as shown below.

STEP 16- The new inflator wiring harness has 2 “sides” with 2-pin connectors on both ends. The side with the black harness tube goes with the black inflator connector and the other side (yellow harness tube) will connect to the orange connector. The end of the inflator aligned with the new Stopper Plate (A) will have a black harness connector while the connector on the opposite end of the inflator will be orange. This makes it impossible to install the harness backwards as the tangs (shown in Step 17) are also in different positions.

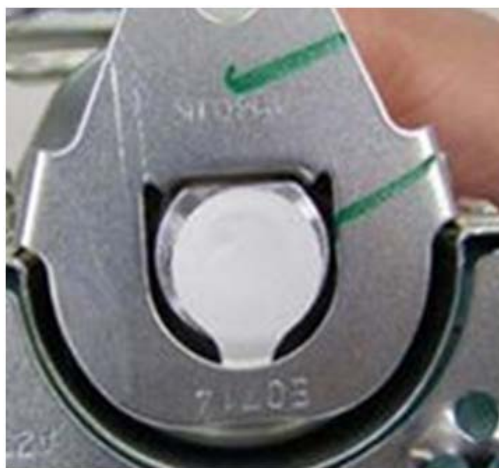
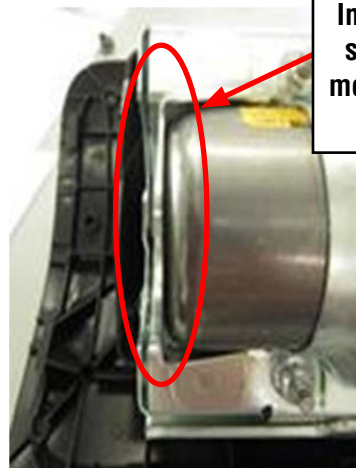
Inflator properly seated against mounting bracket (NO GAP)

STEP 9- Install the new inflator into the mounting bracket so the yellow taped end aligns with the removed stopper plate. Make sure the “D-shaped” portion of the inflator harness connector boss aligns with the “D-shaped” portion of the hole in the end of the mounting bracket as shown below. When properly installed, the end of the inflator will be seated tight against the mounting bracket. Do not peel the white harness connection dust cover at this time.

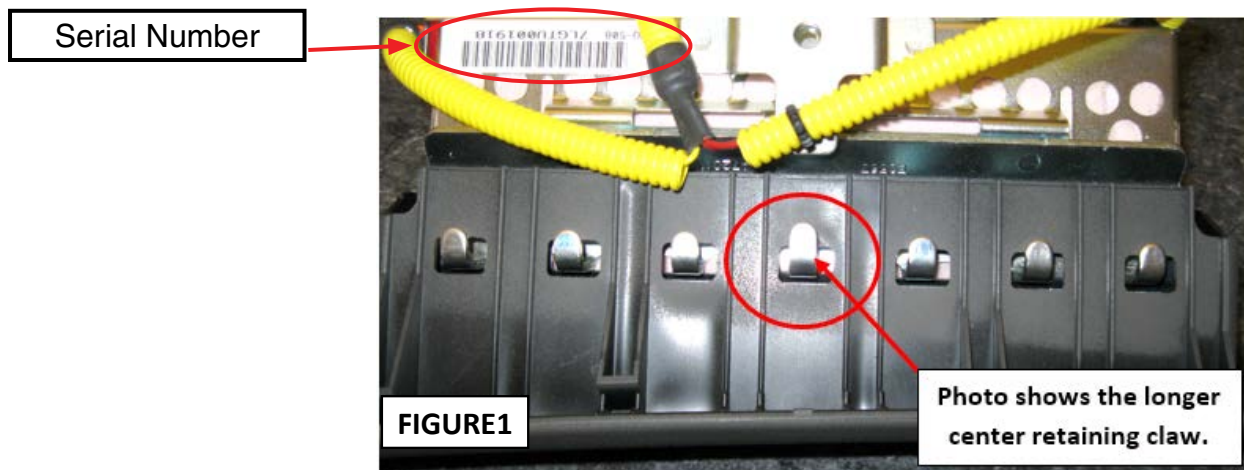
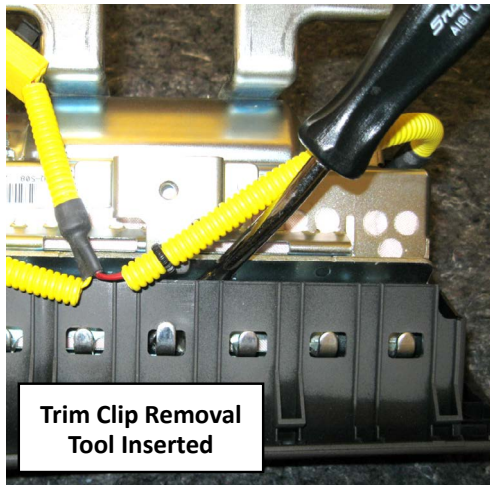
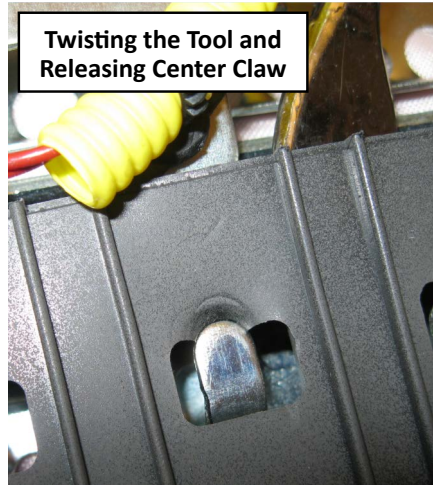
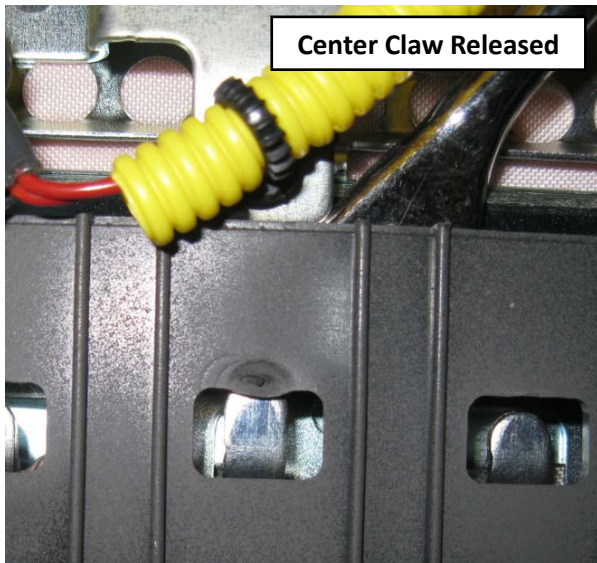
Trim Clip Removal Tool Inserted

Twisting the Tool and Releasing Center Claw

Center Claw Released

All Harness-Side Claws Released

- Using a trim clip removal tool and starting on the harness-side of the module assembly as shown in the sequence below, CAREFULLY insert the tool and twist ONLY AS MUCH AS IS REQUIRED to release the slightly longer center retaining claw from the trim cover. Once released with the tool, the other 6 claws will release easily by hand.
- Rotate the inflator portion of the assembly outward from the cover to release the 7 label-side claws and separate the cover from the module. No tool is required as all the 7 label-side claws are the same size.
