**PRODUCT CAMPAIGN BULLETIN**

**APPLICABILITY:** 2003-2004 Baja  
 2003-2008 Legacy and Outback  
 2004-2005 Impreza, WRX, STI

**SUBJECT:** Takata Front Passenger Air Bag Inflator Replacement

**NUMBER:** WQR-53R  
**DATE:** June 2, 2015  
**REVISED:** January 07, 2016  
**NHTSA ID:** 15V-323

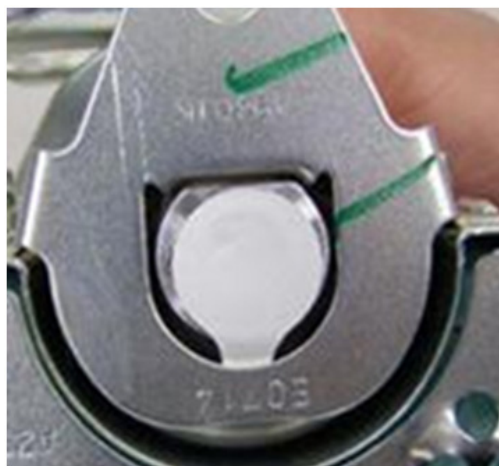
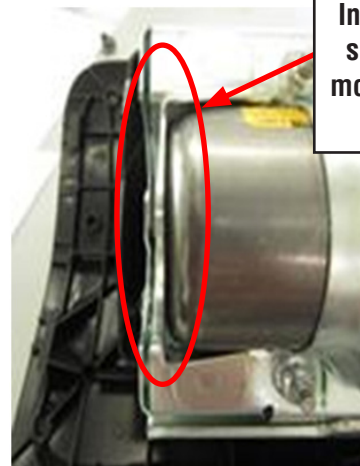
**Inflator properly seated against mounting bracket (NO GAP)**

**STEP 9-** Install the new inflator into the mounting bracket so the yellow taped end aligns with the removed stopper plate. Make sure the “D-shaped” portion of the inflator harness connector boss aligns with the “D-shaped” portion of the hole in the end of the mounting bracket as shown below. When properly installed, the end of the inflator will be seated tight against the mounting bracket. Do not peel the white harness connection dust cover at this time.

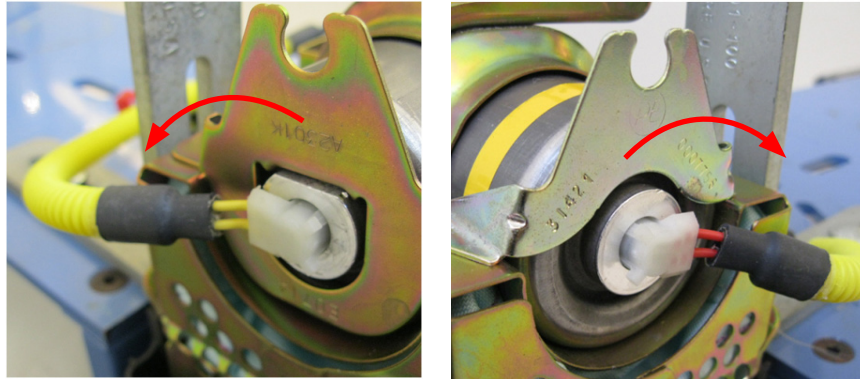
**STEP 11-** The new inflator wiring harness has a “long side” and a “short side” with round 2-pin connectors on both ends. The short side with red wires will connect to the end of the inflator with the round wiring harness connector boss, yellow tape and removable stopper plate. **VERY IMPORTANT: When connecting the new harness to the inflator, both sides of the harness MUST be routed toward the module’s mounting brackets as shown in the photos below.**

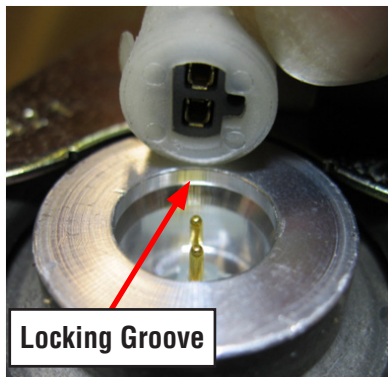
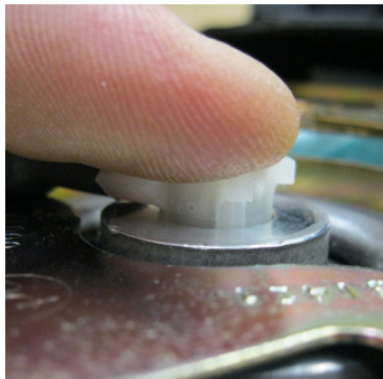
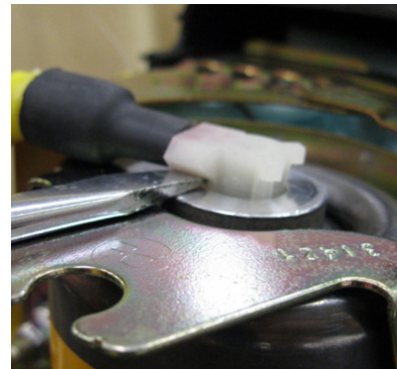
Peel off the white dust cover from the round connector boss end of the inflator **ONLY**. **CAREFULLY** align the pins with the female terminals of the harness connector (2 red wires) as shown in the sequence below. **IMPORTANT: NEVER PEEL BOTH THE WHITE DUST COVERS OFF AT THE SAME TIME!** Once pin alignment is confirmed, push down firmly to engage the connector’s 3 locking tangs into the locking groove inside the connector boss. Confirm the connector is locked by prying up **LIGHTLY** with a small flat-blade screwdriver. Repeat the procedure on the D-shaped connector boss end (2 yellow wires). Reinstall the black wiring harness retaining clip into the mounting bracket to complete the airbag reassembly.

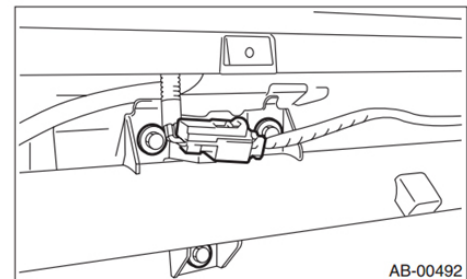
- Disconnect the airbag module harness connector from the support beam bracket.
- Remove the 3 retaining bolts and **CAREFULLY** remove the airbag module from the vehicle and place it on a clean cloth to protect the dash trim surface portion from damage.

**NOTE:** There may be a Security Module secured with the lower airbag module mounting bolt on some models.

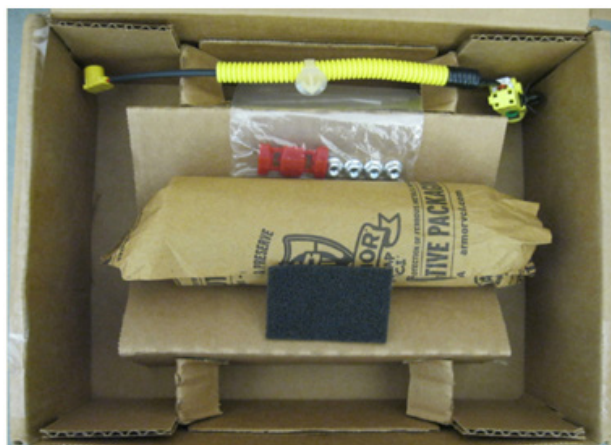
- Open the Kit Box and confirm all the necessary components are included:
  - 4 Self-Locking nuts
  - New Inflator (yellow tape applied to one end to identify it as the replacement part)
  - New Inflator Harness
  - Electro-Tap (red shorting crimp connector)
  - 1 ½” X 2 ¼” piece of self-adhesive Sponge Tape
  - Shipping Documentation and Instructions

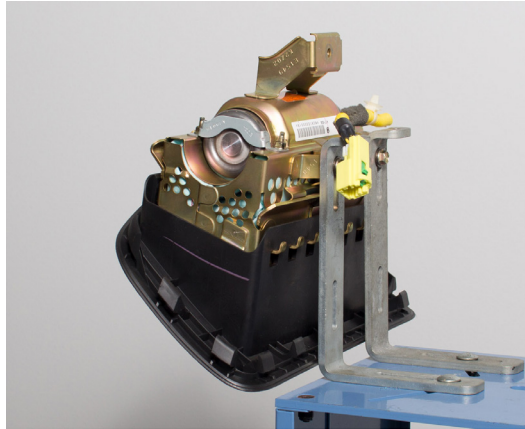
- **IMPORTANT:** The removed airbag module must be mounted to the Airbag Deployment Fixture (part number J-39401-B) as shown in the photo below to better secure it during the inflator and wiring harness component replacement procedures. Always perform this work in an area away from others to reduce chances of inadvertent injury should any deployment occur. Take your surroundings into account to avoid possible hazards should inadvertent deployment occur or sources of static or other electricity that could potentially induce such a deployment.

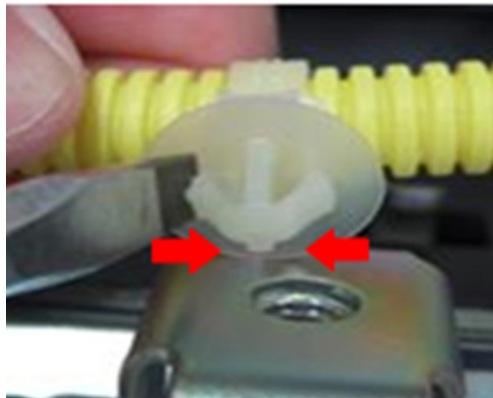
**STEP 2-** Peel the Sponge Tape and remove the harness clip from the retainer bracket by pushing the tangs inward with a flat-blade screwdriver as shown below. Always remove any Sponge Tape adhesive residue from the airbag mounting bracket using mild solvent on a clean shop cloth. **CAUTION:** Never use any silicone-based products for this purpose.

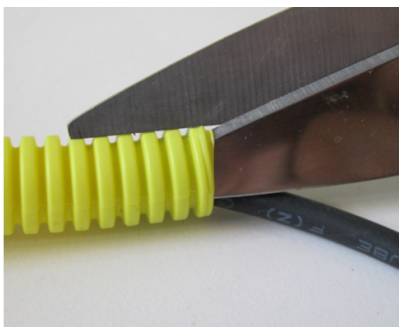
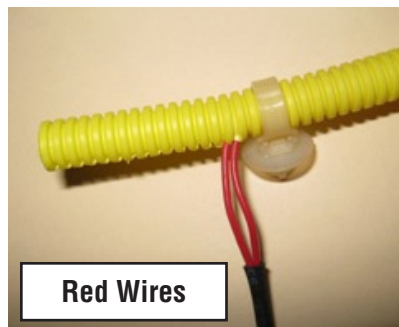
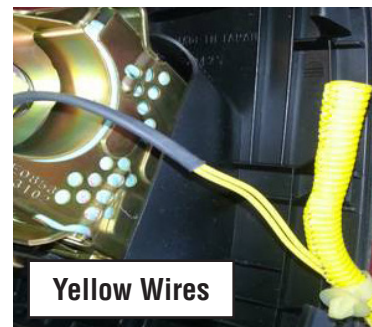
**STEP 3- CAREFULLY** cut the yellow harness cover enough (approximately 2 inches) to expose the 2 red or yellow wires inside and provide enough room to install the Electro-Tap (shorting) connector using a wire cutter or scissor (no knives or razors). **TAKE YOUR TIME AND BE CAREFUL TO NOT CUT THE 2 WIRES!**

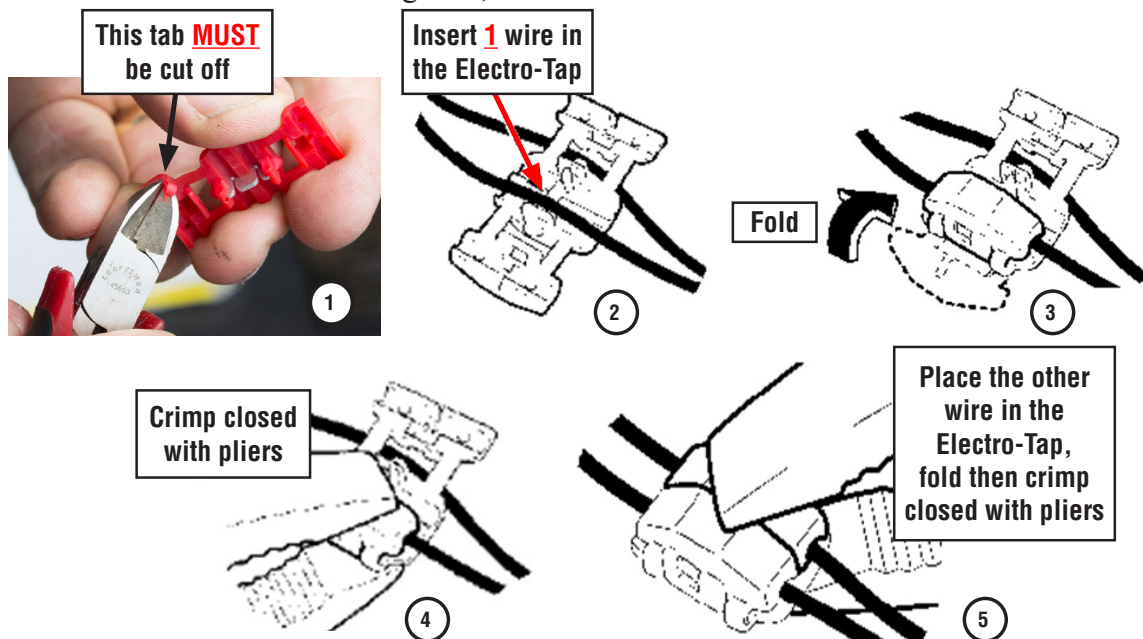
**STEP 4-** Short the 2 wires together by installing the Electro-Tap connector. The connector creates a short circuit which acts as a safeguard to prevent against static discharge that may deploy the removed inflator. The tab portion of the Electro-Tap connector **MUST** be cut off prior to use to insure a good short-circuit is made as shown in the illustration below. **Follow the sequence** below for installing the Electro-Tap connector. Use pliers to squeeze closed the two sections of the connector together, **one section at a time**.

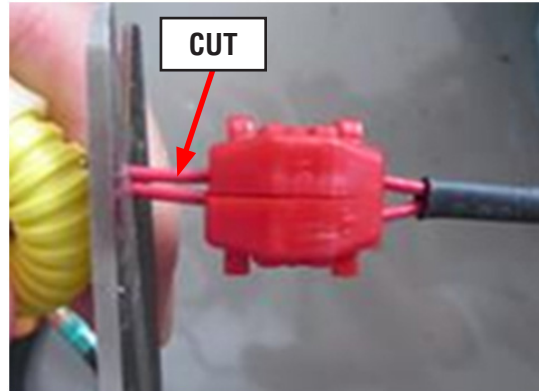
**STEP 5-** Once the Electro-Tap connector is fully crimped in place, cut the 2 wires on the **body harness connector side** of the Electro-Tap connector.

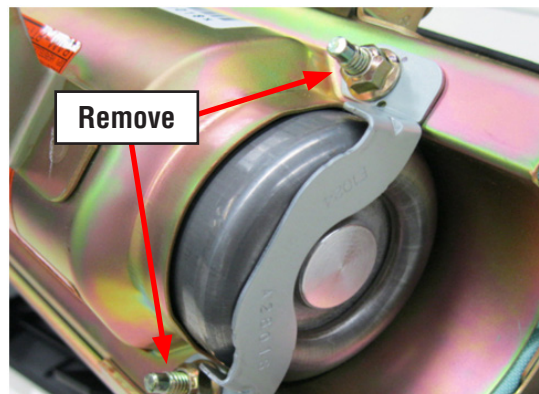
**STEP 6-** Remove the two 8mm self-locking nuts securing the stopper plate. Loosen but **do not remove** the other two nuts on the mounting bracket as leaving them in place will help keep the airbag assembly together.

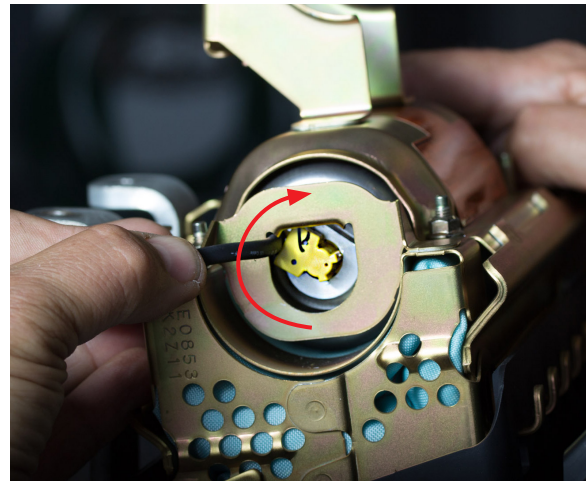
**STEP 7-** With the stopper plate removed and the other 2 self-locking nuts loosened, unseat the inflator off the mounting bracket end plate then rotate it slightly **CLOCKWISE** to make it easier to remove as shown in the photo to the right. Slide the inflator out of its mounting while feeding the cut off portion of the wiring harness through the “D-Shaped” hole in the end of the mounting bracket.

**NEVER ATTEMPT TO REMOVE THE HARNESS FROM THE INFLATOR!**

Place the removed original air bag inflator in the “cradle” of the Kit Box insert.

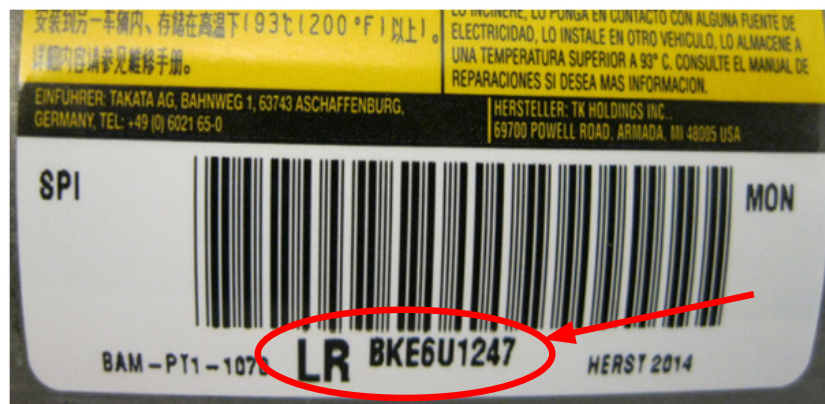
**STEP 8- VERY IMPORTANT:** Record the **11-digit alpha-numeric serial number** for both the new and the removed inflators on the hard copy of the Repair Order. This information will be required for completion of the Part Return Notice which will be forwarded by the retailer to the PCC. The new serial number is also a requirement for claim entry.

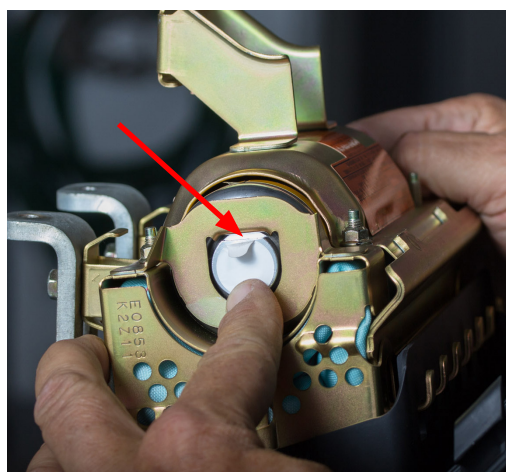
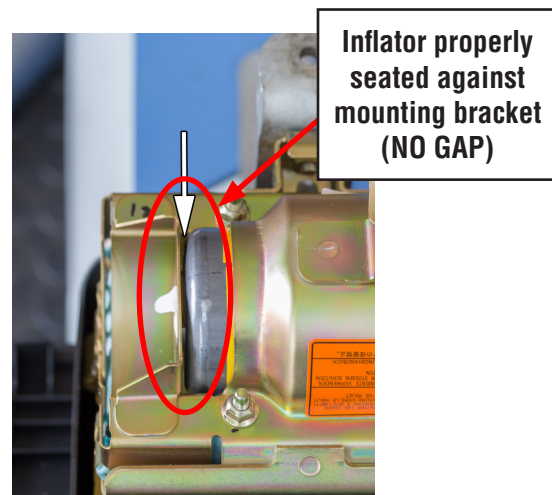
**STEP 9-** Install the new inflator into the mounting bracket with the harness connector end going in first toward the mounting bracket. Make sure the “D-shaped” portion of the inflator harness connector boss aligns with the “D-shaped” portion of the hole in the end of the mounting bracket as shown below. When properly installed, the end of the inflator will be seated tight against the mounting bracket. Do not peel the white harness connection dust cover at this time.

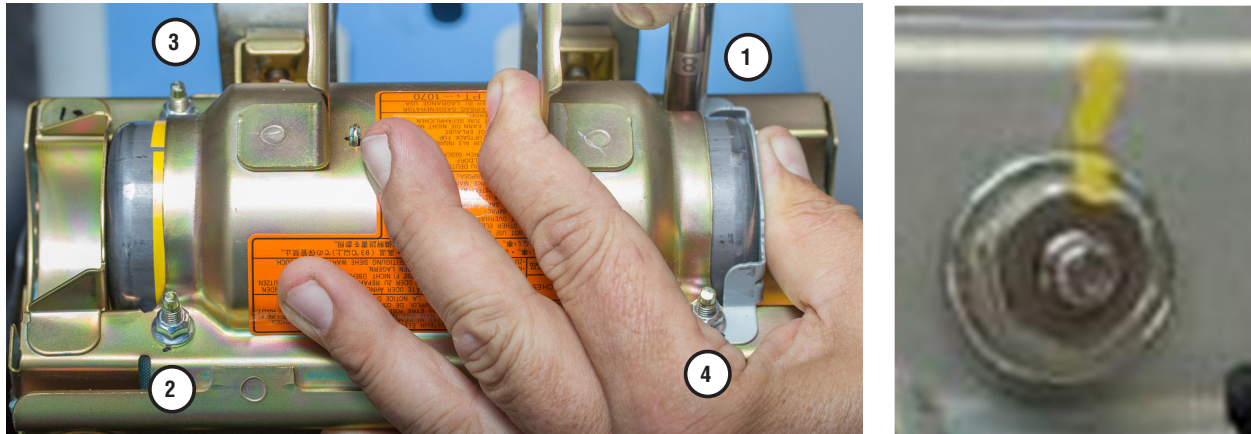
**STEP 10-** As shown below, install but do not fully tighten 2 of the NEW self-locking nuts while holding the stopper plate tight against the inflator. Remove the nuts still installed on the mounting bracket and replace them with 2 NEW self-locking nuts. Once all 4 NEW nuts are in place, torque to 31 - 38 inch pounds in the sequence shown below. Use a marker to mark the nuts after torquing indicating they have been fully tightened.

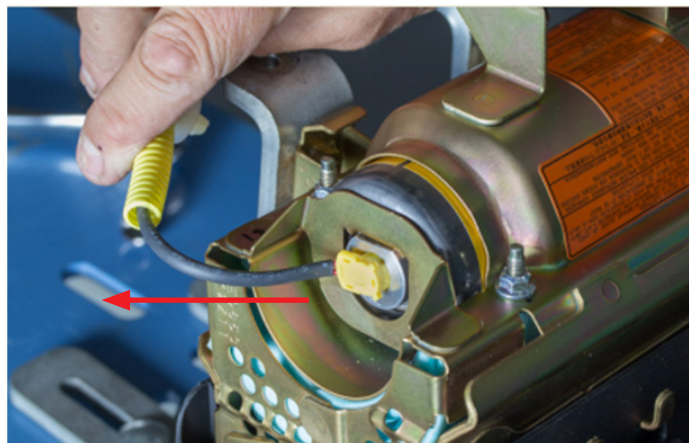
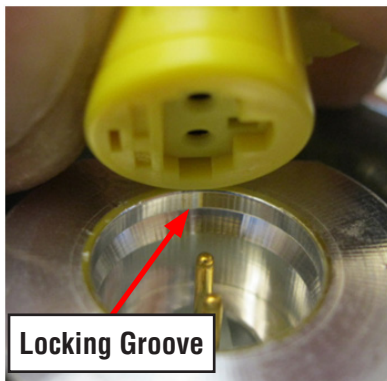
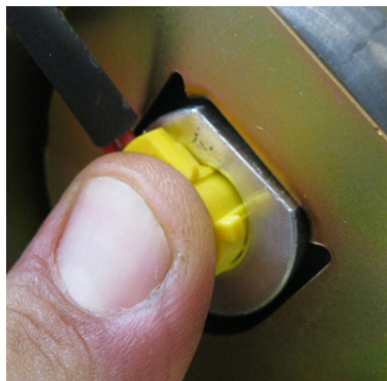
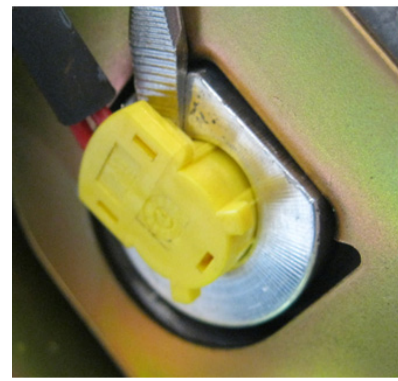
**STEP 11- VERY IMPORTANT:** When connecting the new harness to the inflator, the harness **MUST** be routed toward the module's mounting brackets as shown in the photo below. Peel off the white dust cover and **CAREFULLY** align the 2 inflator pins with the female terminals of the harness connector as shown in the sequence below. Once pin alignment is confirmed, push down firmly to engage the connector's 2 locking tangs into the locking groove of the connector boss. Confirm the connector is fully locked by prying up **LIGHTLY** with a small flat-blade screwdriver.

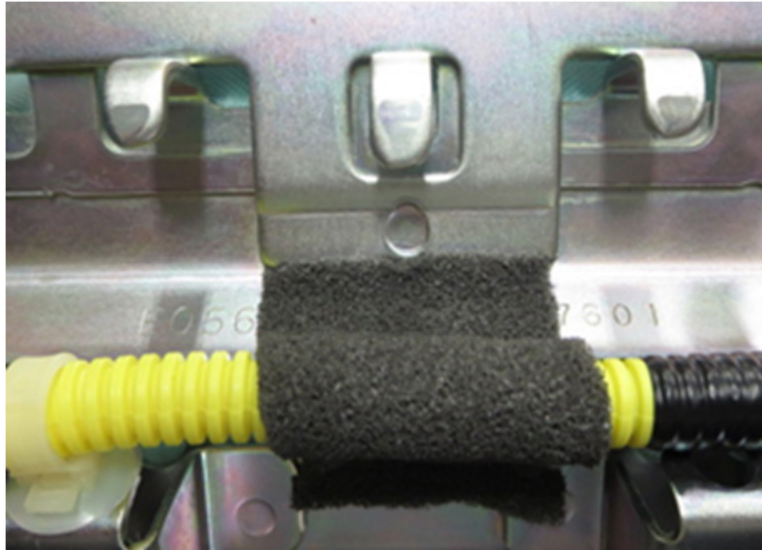
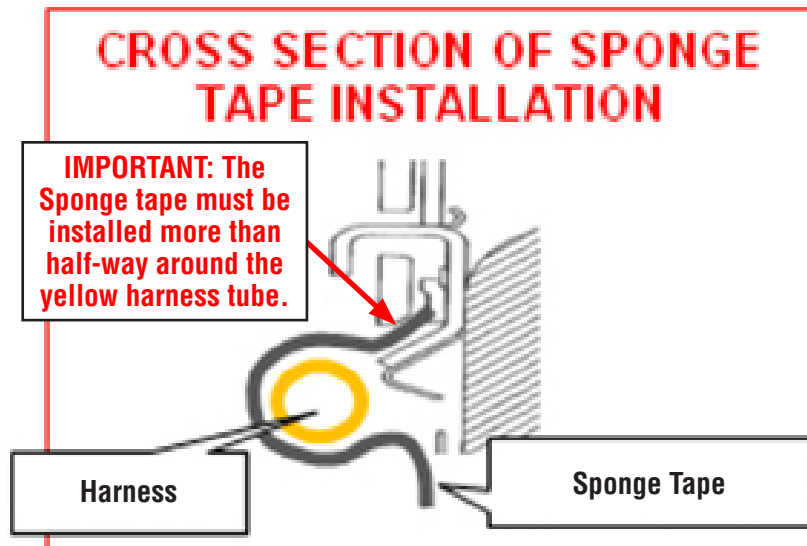
**Placement of Sponge Tape**

**STEP 13-** Peel the adhesive backing and install the new Sponge Tape onto the yellow harness tube first then adhere it to the airbag mounting bracket as shown in the illustrations below.
