PRODUCT CAMPAIGN BULLETIN

APPLICABILITY: 2003-2004 Baja
 2003-2008 Legacy and Outback
 2004-2005 Impreza, WRX, STI
SUBJECT: Takata Front Passenger Air Bag
 Inflator Replacement

NUMBER: WQR-53R
DATE: 06/02/15
REVISED: 05/14/21
NHTSA ID: 15V-323

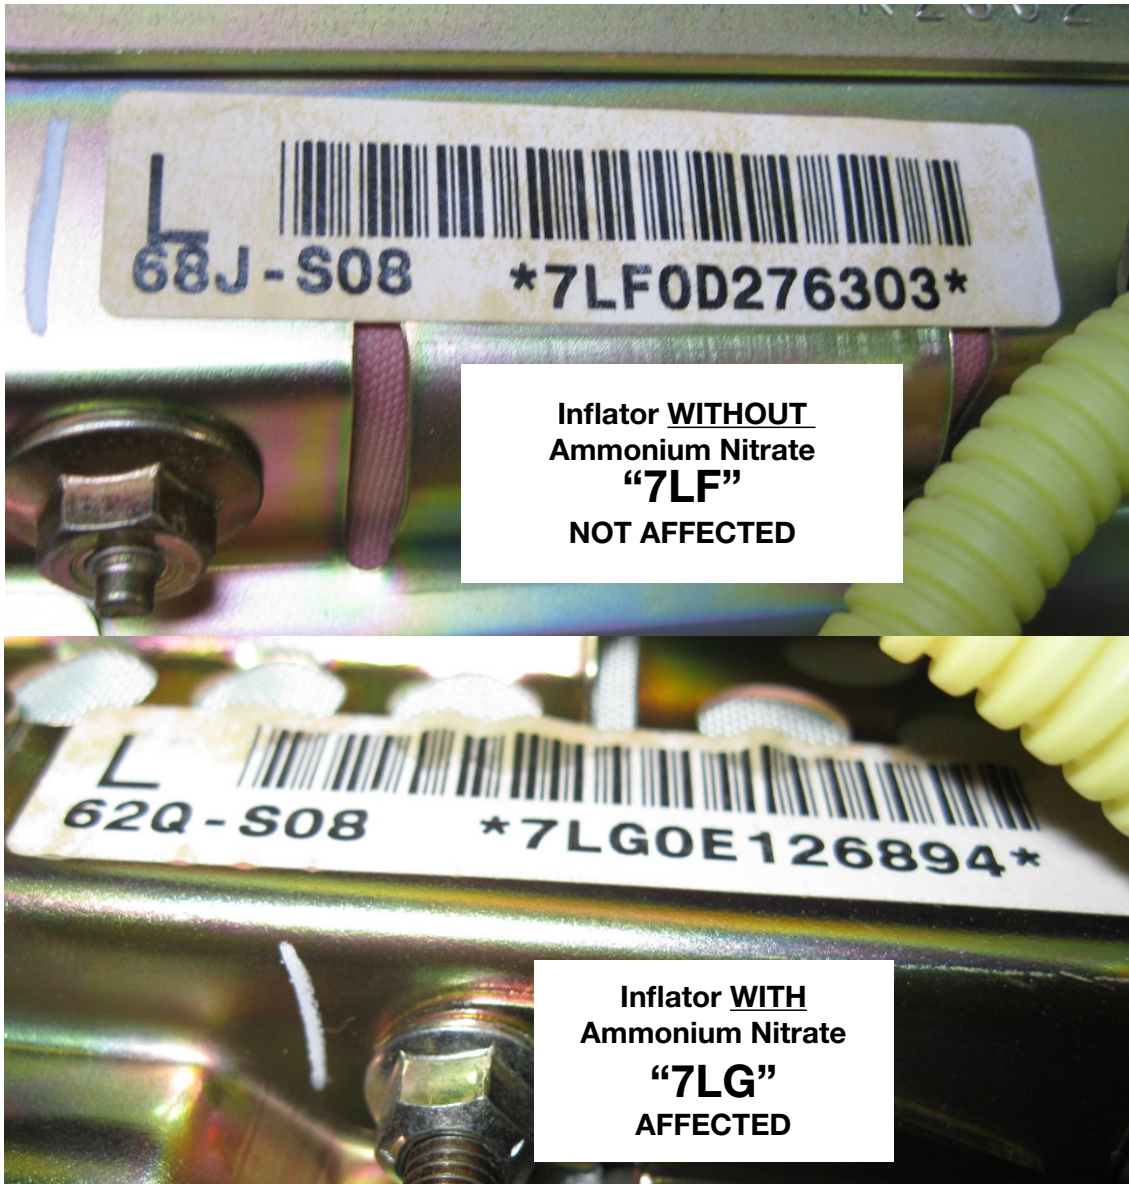
Label Detail

If the serial number label is missing, illegible or if there is any uncertainty if the airbag module is affected by this Recall Campaign, follow the Counterfeit / Non-Genuine airbag inspection process provided above. Always take photos of the module showing the entire inflator along with an additional photo showing the area where the label should be as seen in the photos below. Next, submit a Quality Monitoring Report (QMR) requesting SOA review. A member of the Claims Team will contact the Retailer following review of the QMR submission with information on how to proceed.

IMPORTANT NOTE: The **complete** 11-digit airbag module Serial Number **MUST** be recorded during inspection and entered into the Miscellaneous Detail field as part of the campaign completion / claim entry process.

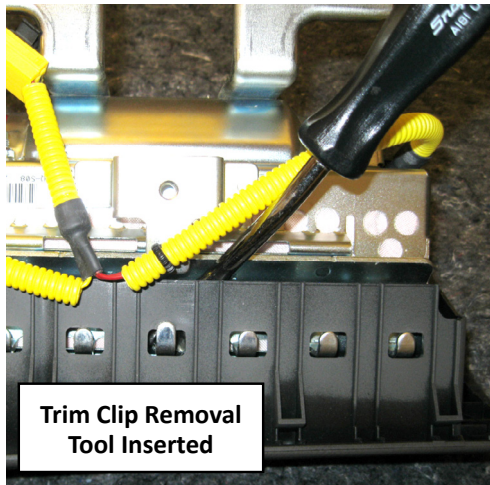
Trim Clip Removal Tool Inserted

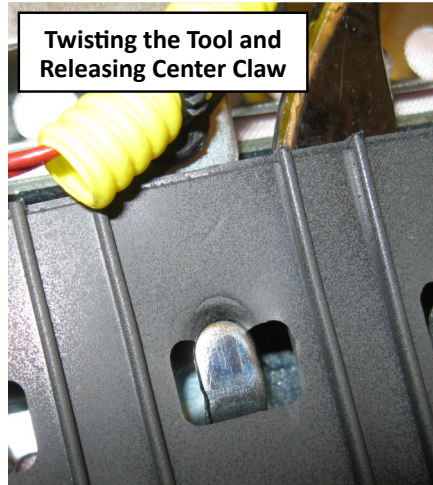
Twisting the Tool and Releasing Center Claw

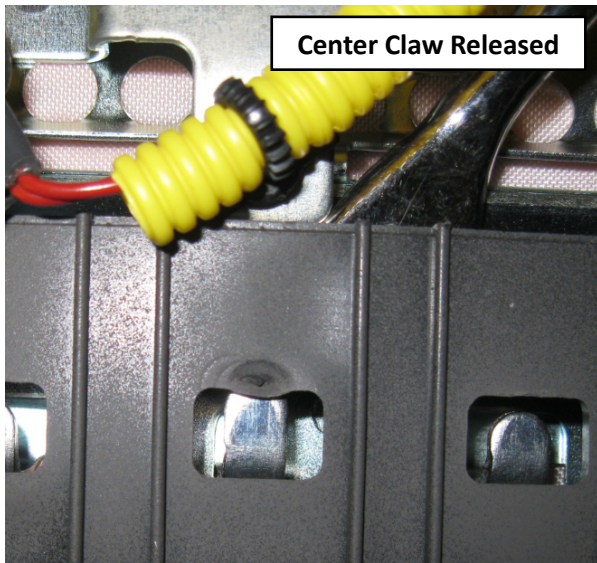
Center Claw Released

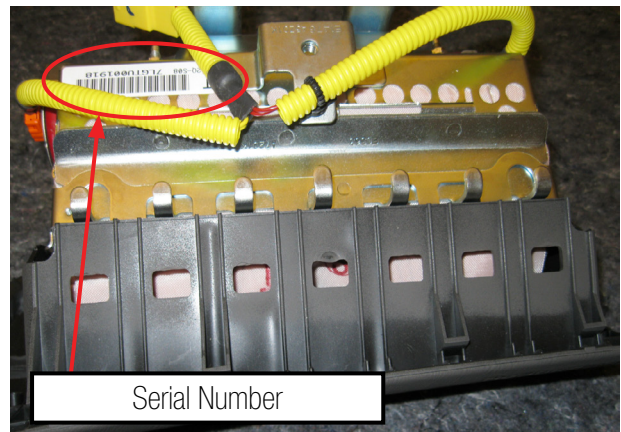
All Harness-Side Claws Released

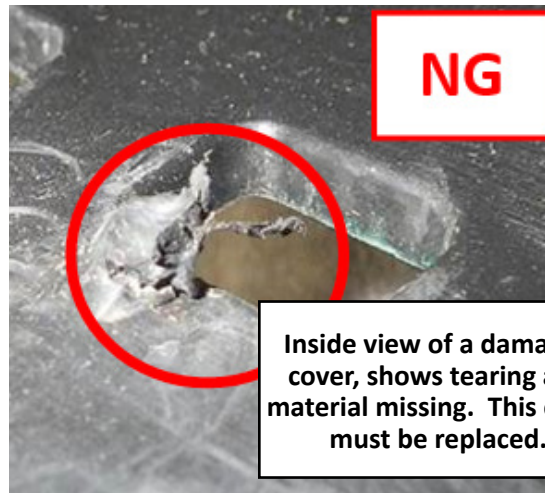
NG

Inside view of a damaged cover, shows tearing and material missing. This cover must be replaced.

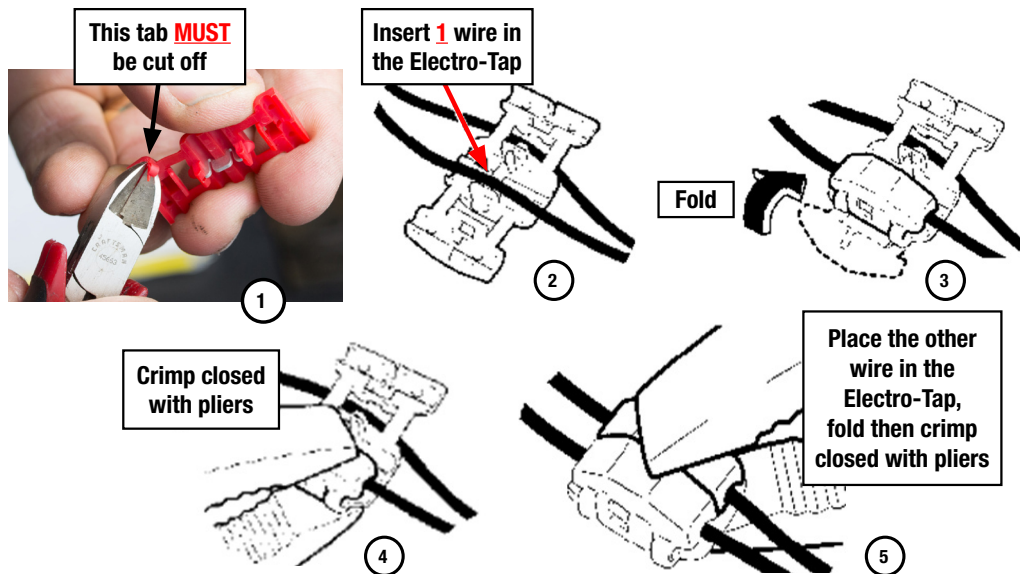
STEP 4- Short the 2 wires together by installing the Electro-Tap connector. The connector creates a short circuit which acts as a safeguard to prevent against static discharge that may deploy the removed inflator. The tab portion of the Electro-Tap connector **MUST** be cut off prior to use to insure a good short-circuit is made as shown in the illustration below. **Follow the sequence** below for installing the Electro-Tap connector. Use pliers to squeeze closed the two sections of the connector together, **one section at a time**.

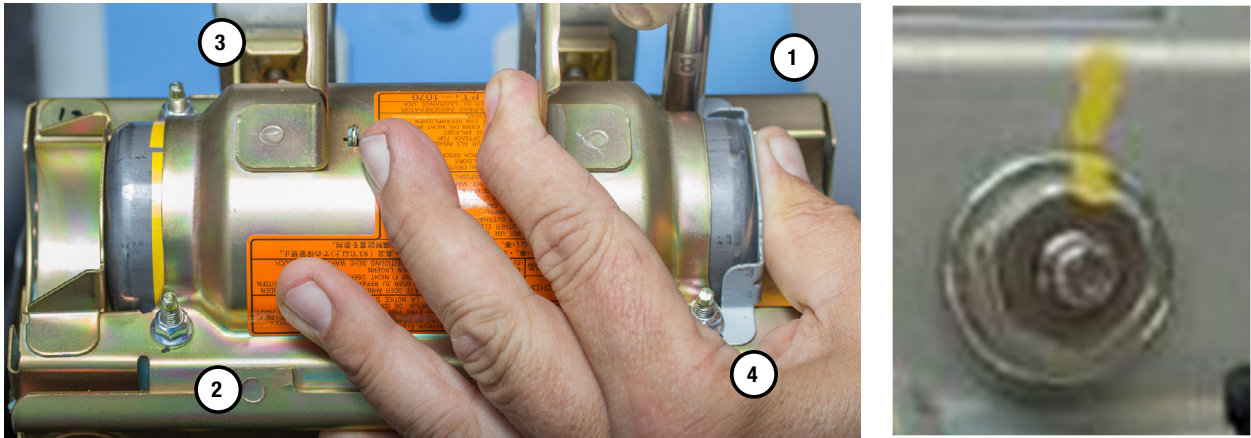
STEP 10- As shown below, install but do not fully tighten 2 of the NEW self-locking nuts while holding the stopper plate tight against the inflator. Remove the nuts still installed on the mounting bracket and replace them with 2 NEW self-locking nuts. Once all 4 NEW nuts are in place, torque to 31 - 38 inch pounds in the sequence shown below. Use a marker to mark the nuts after torquing indicating they have been fully tightened.

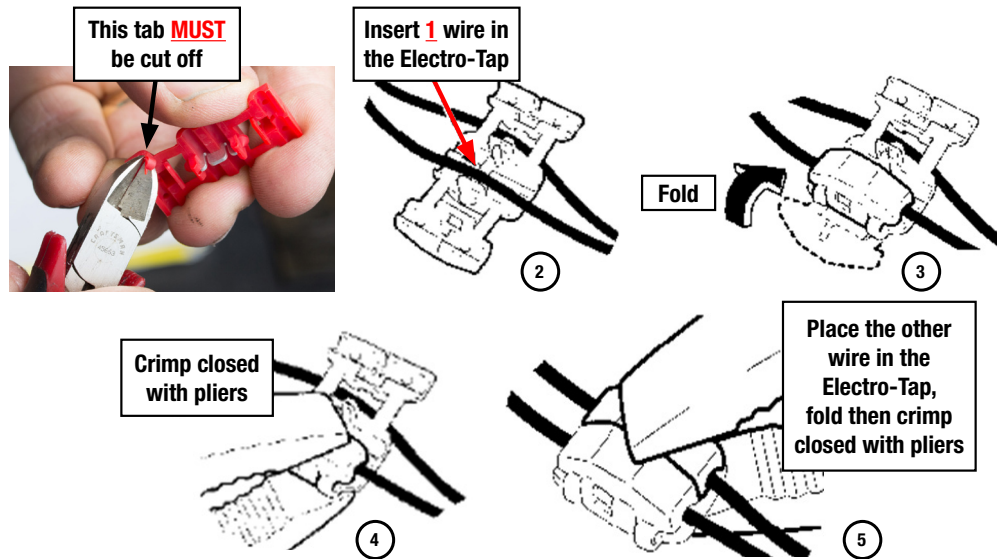
STEP 4- Short the 2 wires together by installing the Electro-Tap connector. The connector creates a short circuit which acts as a safeguard to prevent against static discharge that may deploy the removed inflator. The tab portion of the Electro-Tap connector **MUST** be cut off prior to use to insure a good short-circuit is made as shown in the illustration below. **Follow the sequence** below for installing the Electro-Tap connector. Use pliers to squeeze closed the two sections of the connector together, **one section at a time**.
