PRODUCT CAMPAIGN BULLETIN

APPLICABILITY: 2003-2004 Baja
 2003-2008 Legacy and Outback
 2004-2005 Impreza, WRX, STI

SUBJECT: Takata Front Passenger Air Bag Inflator Replacement

NUMBER: WQR-53R
DATE: June 2, 2015
REVISED: September 7, 2016
NHTSA ID: 15V-323

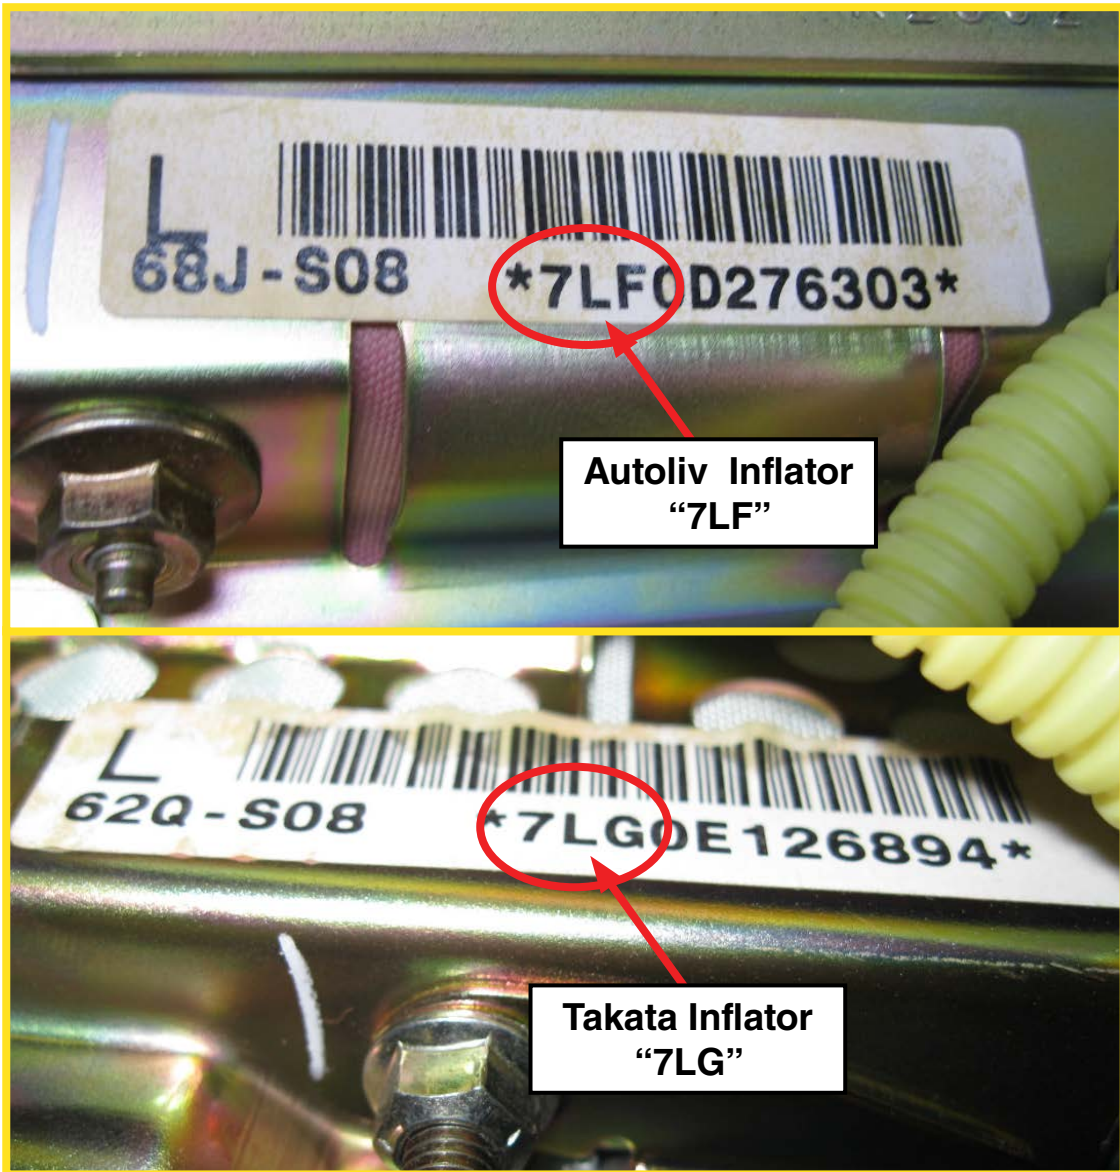
Label Detail

Subaru of America, Inc. (Subaru) has been notified by Fuji Heavy Industries (FHI) that some early production 2003 MY Legacy, Outback, and Baja vehicles may have been incorrectly included in the list of vehicles requiring inflator replacement as part of the on-going Takata recalls listed above.

- These vehicles were NOT equipped with inflators manufactured by Takata.
- These early production 2003 MY vehicles (77,000) were equipped with inflators produced by Autoliv.
- Autoliv produced inflators do not contain ammonium nitrate and are not included in any Takata inflator recall.
- These Autoliv inflators do not require replacement as part of any Subaru airbag recall.

See the Claim Reimbursement and Entry Procedures at the end of this announcement for instructions on how to submit a claim for “Inspection Only” when an Autoliv inflator is found.

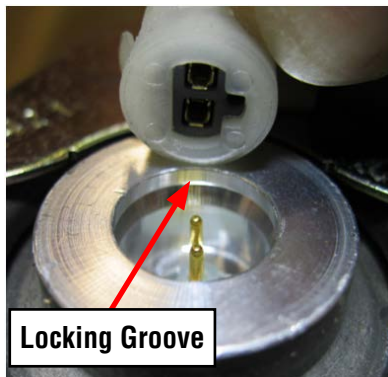
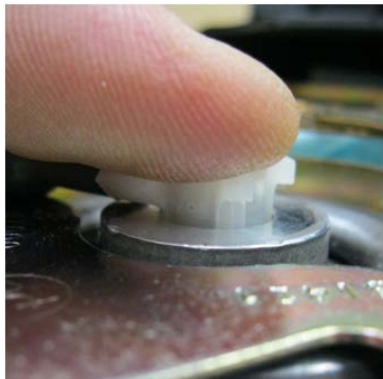
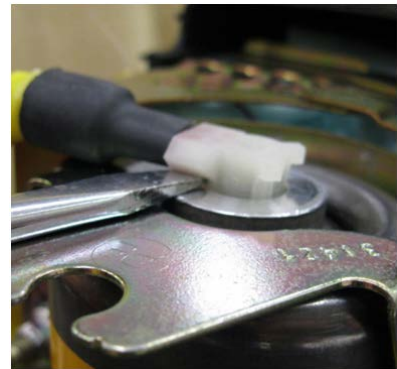
Locking Groove

Peel off the white dust cover from the round connector boss end of the inflator **ONLY**. **CAREFULLY** align the pins with the female terminals of the harness connector (2 red wires) as shown in the sequence below. **IMPORTANT: NEVER PEEL BOTH THE WHITE DUST COVERS OFF AT THE SAME TIME!** Once pin alignment is confirmed, push down firmly to engage the connector’s 3 locking tangs into the locking groove inside the connector boss. Confirm the connector is locked by prying up **LIGHTLY** with a small flat-blade screwdriver. Repeat the procedure on the D-shaped connector boss end (2 yellow wires). Reinstall the black wiring harness retaining clip into the mounting bracket to complete the airbag reassembly.

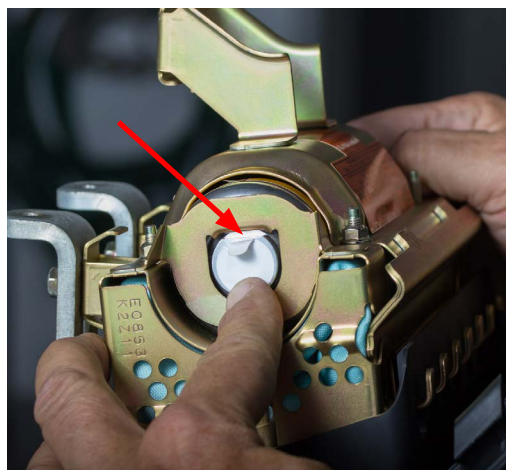
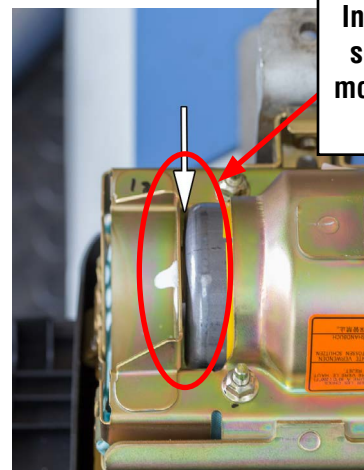
Inflator properly seated against mounting bracket (NO GAP)

STEP 9- Install the new inflator into the mounting bracket with the harness connector end going in first toward the mounting bracket. Make sure the “D-shaped” portion of the inflator harness connector boss aligns with the “D-shaped” portion of the hole in the end of the mounting bracket as shown below. When properly installed, the end of the inflator will be seated tight against the mounting bracket. Do not peel the white harness connection dust cover at this time.
