PRODUCT CAMPAIGN BULLETIN

<p>APPLICABILITY: 2003-2006 model year Baja 2003-2004 model year Legacy 2003-2004 model year Outback 2009-2011 model year Legacy 2009-2011 model year Outback 2009-2011 model year Forester 2006-2011 model year Tribeca 2006-2011 model year Impreza (including WRX and STI)</p>	<p>NUMBERS: TKA-16R TKB-16R TKC-16R</p> <p>DATE: 07/13/16</p> <p style="background-color: #f1c40f;">REVISED: 10/05/17</p> <p>NHTSA ID: 16V-358 16V-359 16V-361</p>
---	--

SUBJECT: Takata Front Passenger Airbag Inflator Replacement

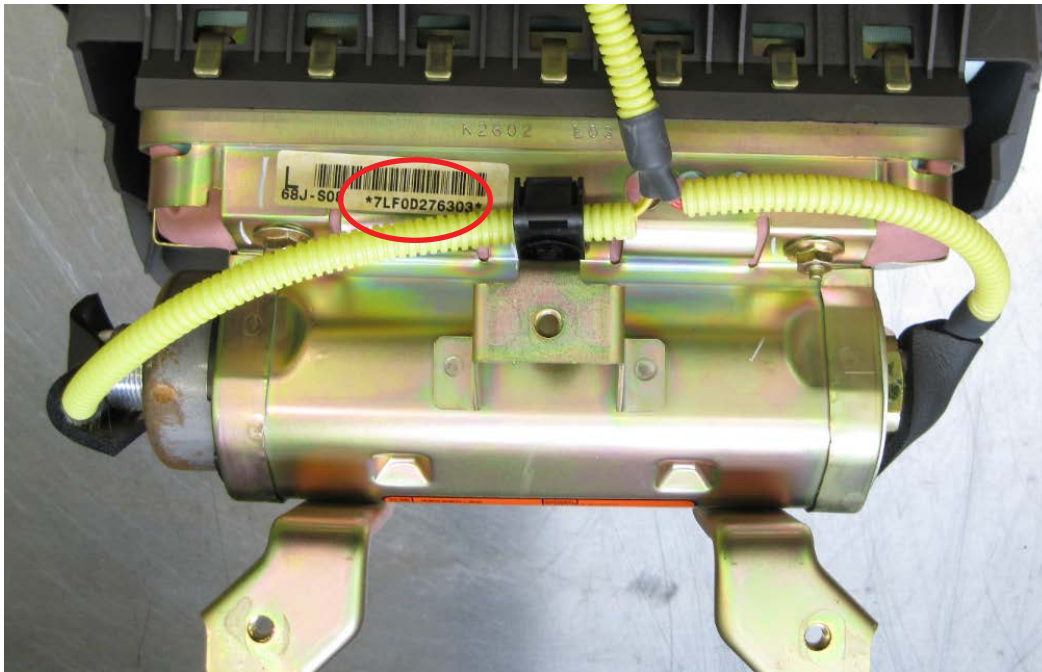
Inflator WITHOUT Ammonium Nitrate- Serial Number Label Location (2003 Legacy, Outback and Baja models only): Record this **11-digit** number for claims purposes.

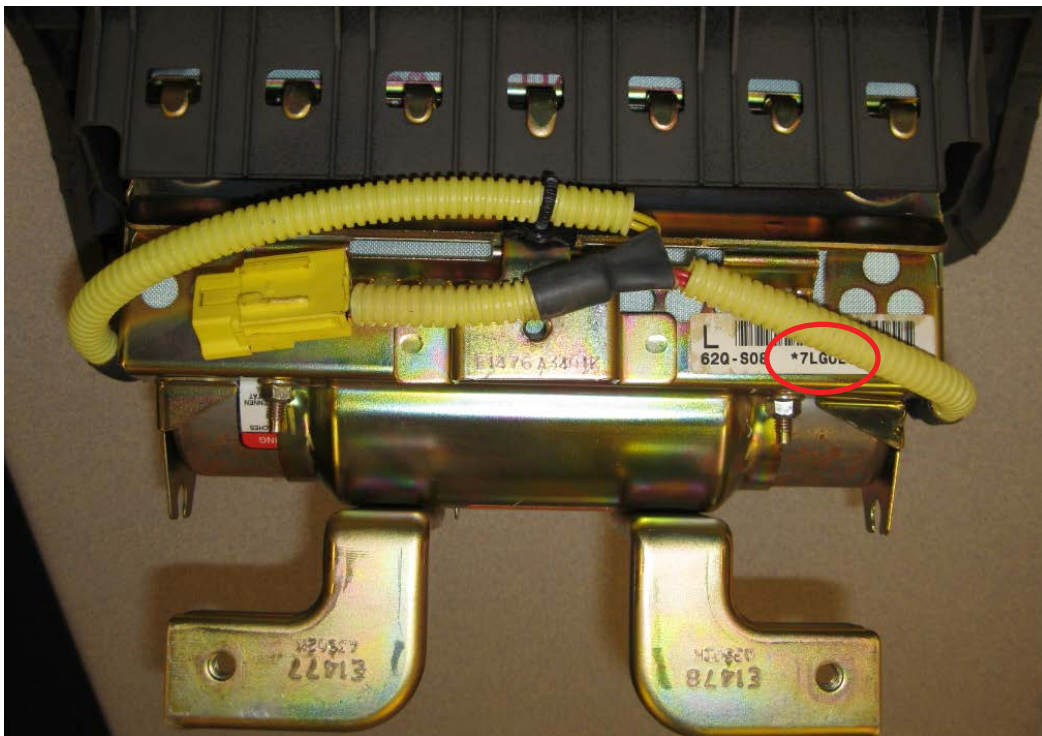
Inflator WITH Ammonium Nitrate- Serial Number Label Location
