SAFETY RECALL ACTION

Reference number:	RA-07-0023	Issued: 6 July, 2017
Subject:	Connector failure on V8 Vantage 6-Speed SportShift Transmission	
Model(s):	V8 Vantage with 6-Speed SportShift Transmission	
VIN range:	Refer to the separately published list of VINs	
Applicable to:	All USA Dealers	
Distribute to:	After Sales Manager Executive Manager Service Manager Sales Manager	Warranty Staff Technician(s) Parts Staff

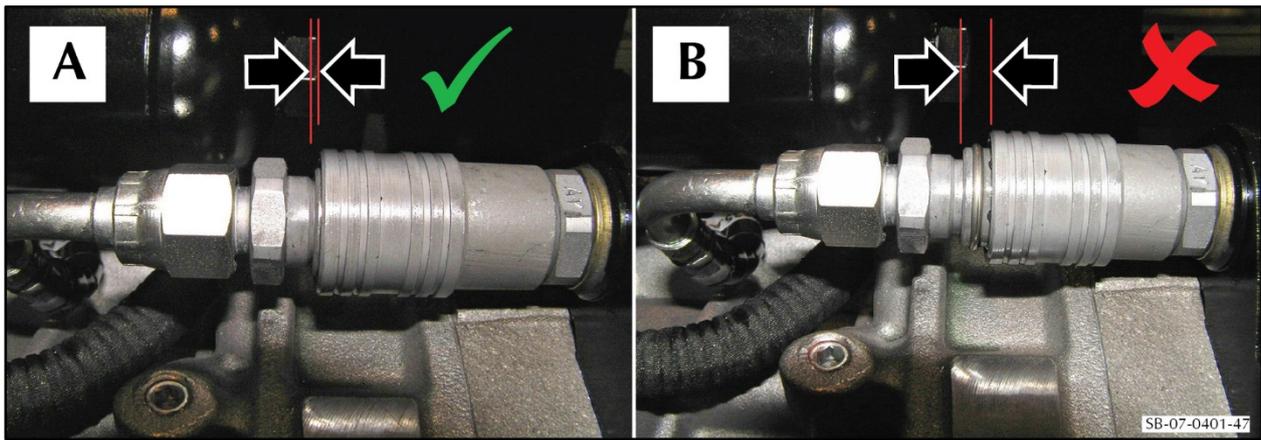
Figure 49

94. Connect the dry-break connector to the tube assembly for the clutch slave cylinder (refer to Figure 48). Make sure that the locking collar for the connector is in the correct position shown in view A of Figure 49. View B shows a connector that is not correctly connected.
