## IMPORTANT SAFETY RECALL

NHTSA Safety Recall  
No. 18V-006

## Slewing Ring Bolt Check

## **TECHNICAL BULLETIN N° 30/2017**

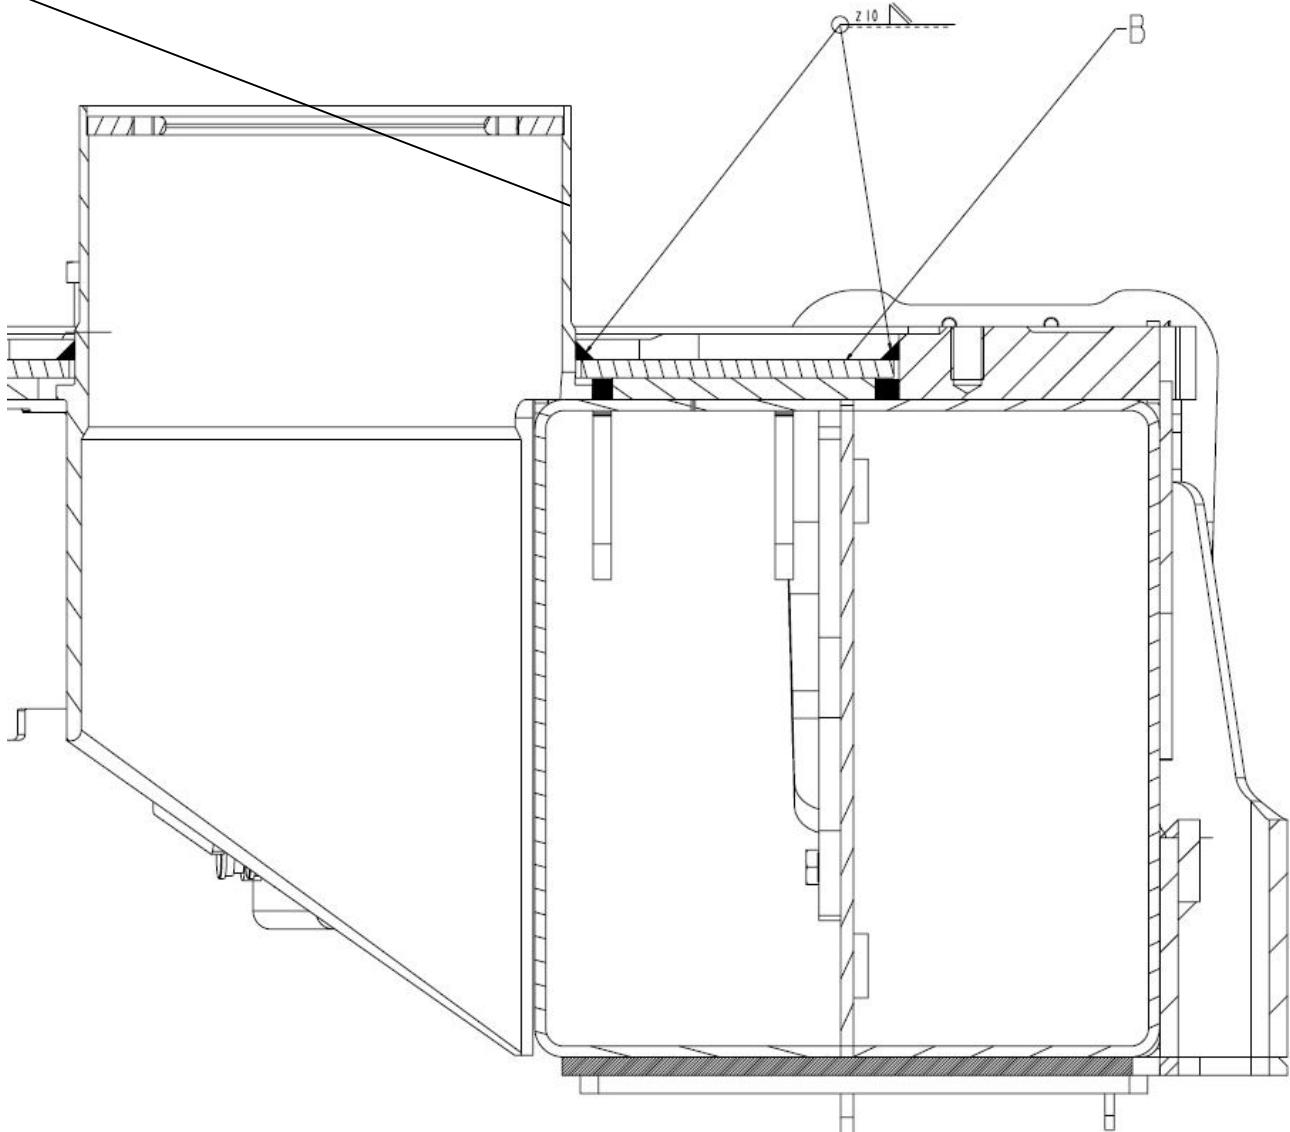
**Picture 5**

The welding between plate B and tube T has to be interrupted in the water drainage area (see picture 4). The final result is shown in picture 5.

9. Paint where necessary except plane W. After the placement of slewing ring H on plane W, tighten bolts G with a torque of **459 Nm**. Tighten following procedure in attachment at the end of the bulletin.
