PRODUCT CAMPAIGN BULLETIN

APPLICABILITY:	2009-2013 model year Legacy 2009-2013 model year Outback 2009-2013 model year Forester 2009-2013 model year Tribeca 2009-2011 model year Impreza 2009-2013 model year WRX and STI	NUMBERS: TKA-18 TKB-18 TKC-18
		DATE: 02/09/18
		NHTSA ID: 18V-012 18V-013 18V-014
SUBJECT:	Takata Front Passenger Airbag Inflator Replacement (2018 Calendar year expansion)

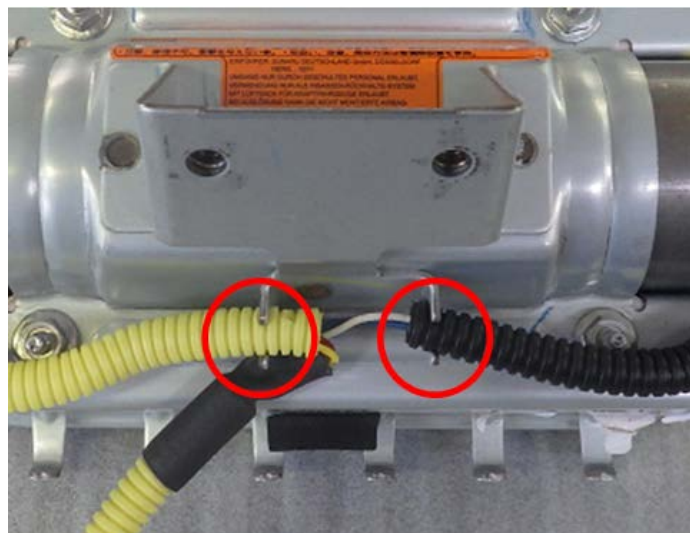
STEP 3- Remove the harness tube from the retainer bracket holders.

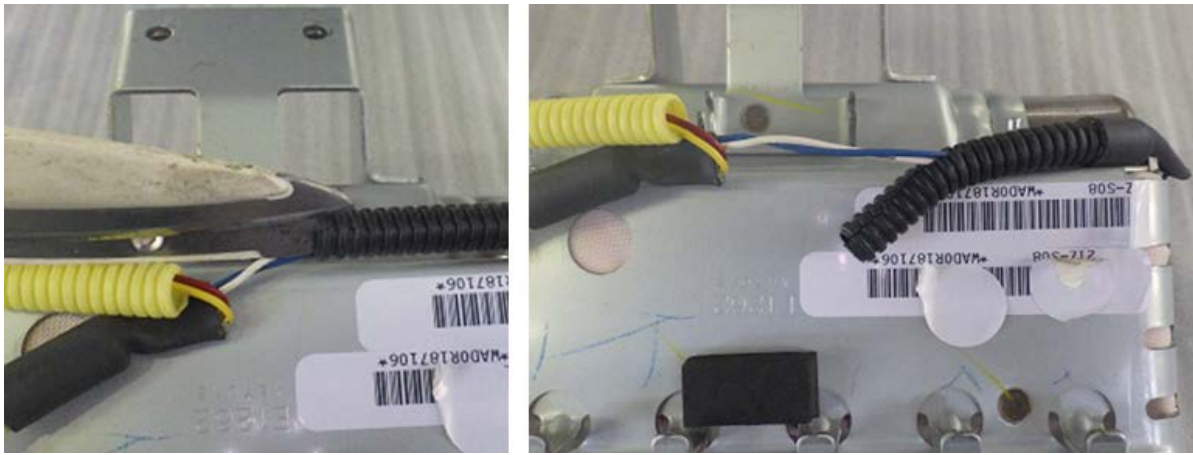
STEP 4- Using a scissor or wire cutter (no knives or razors) **CAREFULLY** cut the black harness cover tube (approximately 1 1/2 inches) enough to expose the blue and white wires inside and provide enough room to install the Electro-Tap (shorting) connector.

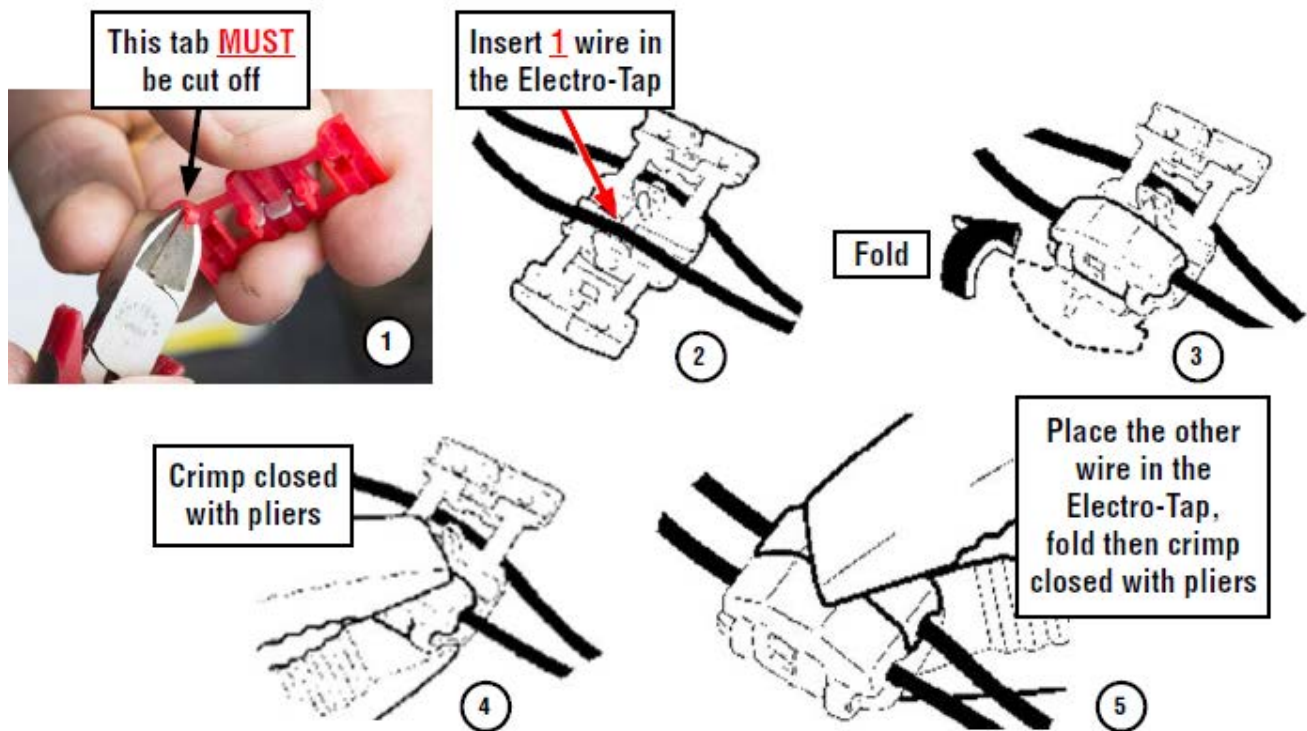
STEP 5- Short the white and blue wires together by installing the Electro-Tap connector. The connector creates a short circuit which acts as a safeguard to prevent against static discharge that may deploy the removed inflator. The tab portion of the Electro-Tap connector **MUST** be cut off prior to use to insure a good short-circuit is made as shown in the illustration below. **Follow the sequence below** for installing the Electro-Tap connector. Use pliers to squeeze closed the two sections of the connector together, **one section at a time**.

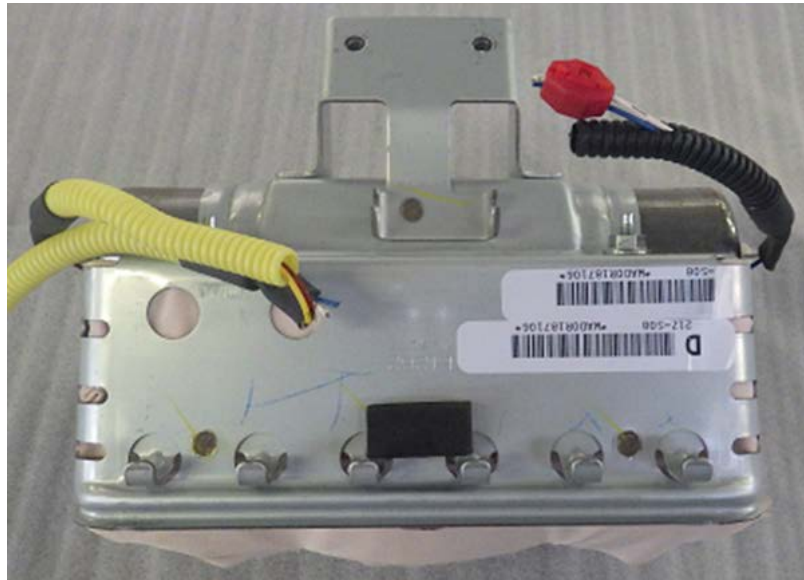
STEP 6- Once the Electro-Tap connector is fully crimped in place, cut the white and blue wires **on the body harness connector side** of the Electro-Tap connector.

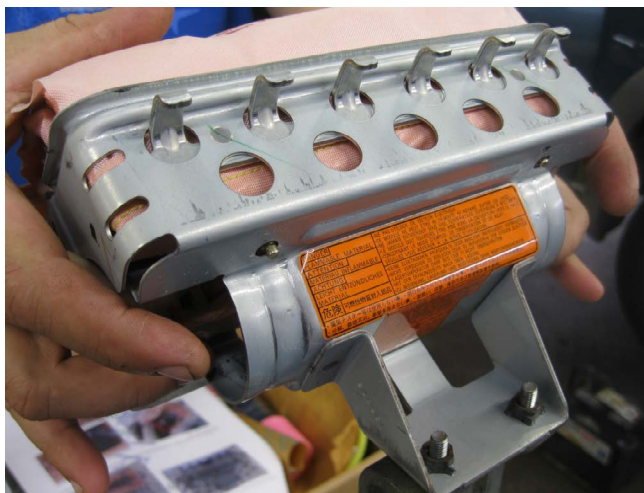
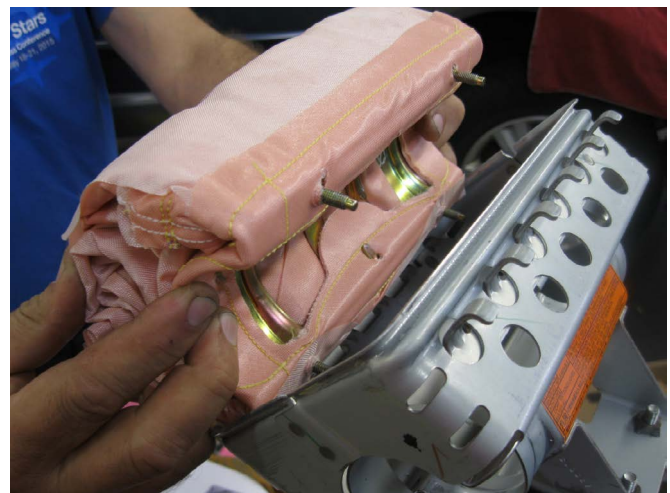
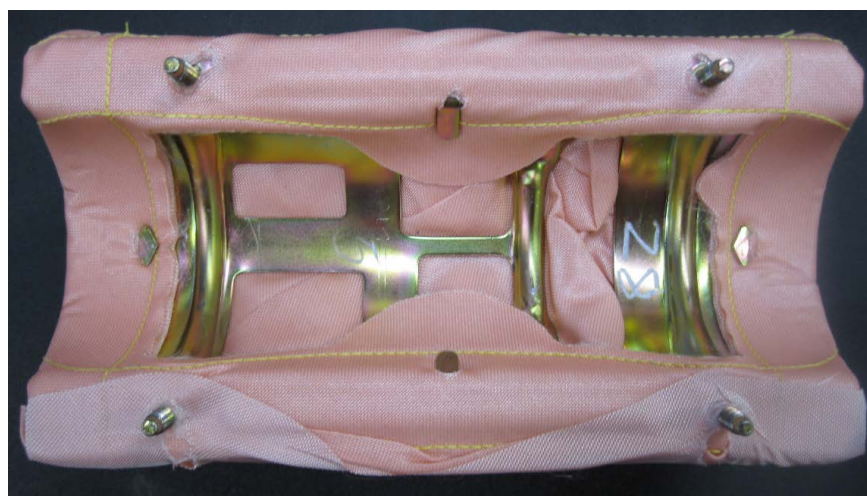
STEP 10- CAREFULLY remove the airbag from the mounting bracket (case).

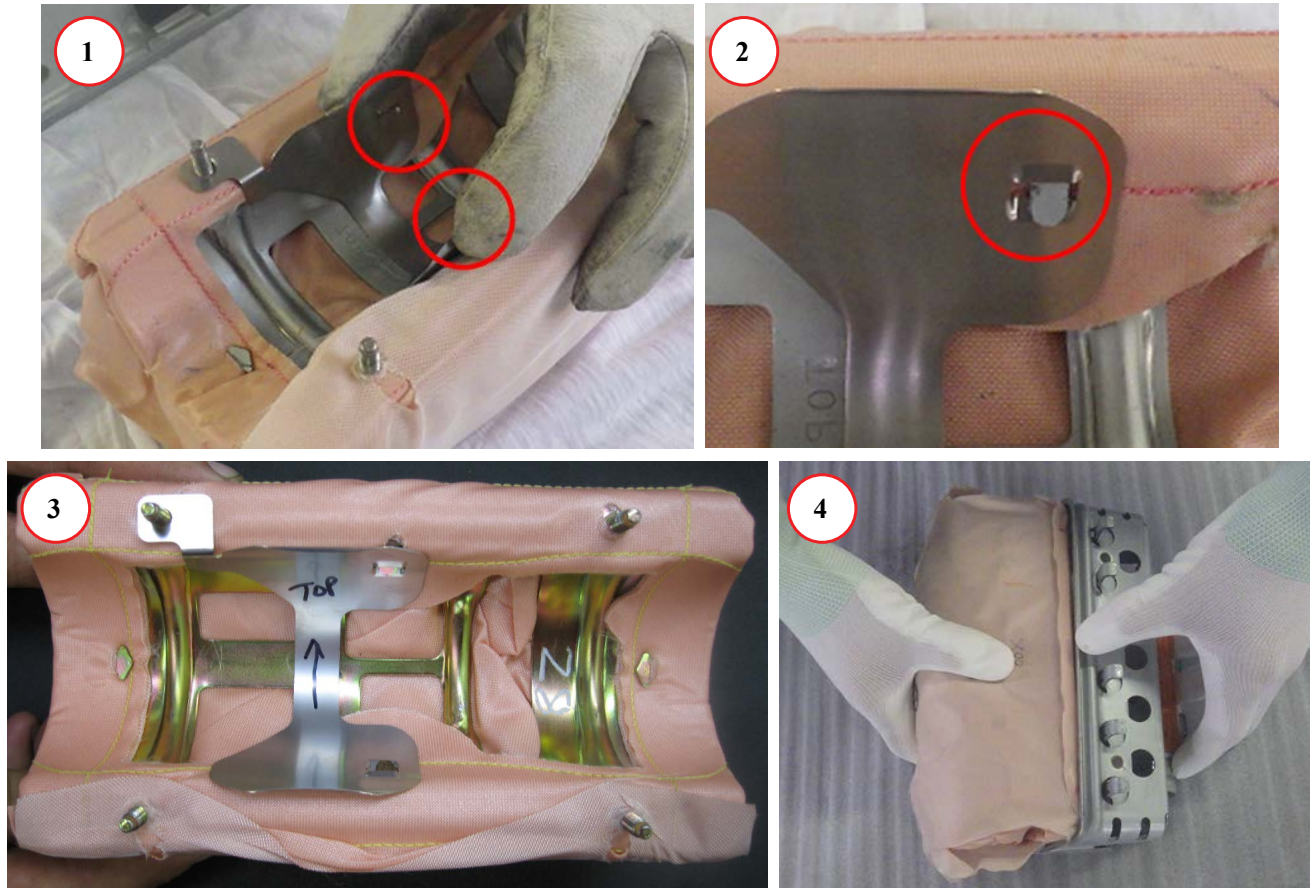
STEP 11- CAREFULLY Install the heat insulating plate into the back (inflator) side of the airbag as shown in photo 1 below. **The plate can only be installed in one direction.** Make sure the 2 retaining claws come through the corresponding holes in the insulator plate as shown in photo 2. The airbag is ready to refit to the mounting bracket in photo 3 and is being reinstalled in photo 4.

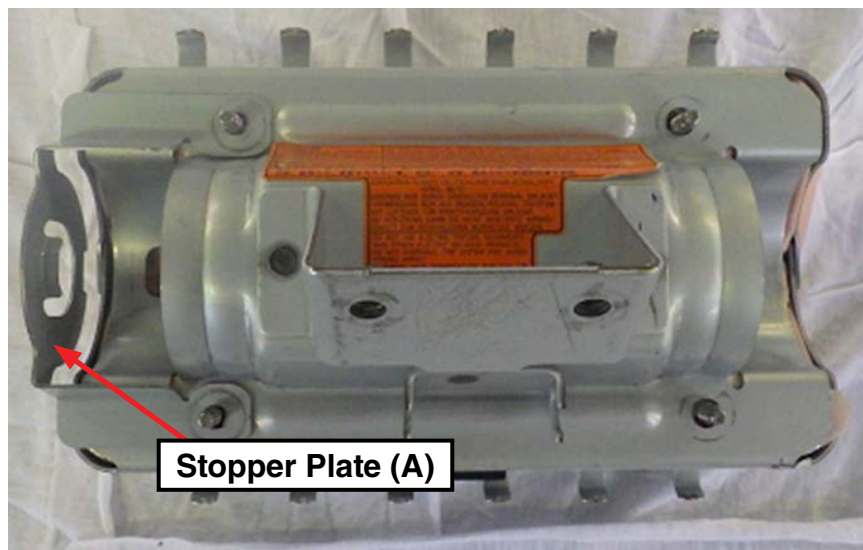
STEP 12- Install the new Stopper Plate (A) onto the mounting bracket.

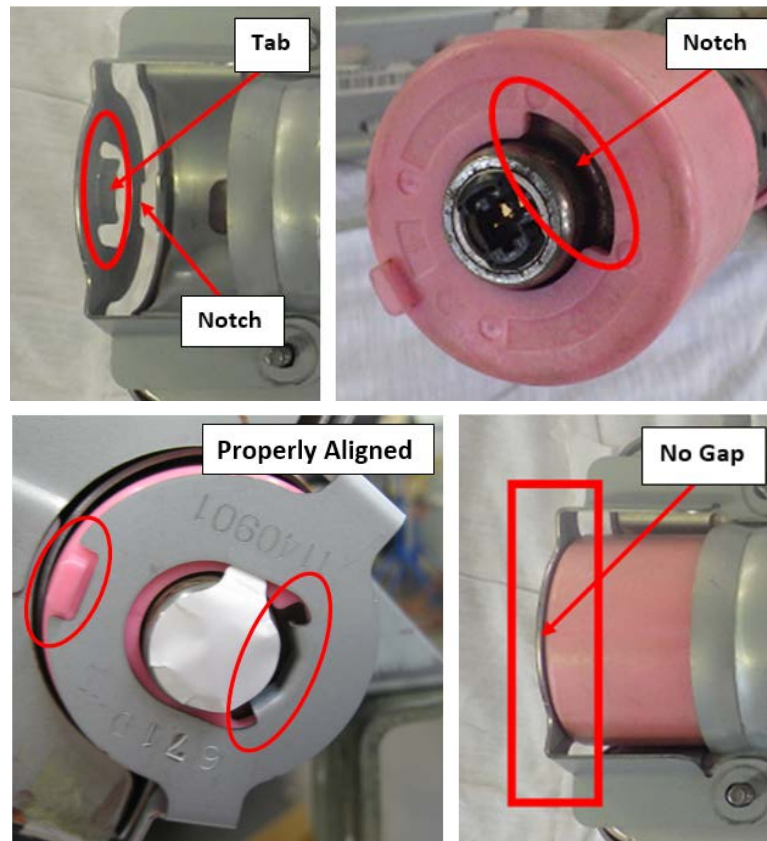
STEP 13- Install the new inflator into the mounting bracket with the short pink collar end toward the new Stopper Plate (A). Align the protrusion on the end of the collar with the notch in the stopper plate. There is also a tab on the inside of Stopper Plate (A) which will align with the notch in the end of the collar. When properly installed the collar will be tight against the plate with no gap.

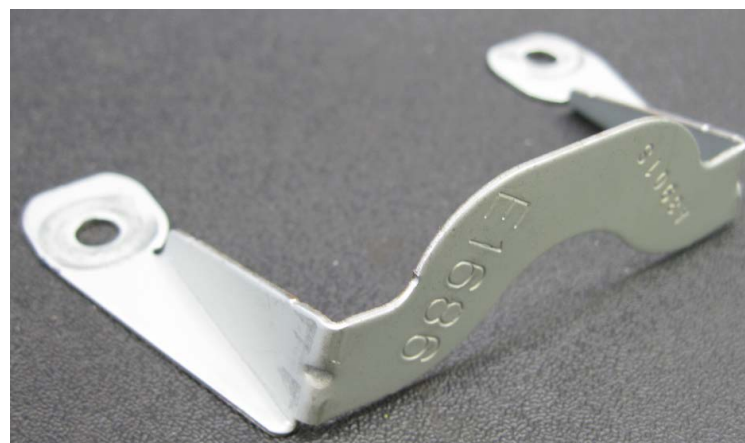
STEP 14- Install the original stopper plate onto the opposite end of the mounting bracket / inflator in the same manner as described in STEP 13 above. Rotate the inflator as needed to insure there is no gap between the collar and stopper plate. **NOTE:** Stopper plates only fit one way as their holes are offset.

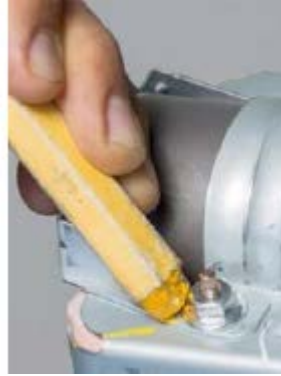
STEP 15- Reinstall the 4 **NEW** self-locking nuts. **SLOWLY** tighten (to prevent over-tightening) then torque the nuts to 31-38 inch-pounds. When complete, use a marker to indicate they have been fully tightened.

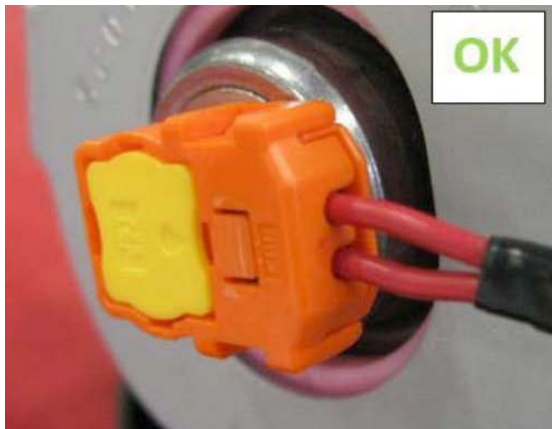
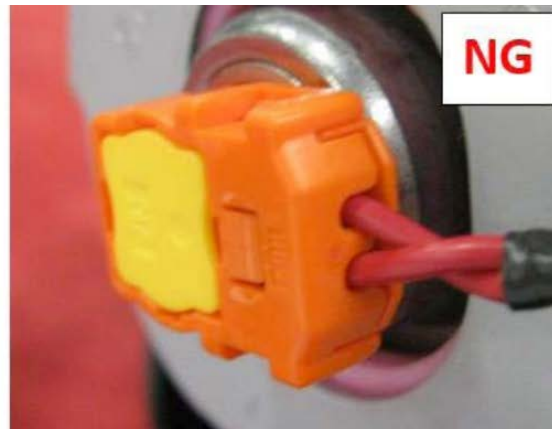
BEFORE connecting the harness to the inflator, make sure the harness is not twisted as shown below.

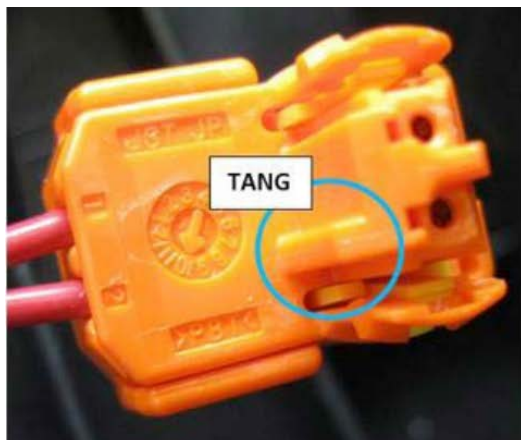
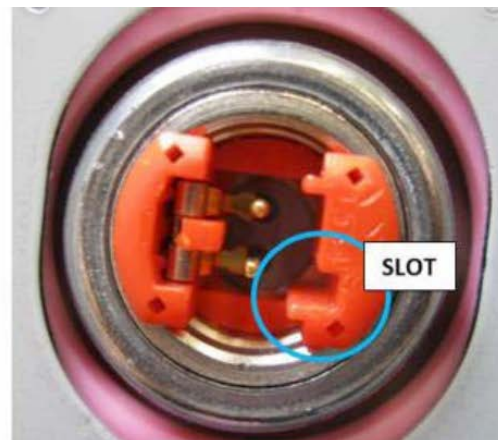
STEP 17- Peel off **one** white dust cover and **CAREFULLY** align the tang of the new harness connector with the receiving slot in the inflator connector. This assures proper routing of the harness in relation to the airbag assembly mounting bracket.

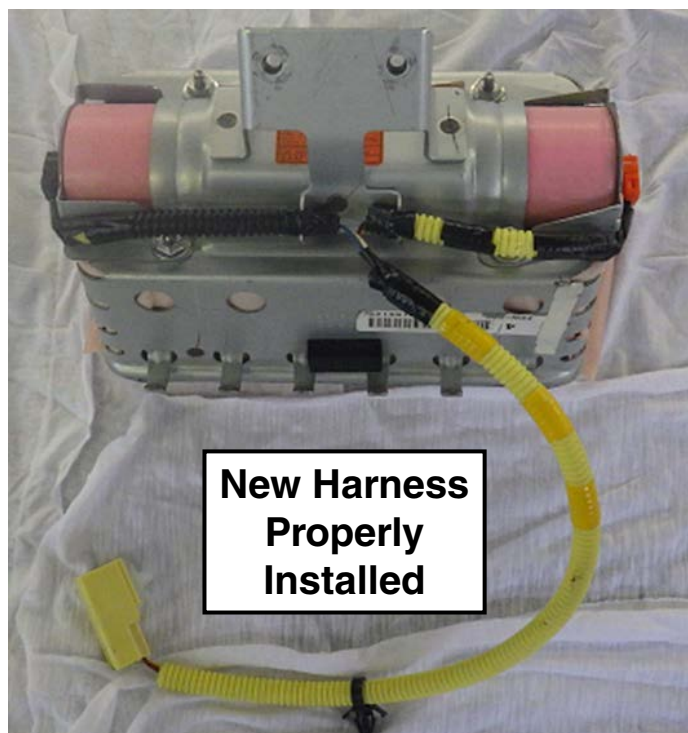
VERY IMPORTANT: After connecting the new harness to the inflator, **both sides MUST be routed as shown** in the “New Harness Properly Installed” photo below.

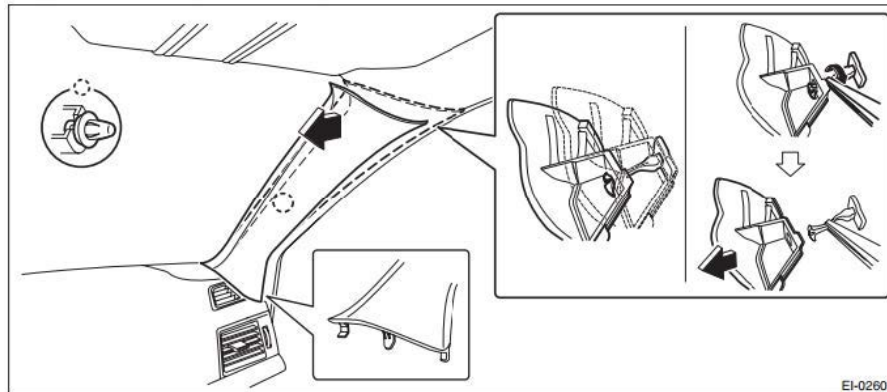
NOTE: When removing the “A” pillar trim, be **VERY CAREFUL** not to damage the upper trim retaining (tether) clip. The clip is located just below where the trim panel meets the head liner. If the tether clip becomes damaged, it **MUST** be replaced. The illustrations below show how to release the tether clip and remove the “A” pillar trim. It is **STRONGLY RECOMMENDED** to use the release tool (p.n. SOA635147) specifically designed for tether clip removal. See pg. 8 of this bulletin for more information.

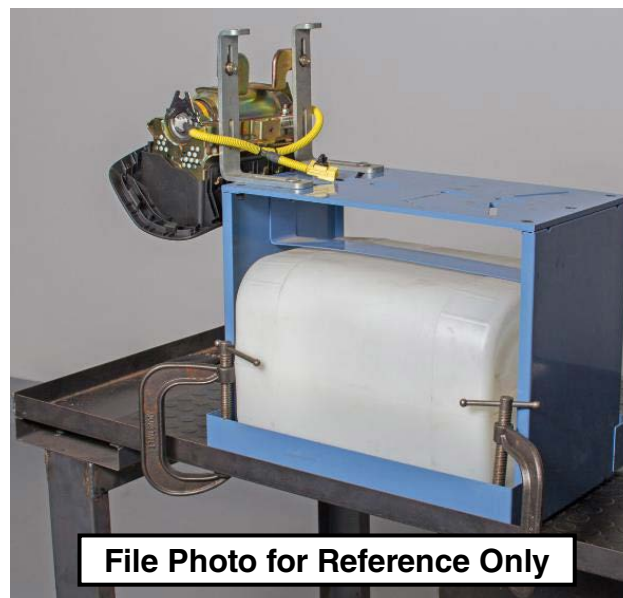
REMINDER: It is **STRONGLY RECOMMENDED** the removed airbag module **ALWAYS** be mounted to the Airbag Deployment Fixture (part number J-39401-B and file photo shown below) to better secure it during the inflator replacement procedure. When mounting the module to the fixture, pay close attention to the harness routing. Always perform this work in an area away from others to reduce chances of inadvertent injury should any deployment occur. Take your surroundings into account to avoid possible hazards should an inadvertent deployment occur or sources of static or other electricity that could potentially induce such a deployment.

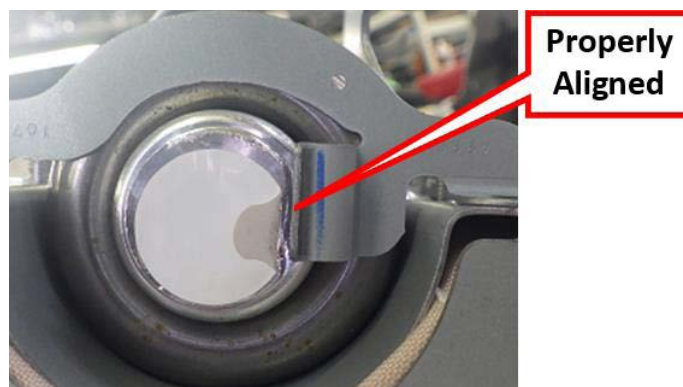
Make sure the “D-shaped” portion of the inflator harness connector boss aligns with the “D-shaped” portion of the original stopper plate as shown below. **Do not peel the white harness connection dust cover at this time.**

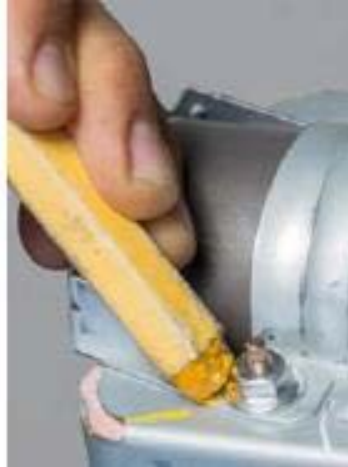
STEP 11- Reinstall the original stopper plate and the 5 **NEW** self-locking nuts. **SLOWLY** tighten (to prevent over-tightening) then torque the nuts to 31-38 inch-pounds. When complete, use a marker to indicate they have been fully tightened.

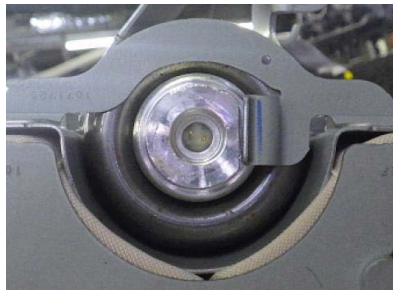
STEP 12- Peel the white dust cover from the d-shaped end of the new inflator. The new inflator wiring harness has 2 “sides” with round 2-pin connectors on both ends. The “short” side with the yellow tape and red / yellow wires will connect to the end of the inflator with the D-Shaped wiring harness connector boss as shown below. Peel the white dust cover from the D-Shaped end of the inflator **ONLY**.

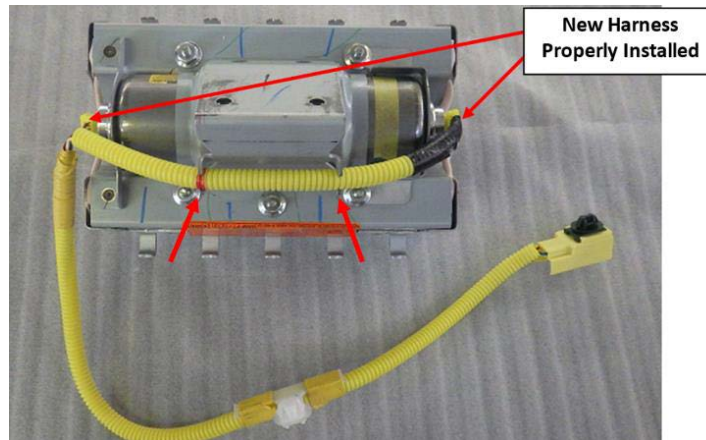
VERY IMPORTANT: When connecting the new harness to the inflator, **both sides MUST be routed as shown** in the “New Harness Properly Installed” photo below.

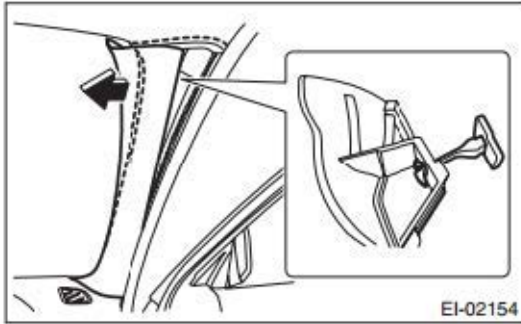
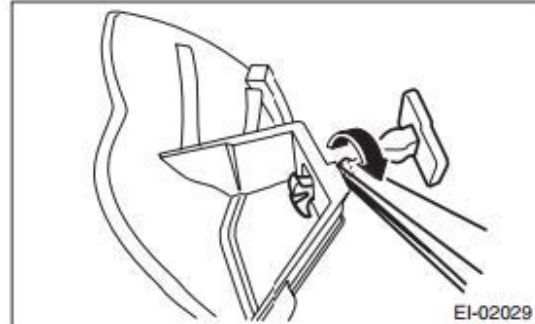
NOTE: On **FORESTER** models, when removing the "A" pillar trim, be **VERY CAREFUL** not to damage the upper trim retaining (tether) clip. It is **STRONGLY RECOMMENDED** to use the release tool (p.n. SOA635147) specifically designed for tether clip removal. See pg. 8 of this bulletin for more information. The clip is located just below where the trim panel meets the head liner. If the tether clip becomes damaged, it **MUST** be replaced. The illustrations below show how to release the tether clip and remove the "A" pillar trim.
