PRODUCT CAMPAIGN BULLETIN

<p>APPLICABILITY: 2009-2013 model year Legacy 2009-2013 model year Outback 2009-2013 model year Forester 2009-2013 model year Tribeca 2009-2011 model year Impreza 2009-2013 model year WRX and STI</p> <p>SUBJECT: Takata Front Passenger Airbag Inflator Replacement (2018 Calendar year expansion)</p>	<p>NUMBERS: TKA-18R TKB-18R TKC-18R</p> <p>DATE: 02/09/18 REVISED: 03/06/18</p> <p>NHTSA ID: 18V-012 18V-013 18V-014</p>
---	---

DESCRIPTION OF THE SAFETY DEFECT AND SAFETY HAZARD

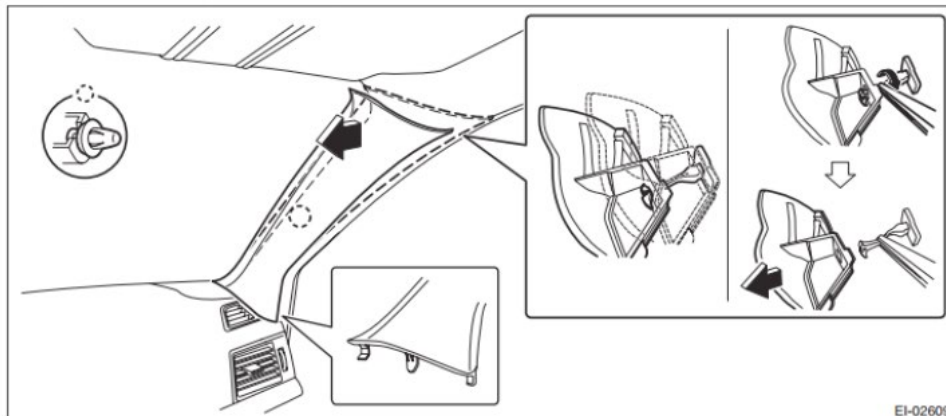
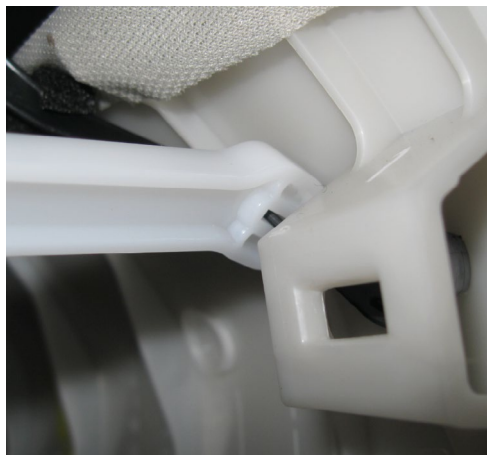
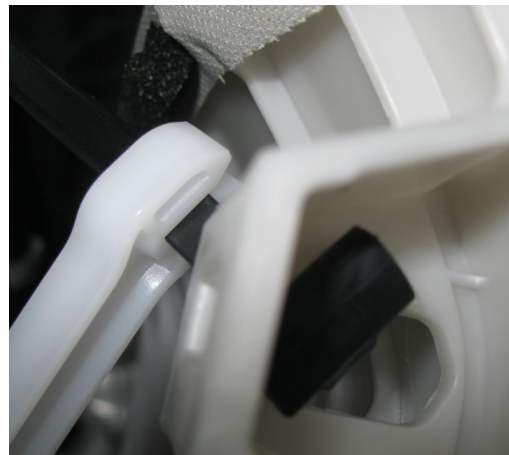
NOTE: Some models utilize a “tether clip” to secure the upper portion of the “A” pillar trim. The tether clip is located just below where the “A” pillar trim meets the head liner. If the tether clip becomes damaged, it **MUST** be replaced. The illustrations and photos below show the location of the tether clip and how to release it. It is **STRONGLY RECOMMENDED** to use the release tool (p.n. **SOA635147**) specifically designed for tether clip removal. Each Retailer has been supplied with 2 of these tools. If the tool is unavailable, a needle-nosed plier can be used to **CAREFULLY** release the tether clip as shown in the illustration below.

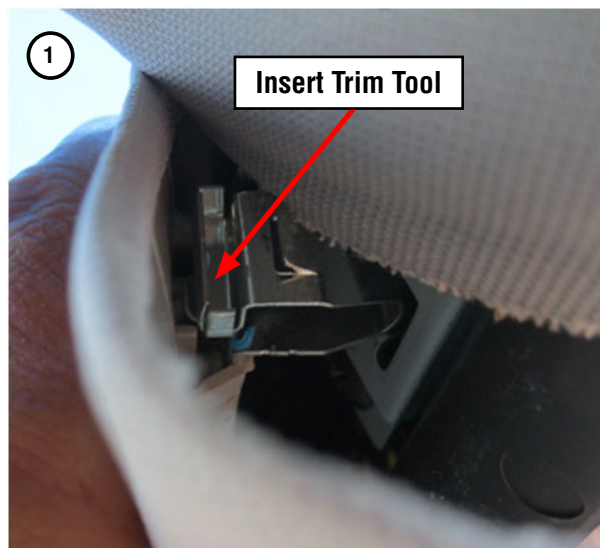
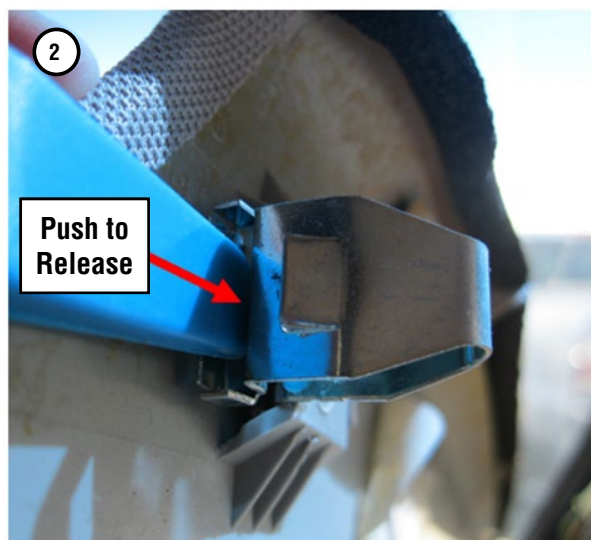
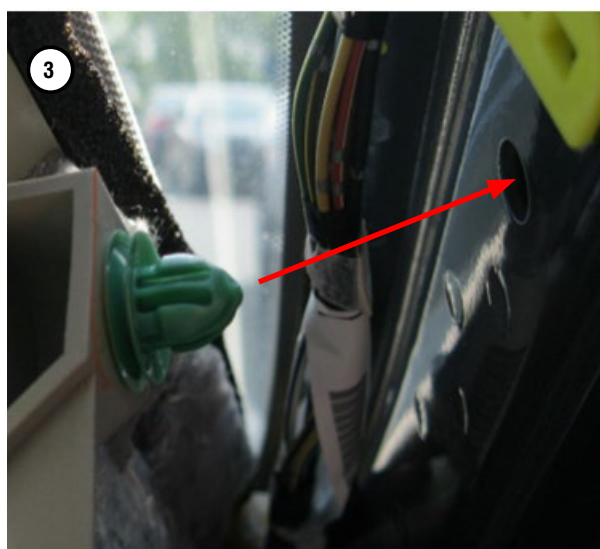
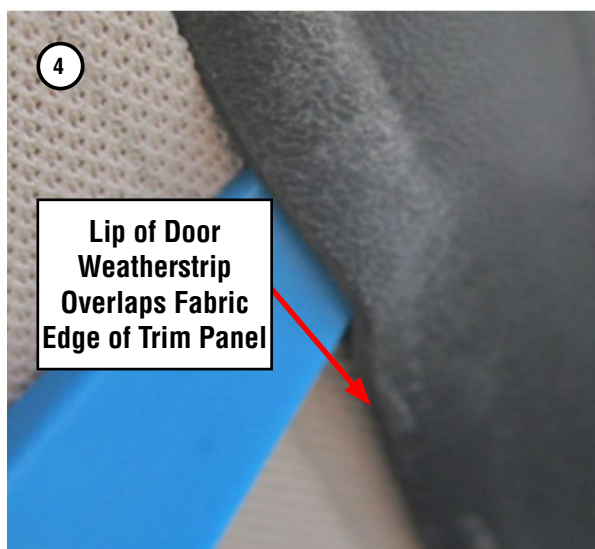
NOTE: When removing the "A" pillar trim, be **VERY CAREFUL** not to damage the upper metal retaining clip. The clip is located just below where the trim panel meets the head liner. If the metal retaining clip becomes damaged or separated from the trim panel, the trim panel **MUST** be replaced as the clip is not available separately. Use a plastic trim tool to push and release the upper portion of the metal clip from the body. Be careful to not pull the trim panel open any further than necessary to gain access for releasing the clip. There is a plastic retaining clip in the lower portion of the trim panel which will release easily once the upper retaining clip is loose. At reassembly and using a plastic trim tool, make sure the inner lip of the door weatherstrip overlaps the outer fabric edge of the trim panel to help secure it.
