PRODUCT CAMPAIGN BULLETIN

<p>APPLICABILITY: 2009-2013 model year Legacy 2009-2013 model year Outback 2009-2013 model year Forester 2009-2013 model year Tribeca 2009-2011 model year Impreza 2009-2013 model year WRX and STI</p> <p>SUBJECT: Takata Front Passenger Airbag Inflator Replacement (2018 Calendar year expansion)</p>	<p>NUMBERS: TKA-18 TKB-18 TKC-18</p> <p>DATE: 02/07/18</p> <p>NHTSA ID: 18V-012 18V-013 18V-014</p>
---	--

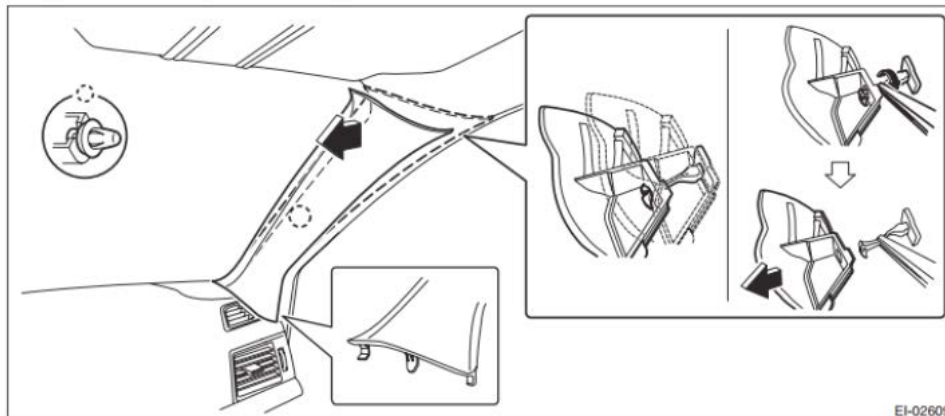
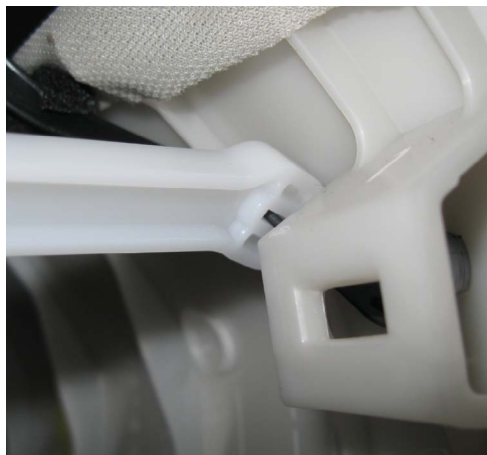
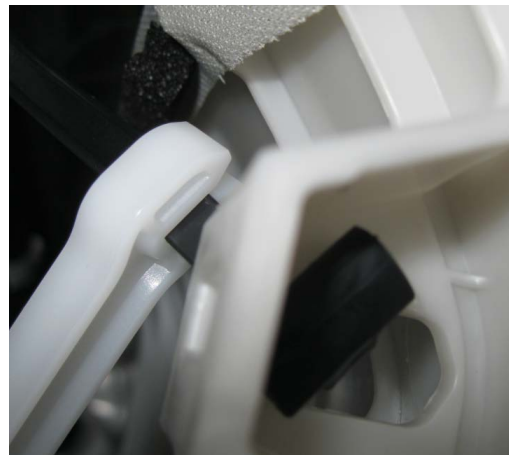
NOTE: Some models utilize a “tether clip” to secure the upper portion of the “A” pillar trim. The tether clip is located just below where the “A” pillar trim meets the head liner. If the tether clip becomes damaged, it **MUST** be replaced. The illustrations and photos below show the location of the tether clip and how to release it. It is **STRONGLY RECOMMENDED** to use the release tool (p.n. **SOA635147**) specifically designed for tether clip removal. Each Retailer has been supplied with 2 of these tools. If the tool is unavailable, a needle-nosed plier can be used to **CAREFULLY** release the tether clip as shown in the illustration below.

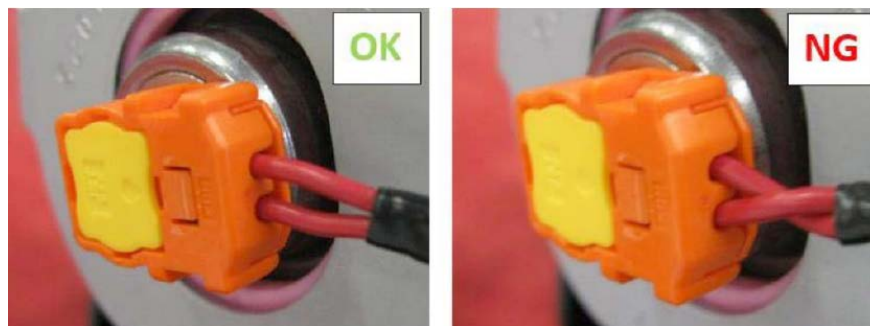
BEFORE connecting the harness to the inflator, make sure the harness is not twisted as shown below.
