David J. Johnson
Director
Service Engineering Operations
Ford Customer Service Division

September 24, 2018

SUBJECT: **Safety Recall 18S01 – Supplement #6**
Certain 2009-2010 and 2013 Mustang, 2009-2010 Ranger, 2009-2010 Fusion and Milan, 2009-2010 MKZ, and 2009-2010 Edge and MKX Vehicles
Passenger Airbag Inflator Replacement

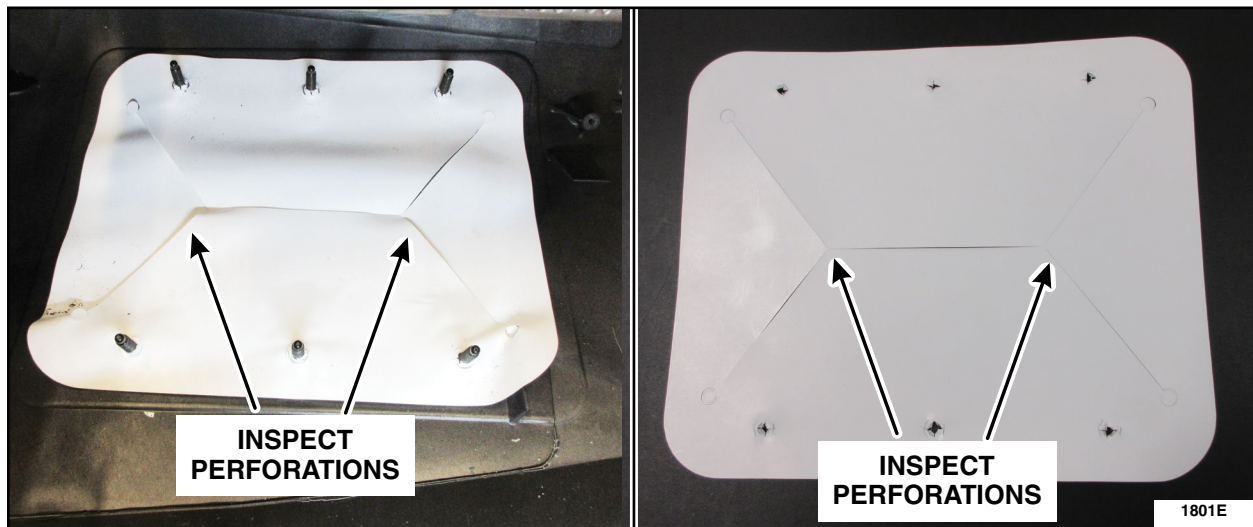
FIGURE 6

NOTE: If any damage is present on the existing or new airbag cushion sheet it must be replaced. Type of damage includes, but is not limited to, cuts, creases, folds, or the perforations being broken.

6. Inspect the white airbag cushion sheet installed on the instrument panel and the new airbag cushion sheet included with the new airbag module. See Figure 6.

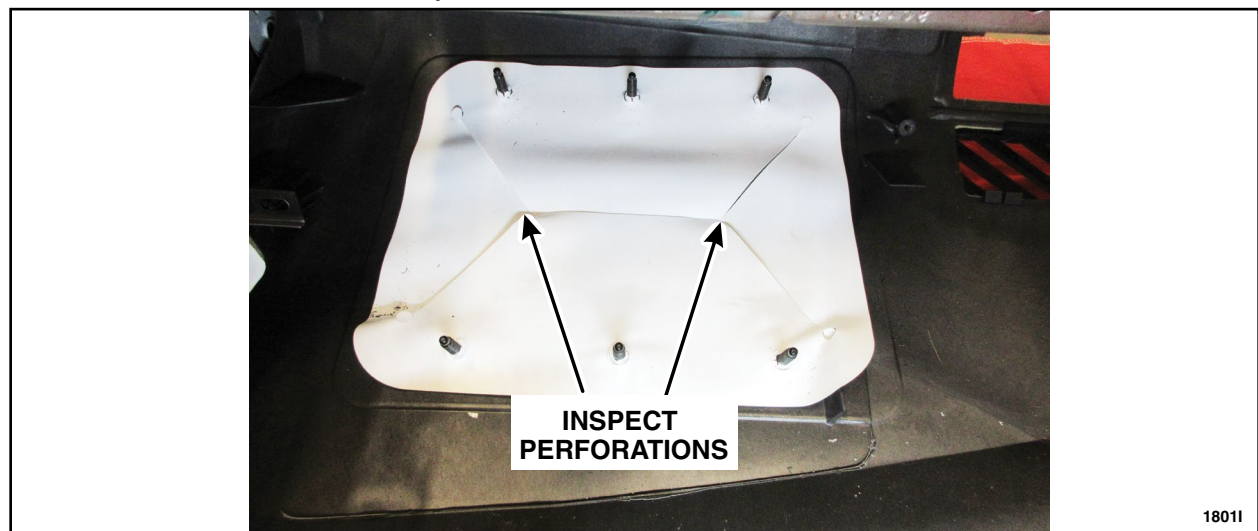
FIGURE 6

NOTE: If any damage is present on the existing sheet it must be replaced. Type of damage includes, but is not limited to, cuts, creases, folds, or the perforations being broken.

6. Inspect the white airbag cushion sheet installed on the instrument panel. See Figure 6.
