October 2018
FL766A
NHTSA #18V-191
Transport Canada #18-190

Subject: Western Star Power Cable Studs

Models Affected: Specific Western Star 4700, 4900, 5700, and 6900 model vehicles manufactured September 12, 2016, through February 6, 2018.

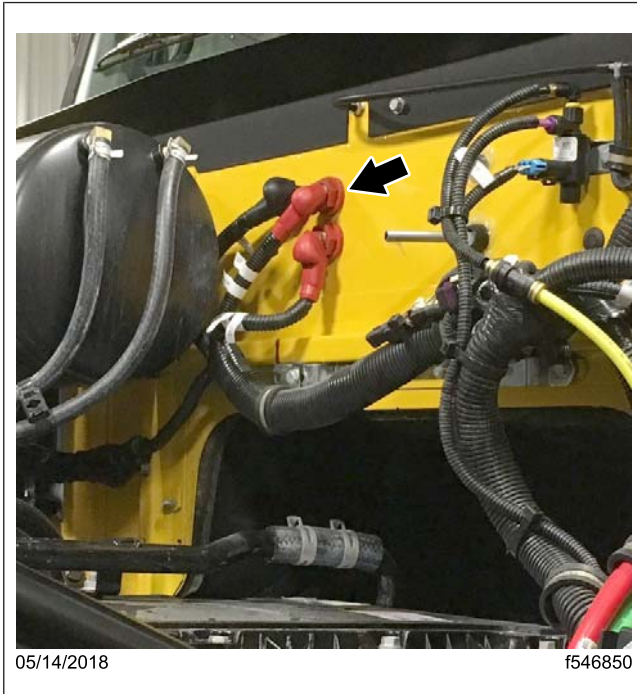
Fig. 1, Power Cable Stud Connector Location

1. Check the base label (Form WAR259) for a completion sticker for FL766 (Form WAR260) indicating this work has been completed. The base label is usually located on the passenger-side door, about 12 inches (30 cm) below the door latch. If a completion sticker is present, no work is needed. If a completion sticker is not present, proceed to the next step.
2. Park the vehicle on a level surface, shut down the engine, and set the parking brake. Chock the tires.
3. Open the hood and locate the three power cable stud connectors on the front wall. See [Fig. 1](#).

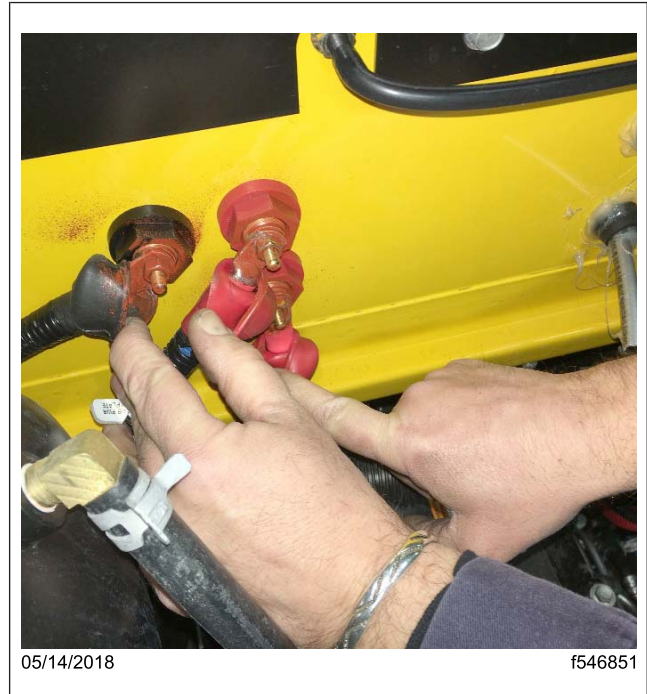
Fig. 2, Removing Connector Protective Cover

4. Pull back the covers on the power cable stud connectors. See [Fig. 2](#). Inspect each cable stud to make sure at least one thread protrudes past the plastic nut. See [Fig. 3](#) and [Fig. 4](#).

If at least one thread does **NOT** protrude past the plastic nut, the installation is **INCORRECT**. Proceed to "Power Cable Stud Replacement."

If at least one thread protrudes past the plastic nut, the installation is **CORRECT** and the recall is complete. Continue with the next step.

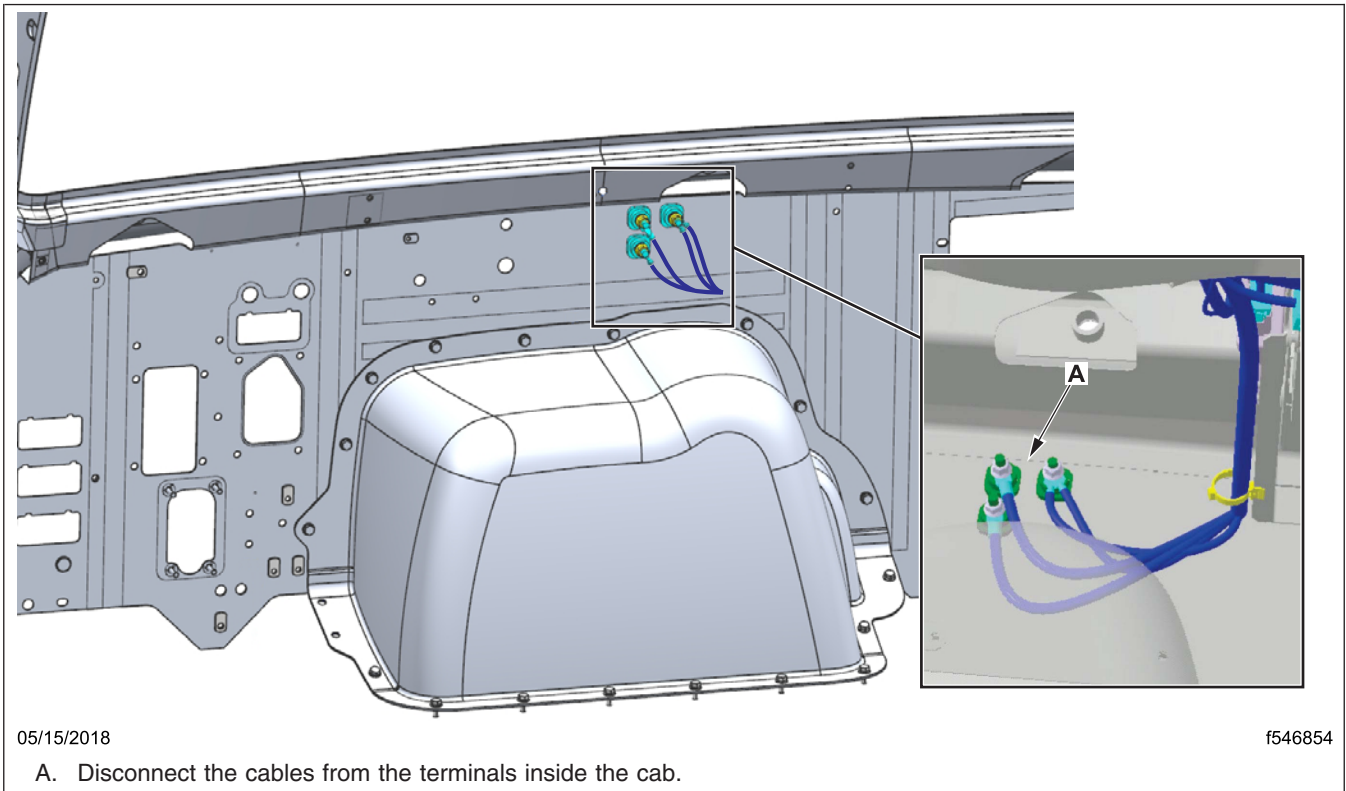
Fig. 5, Location of Front-Wall Power Terminals (inside the cab)

4. Disconnect the cables from the terminals inside the cab. See [Fig. 5](#)

5. Disconnect the cables from the terminals on the outside of the front wall.
6. Remove the plastic nuts and the studs.
7. Remove the old power cable studs and replace them with the new power cable studs.
8. Fully seat each stud in the square hole.
9. Tighten the plastic nuts 60 to 84 lbf-in (680 to 950 N-cm). Make sure at least one thread is exposed past the plastic nut.
10. Connect the cables to the terminals on the outside of the front wall.
11. Connect the cables to the terminals inside the cab.
12. Install the dash. Refer to *Western Star Workshop Manual*, **Section 60.06, Subject 110**.
13. Clean a spot on the base label (Form WAR259). Write the campaign number, FL766, on a blank red completion sticker (Form WAR260) to indicate the work has been completed and attach it to the base label.
