Dealer Service Instructions for:

Safety Recall U34 / NHTSA 18V-203 Safety Recall U36 / NHTSA 18V-205 Water Intrusion

2018 (GU) Alfa Romeo Stelvio

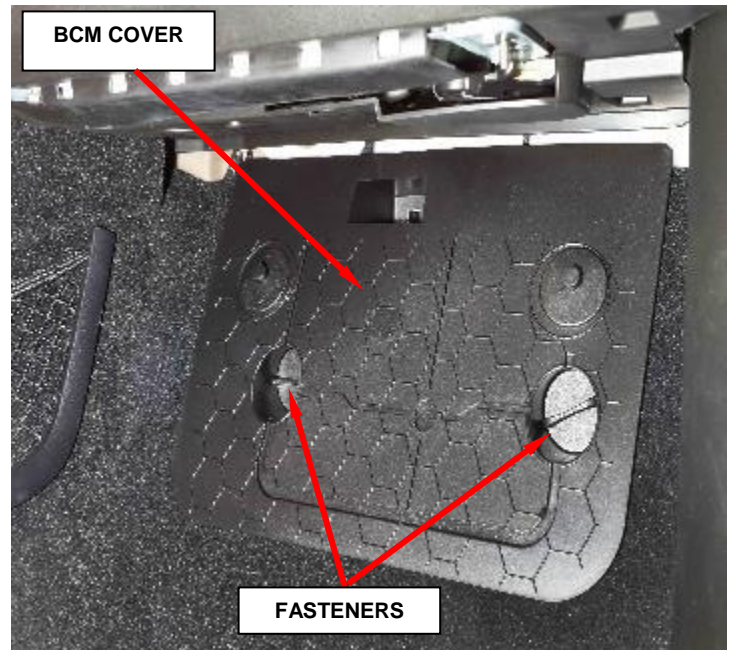
Figure 22 – Remove BCM Cover

3. Without disconnecting the electrical connections, inspect the BCM cover pad and carpeting for evidence of dampness.
4. Inspect for evidence of dry water spots on BCM.
 - If any evidence of dampness or water spots are present, contact the STAR Center for additional repair guidance

1. Remove the floor mat
2. Remove the fasteners, then remove the BCM cover, releasing it from the lower side (Figure 22).
