Safety Recall U34 / NHTSA 18V-203

Safety Recall U36 / NHTSA 18V-205

Water Intrusion

2018 (GU) Alfa Romeo Stelvio

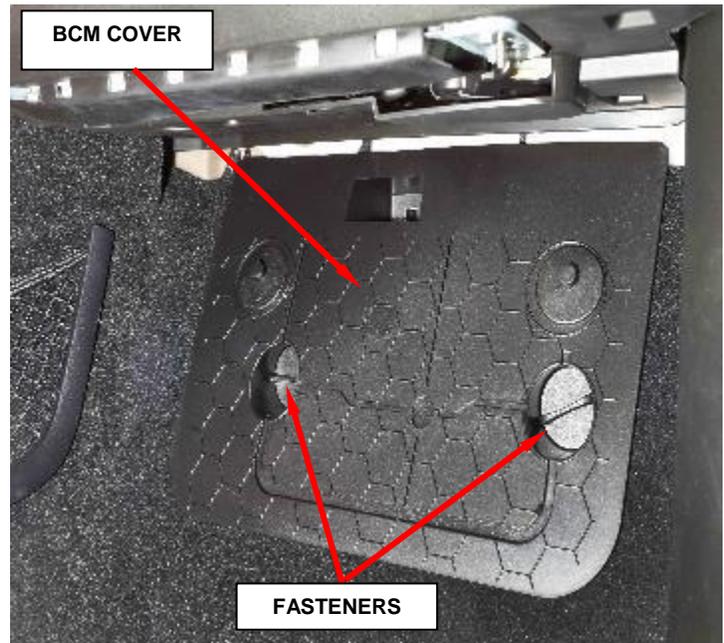
Figure 22 – Remove BCM Cover

3. Without disconnecting the electrical connections, inspect the BCM cover pad and carpeting for evidence of dampness.
4. Inspect for evidence of dry water spots on BCM.
 - If any evidence of dampness or water spots are present, contact the STAR Center for additional repair guidance

1. Remove the floor mat
2. Remove the fasteners, then remove the BCM cover, releasing it from the lower side (Figure 22).
