MODEL:	TYPE:	SECTION/GROUP:	DATE:
			March 12,
J Series	Field Change Program	03- Body	2019

Ref. MCI NHTSA Recall No.: 18V-225

Ref. MCI Transport Canada Recall No.: 2019-049

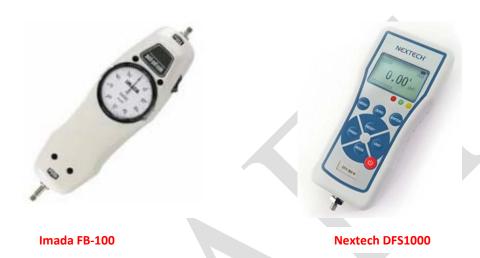
A force gauge capable of applying 20 to 50 pounds of pressure is required. The gauge used in this procedure is an "Imada FB-100". An alternative is the "Nextech DFS1000".

A push-jig such as a plastic block may also be used to help distribute force from the gauge.
