PRODUCT CAMPAIGN BULLETIN

APPLICABILITY: 2018 Model Year Legacy and Outback Vehicles **NUMBER:** WTW-82R
SUBJECT: Combination Meter Reprogramming **NHTSA ID:** 18V-773
DATE: 12/11/18
REVISED: 02/20/19

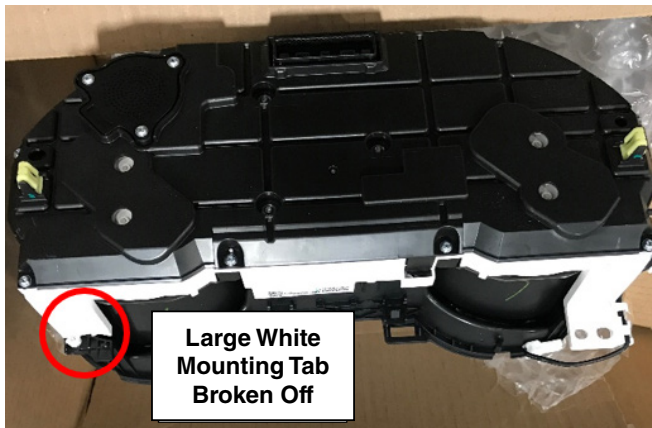
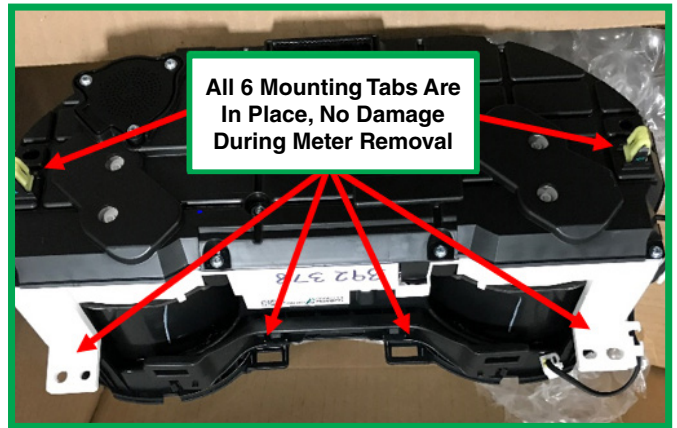
REMINDER: Before proceeding to **Step 6** below, it cannot be stressed enough for Technicians to **TAKE THEIR TIME** when removing and reinstalling the combination meter. The photos below illustrate what can happen to the meter assembly when not performing these steps **CAREFULLY**. These 3 examples all show damage caused by outside influence which is not a matter for warranty.

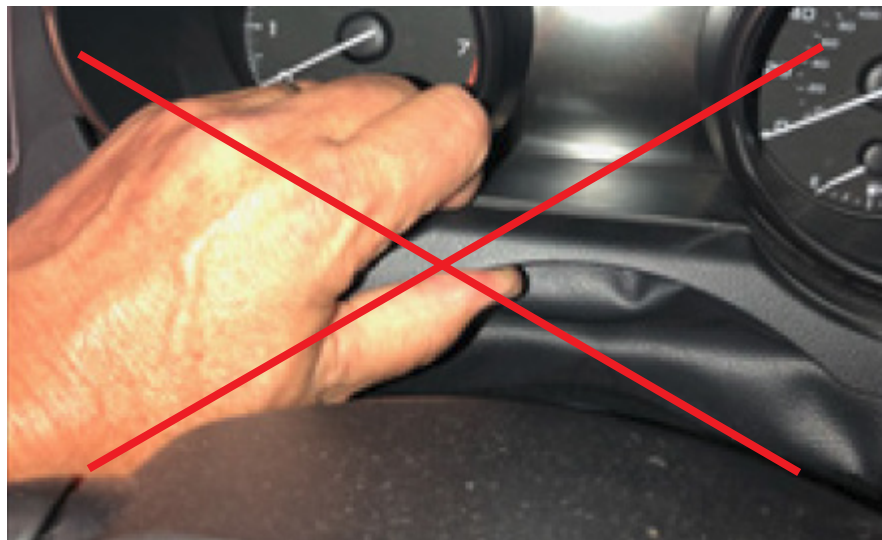
Step 6: NOTE: Previously, the removal procedure showed releasing the top claws on each end then grasping the bezel with the thumb and forefinger and pulling straight back to release the 2 center retaining clips.
