PRODUCT CAMPAIGN BULLETIN

<p>APPLICABILITY: 2010-2014 MY Legacy 2010-2014 MY Outback 2010-2013 MY Forester 2010-2014 MY Tribeca 2010-2011 MY Impreza 2010-2014 MY WRX and STI</p> <p>SUBJECT: Takata Front Passenger Airbag Module / Inflator Replacement (2019 Calendar year expansion)</p>	<p>NUMBERS: TKA-19 TKB-19 TKC-19</p> <p>DATE: 01/14/19</p> <p>REVISED: 04/10/19</p> <p>NHTSA ID: 19V-007 19V-008 19V-009</p>
--	--

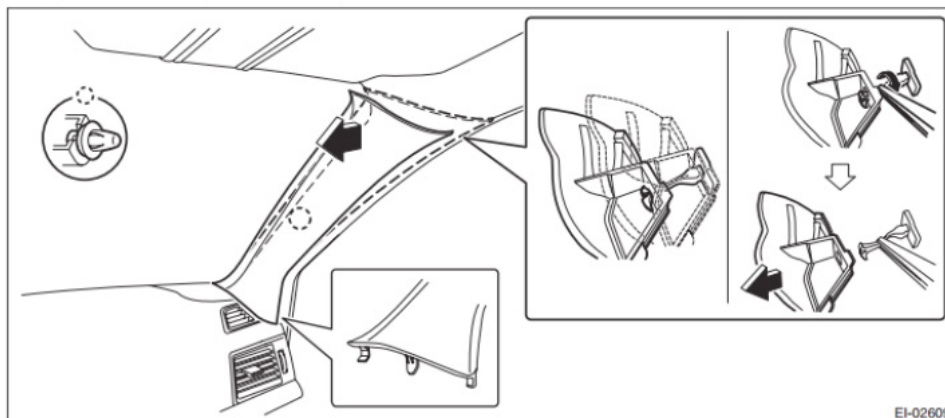
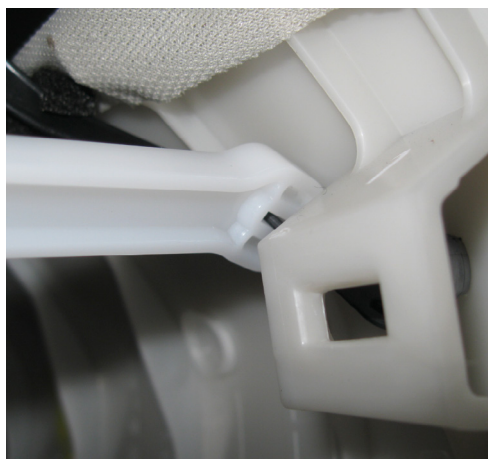
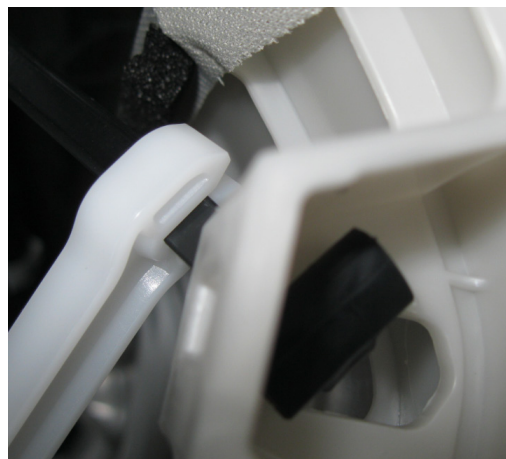
NOTE: Some models utilize a “tether clip” to secure the upper portion of the “A” pillar trim. The tether clip is located just below where the “A” pillar trim meets the head liner. If the tether clip becomes damaged, it **MUST** be replaced. The illustrations and photos below show the location of the tether clip and how to release it. It is **STRONGLY RECOMMENDED** to use the release tool (p.n. **SOA635147**) specifically designed for tether clip removal. Each Retailer has been supplied with 2 of these tools. If the tool is unavailable, a needle-nosed plier can be used to **CAREFULLY** release the tether clip as shown in the illustration below.
