SI B63 02 19
Lights

RECALL CAMPAIGN 19V-074: REAR TAIL LIGHT

F48 (X1 SAV)

Produced from October 5th, 2018- January 18th, 2019.

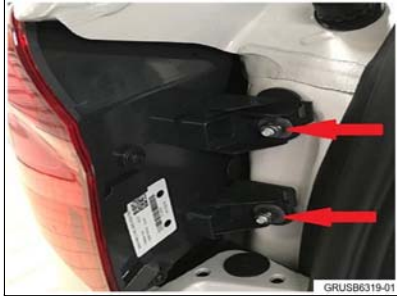
<p>GRUSB6319-01</p>	<p>“Replace trim for water channel (left or right).</p> <p>2. Before removing the tail light mounting nuts, carefully inspect the tail light mounting areas shown to the left for signs of cracking.</p>

1. Remove the water channel trim on both tail lights, following repair instructions REP **63 21 400**
