# Product Safety Recall

## N182204190 Chassis Cab Truck Fuel Leak

**Release Date:** September 2019

**Revision:** 02

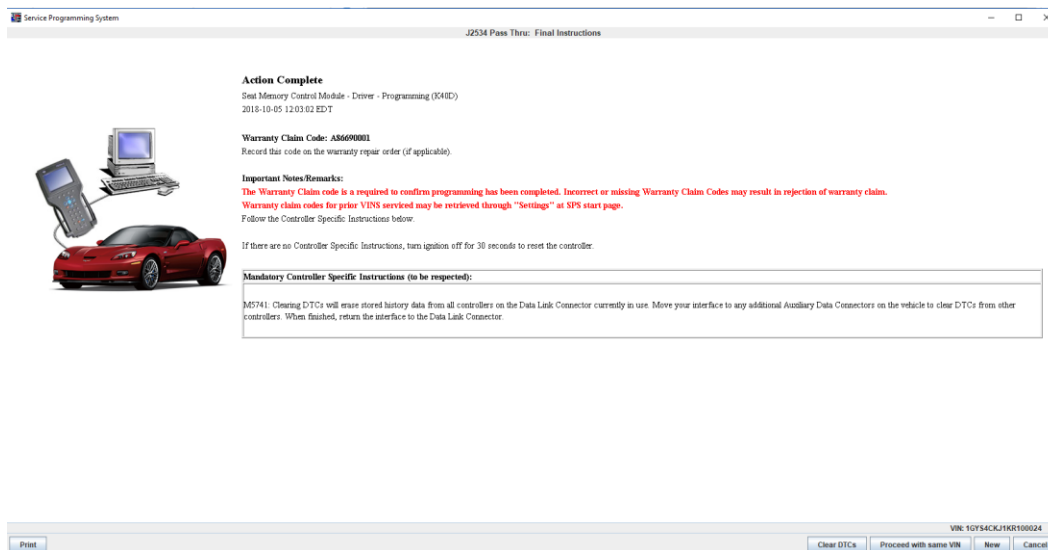
5164843

**Note:** If the Same Calibration/Software Warning is noted on the SPS Summary screen, record the warranty claim code (WCC) and select OK and follow screen instructions. After a successful programming event, the WCC is located in the Service Programming System dialogue box of the SPS Summary screen. No further action is required. Refer to the Warranty section of the bulletin.

8. Record SPS Warranty Claim Code on job card for warranty transaction submission.
