SAFETY RECALL BULLETIN

February 2019
D18R7 (FL802)
NHTSA #18V-913 (Non-School Buses)
#18V-914 (School Buses)
Transport Canada #18-719 (Non-School Buses)
#18-720 (School Buses)

Subject: **Detroit™ Axle Steering Arm / Tie Rod Arm Capscrew Inspection**

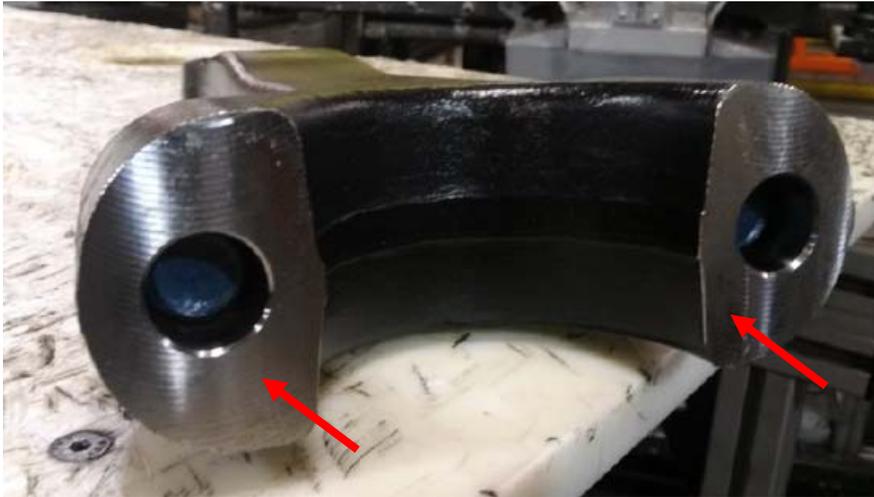
Figure 3 – Dent at the Loose Joint

11. Are the joint surfaces of either the steering or tie rod arm or steering knuckle damaged?
 - a. Yes; proceed to step 12 to replace the knuckle and the arm.
 - b. No; proceed to step 14 to replace the capscrews only.
12. **Remove the steering or tie rod arm and steering knuckle. Reference** section “Dissassembly of the Steering Knuckle” in the Front Axles chapter of the *Detroit Axles Manual* (DDC-SVC-MAN-0141).
13. **Install a new steering or tie rod arm and new steering knuckle. Reference** section “Assembly of the Steering Knuckle” in the Front Axles chapter of the *Detroit Axles Manual* (DDC-SVC-MAN-0141).
14. **Install two new steering or tie rod arm capscrews. Reference** section “Assembly of the Steering Knuckle” in the Front Axles chapter of the *Detroit Axles Manual* (DDC-SVC-MAN-0141).
15. Repairs are complete.
