PRODUCT CAMPAIGN BULLETIN

APPLICABILITY: 2009-2013 Forester
 2008-2014 Impreza
 2005-2014 Legacy
 2005-2014 Outback
 2006-2008 Tribeca

NUMBER: WUF-91
NHTSA: 19V-297
DATE: 04/15/19

SUBJECT: Replacement Ignition Switch Recall

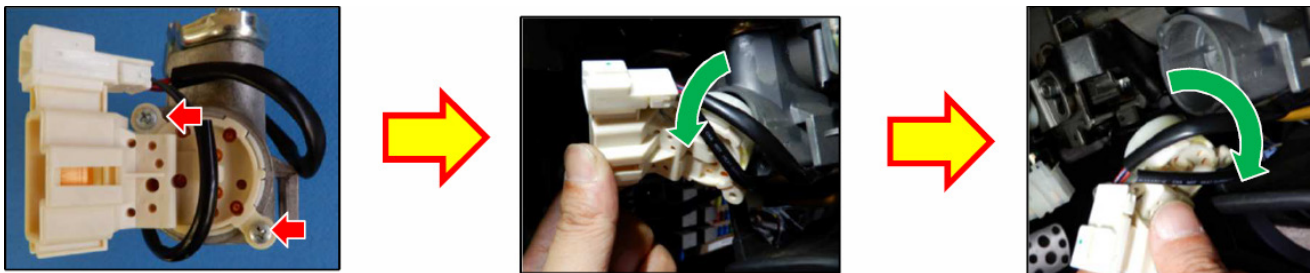
CAUTION: The harness for the key lock solenoid is routed around the ignition lock assembly. After CAREFULLY disconnecting the harness connector, do not pull on, reposition or un-twist the key lock solenoid harness any more than necessary to facilitate removing the ignition switch from ignition lock assembly.

1. Disconnect the ignition switch harness and key lock solenoid connectors.

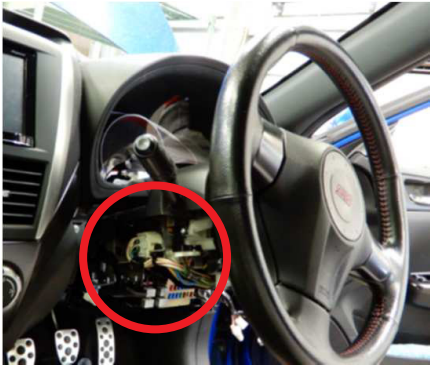
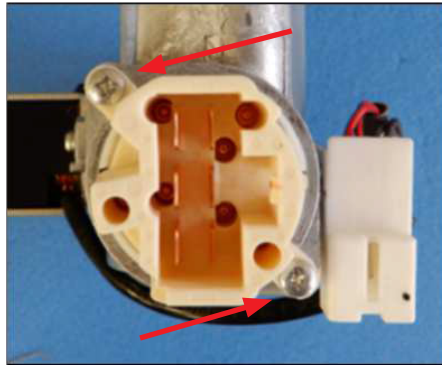
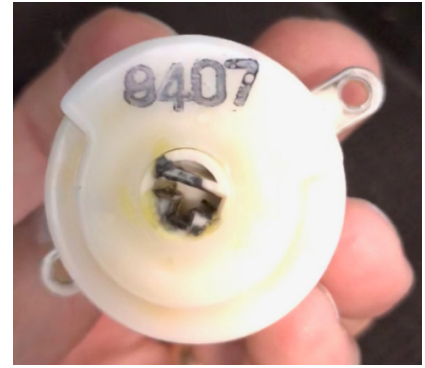
Using the chart above as a guide, if the Lot Number is between **6Z18** (December 18, 2016) and **7602** (June 2, 2017), the ignition switch MUST be replaced. **NOTE:** If the Lot Number is illegible, **REPLACE** the ignition switch assembly.

- **For 2007-2009MY Legacy, Outback, Impreza, WRX, STI and Forester Models:**
 1. Remove the harness connector from the ignition switch.
 2. Remove the two (2) ignition switch Philips head retaining screws.

3. Remove the ignition switch from the ignition lock assembly.
4. Confirm the Lot Number on the face of the ignition switch using the chart below.

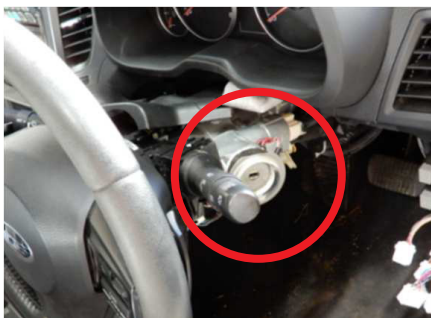
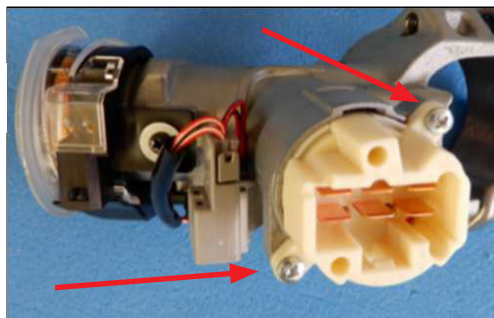
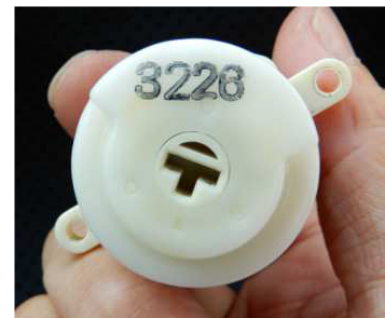
Using the chart above as a guide, if the Lot Number is between **6Z18** (December 18, 2016) and **7602** (June 2, 2017), the ignition switch **MUST** be replaced. **NOTE:** If the Lot Number is illegible, REPLACE the ignition switch assembly.

1. Remove the harness connector from the ignition switch.
2. Remove the two (2) Philips head retaining screws.

3. Remove the ignition switch from the ignition lock assembly.

5. **CAUTION:** After reinstalling the ignition switch back into the lock housing, torque the 2 retaining screws to 1.1 Nm (9.7 inch-pounds). **DO NOT OVER-TIGHTEN.** Confirm all functions of the ignition switch (OFF, ACC, ON, and START). With the engine OFF and parking brake fully engaged, confirm the function of the ignition interlock by attempting key removal in a gear other than park. Proceed to **Step 5** below.
