May 24, 2019

Version 3

Safety Recall: 2018-19 Odyssey Check Park Mechanism, Battery Terminal Inspection, and Update TCM

Supersedes 19-046, dated May 1, 2019, to revise the information highlighted in **yellow**

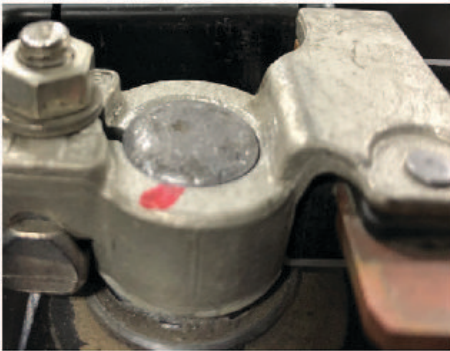
- Battery terminal installation on this vehicle is critical. Failure to follow the terminal installation, or inspection procedures could cause electrical problems, stalling, and/or DTCs to set. Do not over torque the terminals, and do not use an impact gun.
 - Battery terminal installation must be level or below the post. See GOOD and NO GOOD example pictures.
1. Remove the front bulkhead cover.

3. Compare both battery terminals to the examples below.

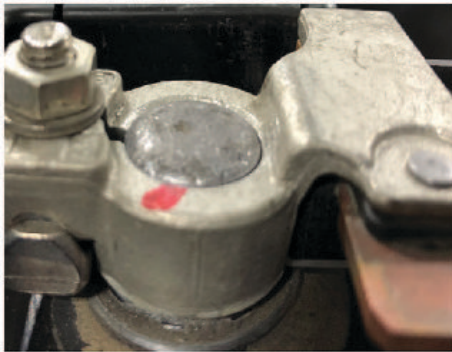
**GOOD**

7. Compare both of the battery terminals to the examples below.

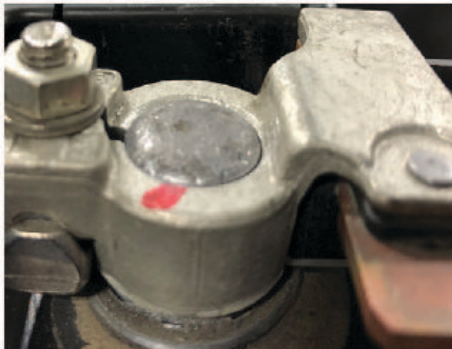
**GOOD**

- Battery terminal installation on this vehicle is critical. Failure to follow the terminal installation or inspection procedures could cause electrical problems, stalling, and/or DTCs to set. Do not over torque the terminals, and do not use an impact gun.
- Battery terminal installation must be level or below the post. See GOOD and NO GOOD example pictures.
