June 13, 2019

Safety Recall: 2018-19 Odyssey Check Park Mechanism (Snapshot Upload Required), Battery Terminal Inspection, and Update TCM

Supersedes 19-046 Safety Recall: 2018-19 Odyssey Check Park Mechanism, Battery Terminal Inspection, and Update TCM, dated May 24, 2019, to revise the information highlighted in **yellow**

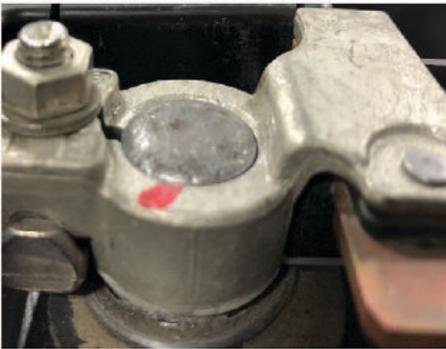
- Battery terminal installation on this vehicle is critical. Failure to follow the terminal installation, or inspection procedures could cause electrical problems, stalling, and/or DTCs to set. Do not over torque the terminals, and do not use an impact gun.
 - Battery terminal installation must be level or below the post. See GOOD and NO GOOD example pictures.
1. Remove the front bulkhead cover.

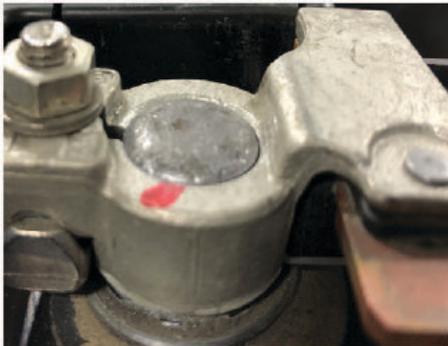
**GOOD**

- Battery terminal installation on this vehicle is critical. Failure to follow the terminal installation or inspection procedures could cause electrical problems, stalling, and/or DTCs to set. Do not over torque the terminals, and do not use an impact gun.
- Battery terminal installation must be level or below the post. See GOOD and NO GOOD example pictures.

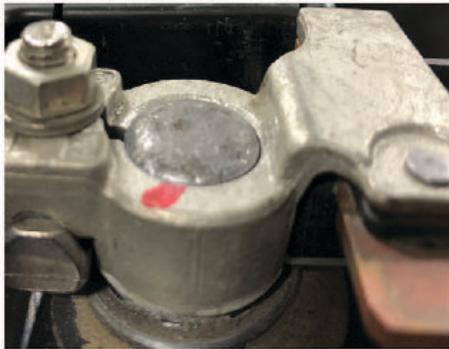
**GOOD**

3. Compare both of the battery terminals to the examples below.

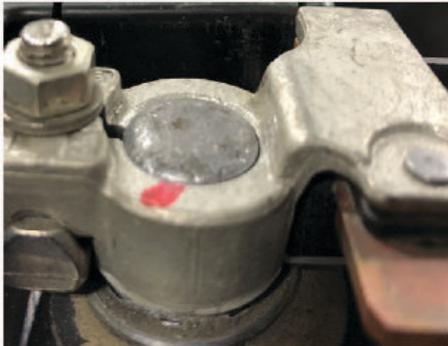
**GOOD**

- Always disconnect the negative side first.
 - To prevent damage, do not hold the connector when removing the battery terminal.
 - Do not disconnect the battery sensor from the cable.
3. Compare both of the battery terminals to the examples below.
