A. VEHICLE INSPECTION PROCEDURE

2009 Mazda6 (HP) and 2010-2013 Mazda6 (HZ) vehicles, which were originally sold in, or currently or previously registered in Salt Belt States listed below.

B. CROSS MEMBER INSPECTION PROCEDURE 2009-2013 MAZDA6

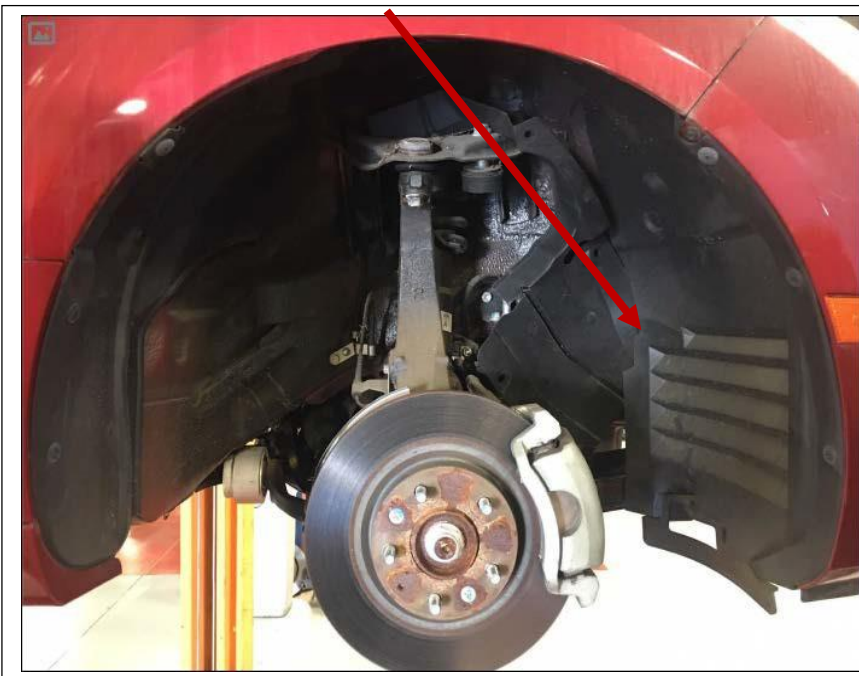
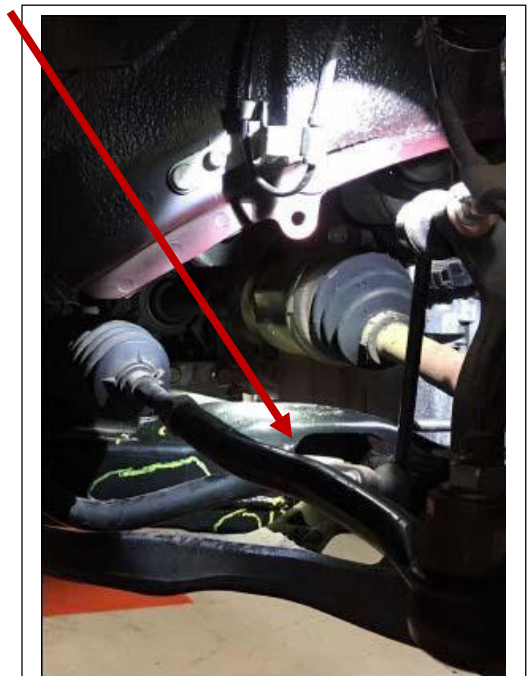
- A. Remove the right front tire.
- B. Remove **visible** clips of side cover of right front tire house.
Then bend the side cover so that Inspection point Zone No.1: Upper surface of the cross member can be seen

Check for perforation at all three areas by visual inspection: Top Surface, Inside and Side.

If even one hole exists at these points Zone No.1 to Zone No.3, the vehicle needs replacement of the cross member.

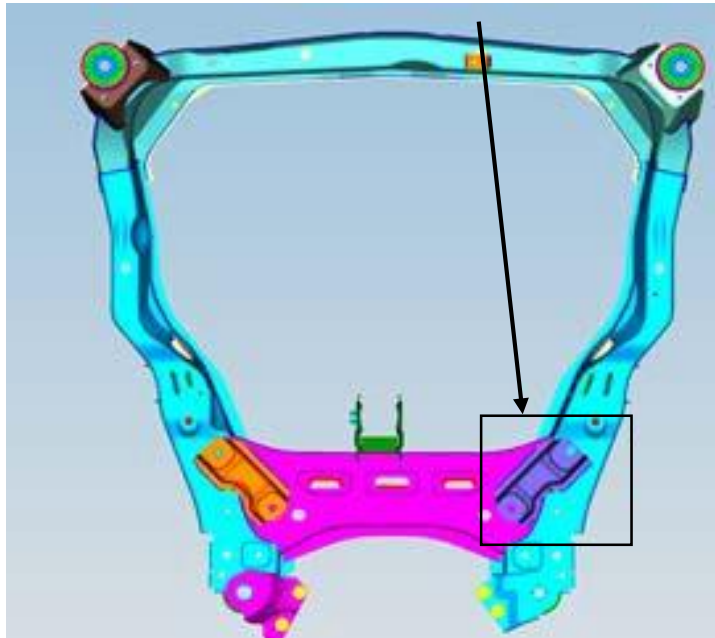
Top View – Area affected (Right Top Side)

Zone 1 Inspection – Upper Surface/Top side

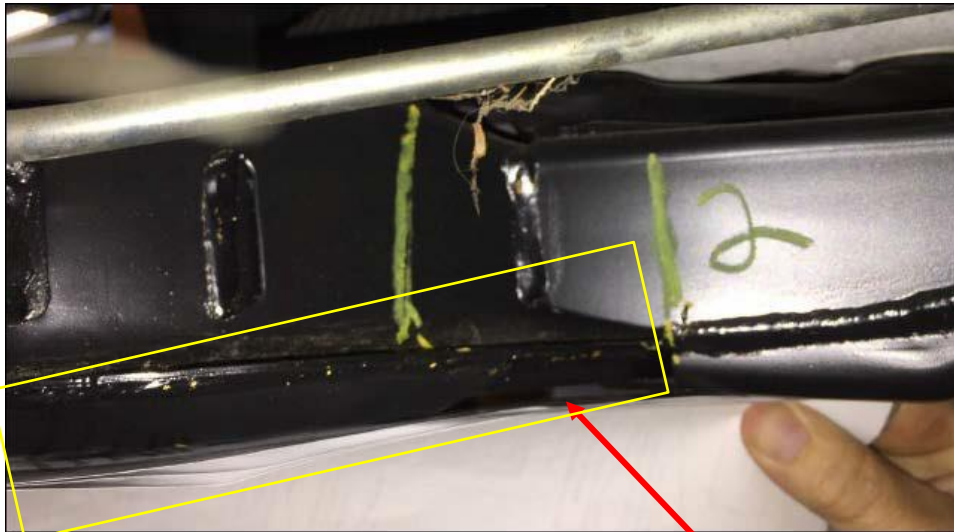
Inside View: Non-Damaged Cross member

Look for perforation or crack along the flange in this area. If a crack or perforation is present, replace the cross member.
