# Safety Recall Code: 93E8

#### **NHTSA:** 19V434

## Subject: Safety Recall 93E8 – High-Voltage (HV) Battery Charging Socket 2019 Model Year Audi e-Tron

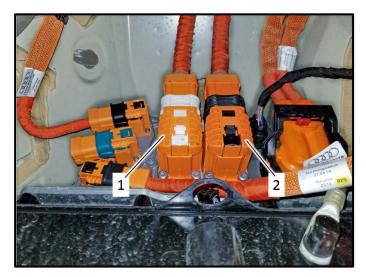
#### Disconnect charging socket cable from SX6:

• Disconnect charging socket cable connectors <1> and <2> from the high-voltage battery control module SX6.
