PRODUCT CAMPAIGN BULLETIN

APPLICABILITY: 2019MY Ascent **NUMBER:** WUI-94R
SUBJECT: STOP SALE: Propeller Shaft **DATE:** 07/02/19
NHTSA: 19V519
REVISED: 07/22/19

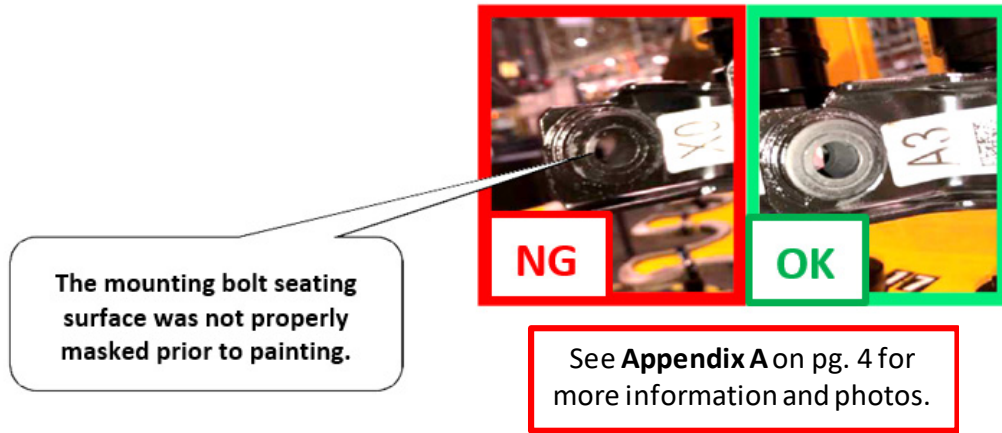
VERY IMPORTANT: After removing the original propeller shaft, confirm there is no residual **BLACK** paint remaining from the center support brace on both mounting surfaces of the body. The mounting surfaces **must be clean** as shown below. Use a mild solvent on a clean shop cloth to clean the area if necessary. **NEVER** use an abrasive disc or otherwise remove the tan-colored protective underbody finish coat. Doing so will expose bare metal making it susceptible to corrosion / rust.
