# Campaign Service

**BULLETIN NUMBER:**  
CB19-N-002B

## IMPORTANT SAFETY RECALL

**RELAY BOX INSPECTION – 19V-647**  
(Transport Canada 2019-452)

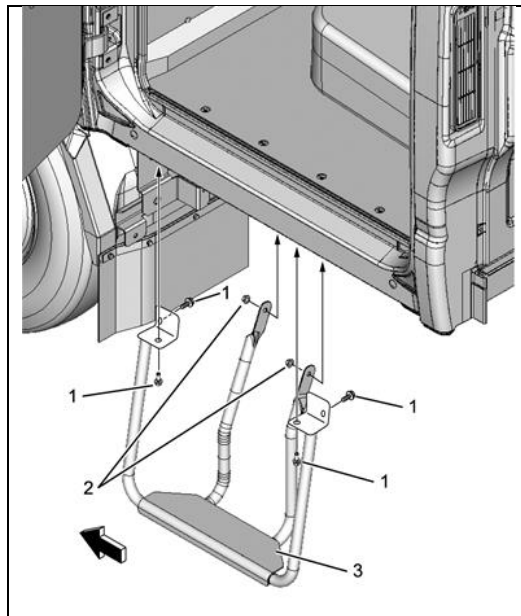
**Figure 1**

1. Place the vehicle in park, apply the parking brake, and remove the key from the engine control switch.
2. Disconnect the negative battery cable.
3. If the vehicle is a crew cab model, remove the driver side rear step. (See Figure 1.) If the vehicle is a standard cab, proceed to the next step.

1. Bolt
2. Nut
3. Rear Step

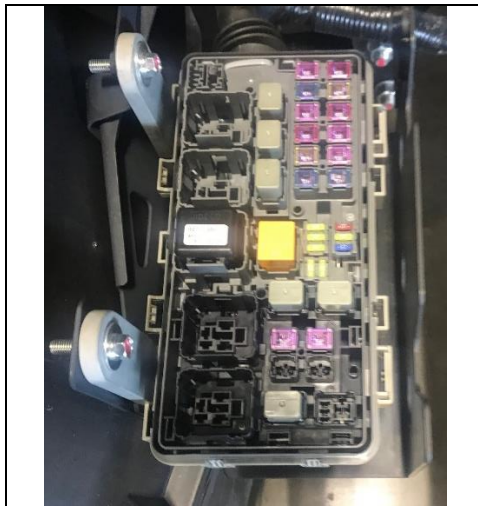
**Figure 2**

4. Remove the fuse box lid to expose the relays and fuses. (See Figure 2.)

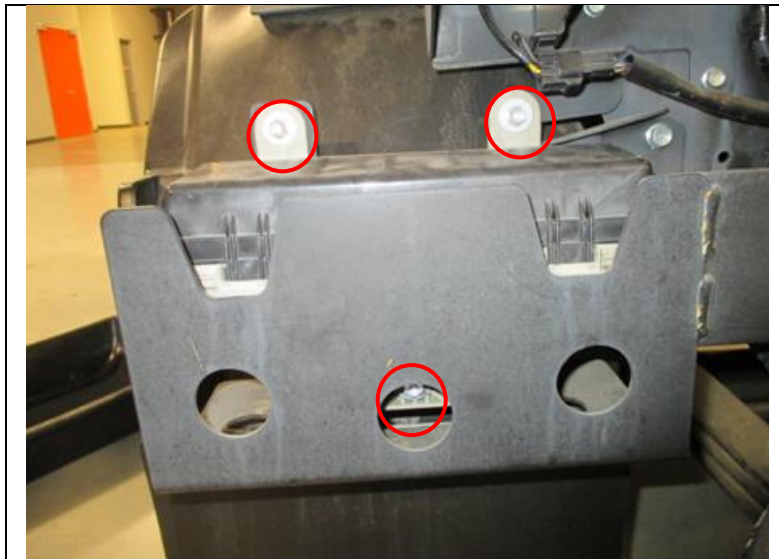
**Figure 3**

5. Remove the three (3) 12mm fuse box mounting bolts and set aside for later use. (See Figure 3.)

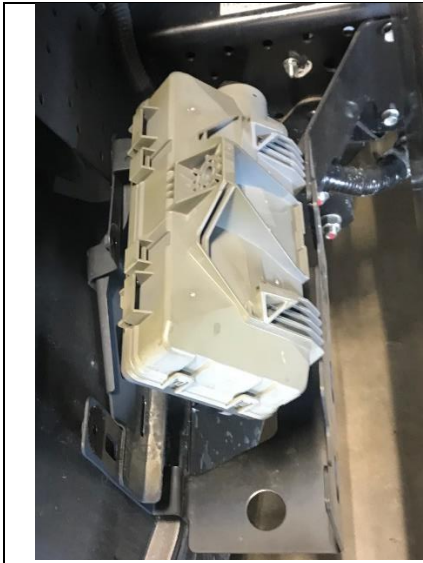
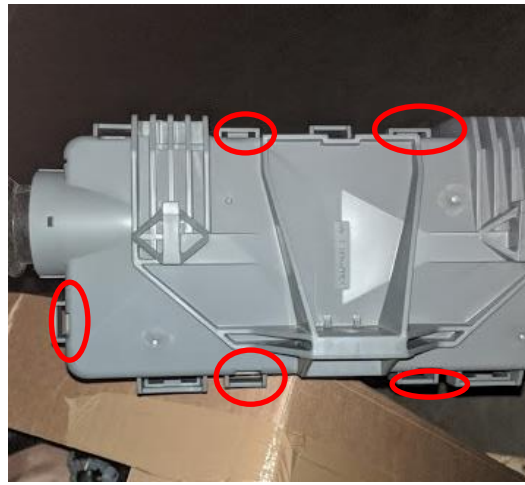
6. Flip the fuse box over and remove the lower cover using a flat blade screwdriver to release the five (5) locking tabs. Set the lower cover aside for later use. (See Figures 4 and 5.)

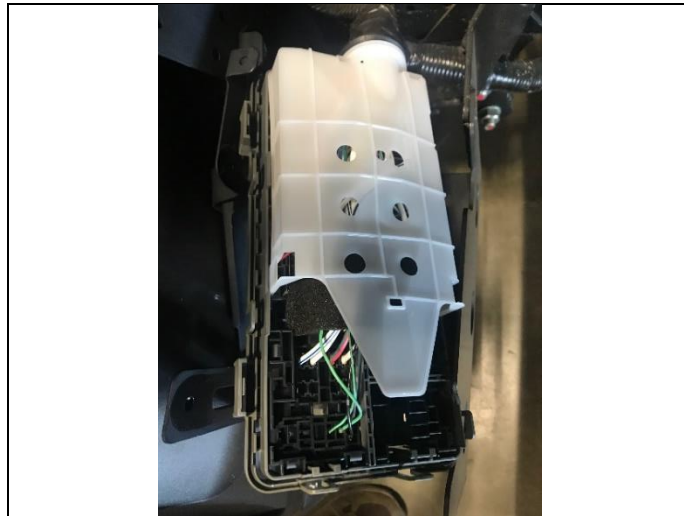
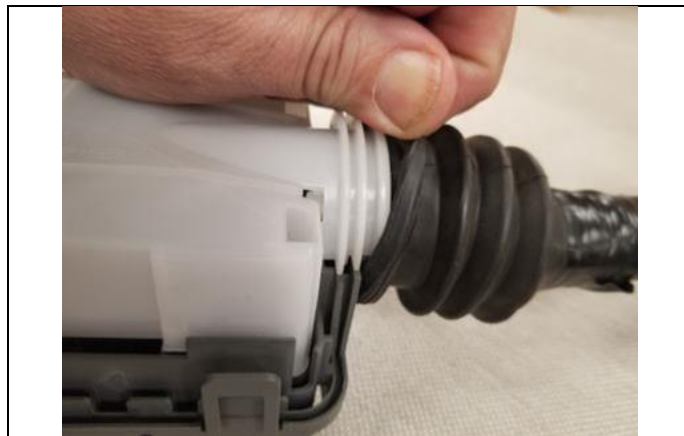
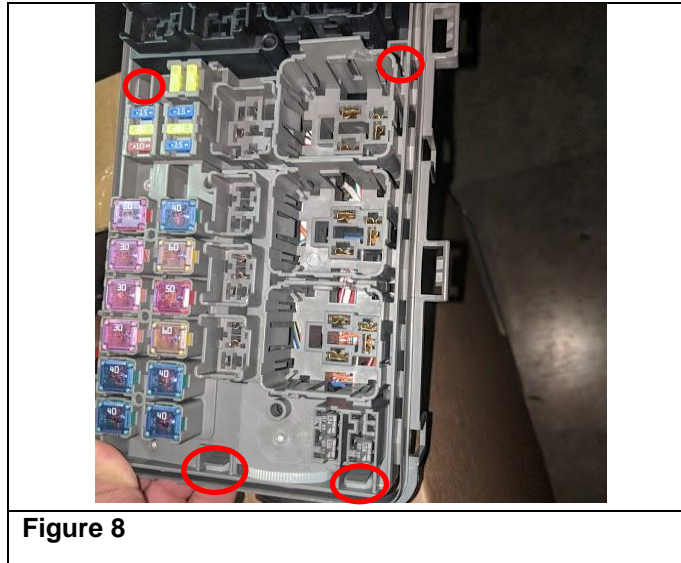
7. Remove the inner cover by removing the PVC tape, pulling the grommet off the end of the fuse box halves and using the same process to release the locking tabs as in Step 4. Set the cover to the side. (See Figures 6, 7 and 8.)
