RECALL CAMPAIGN BULLETIN

Classification: EL19-031	Reference: NTB19-088	Date: October 29, 2019
-----------------------------	-------------------------	---------------------------

VOLUNTARY RECALL CAMPAIGN 2018-2019 ROGUE SPORT; AV CONTROL UNIT (INFOTAINMENT) SOFTWARE UPDATE

CAMPAIGN ID #: R1911
NHTSA #: 19V-654
APPLIED VEHICLES: 2018-2019 Rogue Sport (J11)

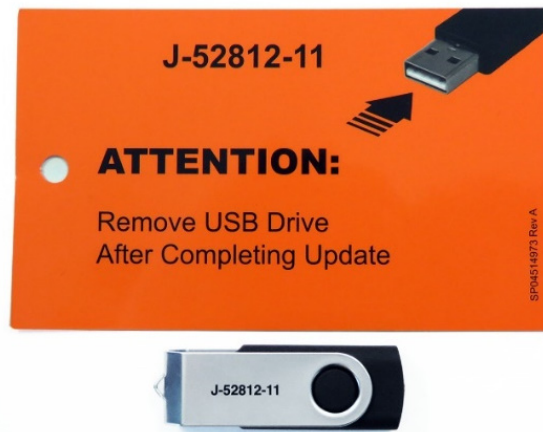
Figure 1

- Confirm “**J**” is the letter displayed in the 10th position of the VIN
- Proceed to **Update AV Control Unit – 2018 Rogue Sport (USB drive J-52812-11)** on page 4

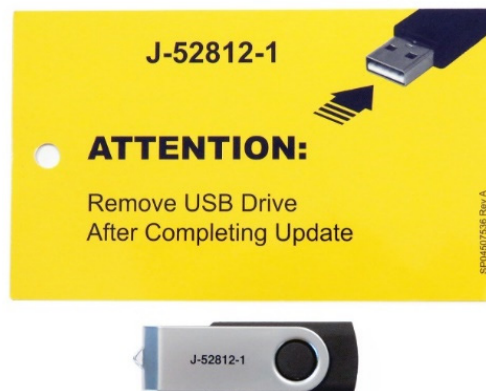
Figure 2

- Confirm “**K**” is the letter displayed in the 10th position of the VIN
- Proceed to **Update AV Control Unit – 2019 Rogue Sport (USB drive J-52812-1)** on page 11

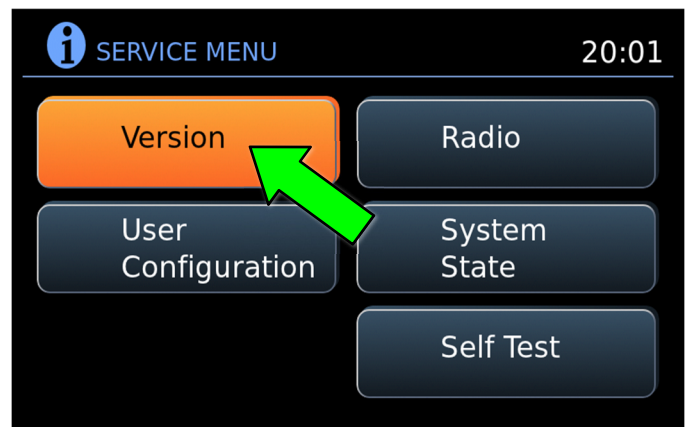
Figure 3

9. Select **Version**.

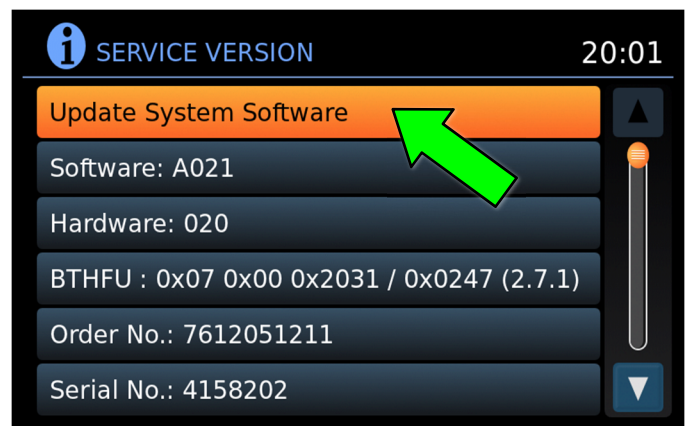
Figure 4

10. Select **Update System Software**.

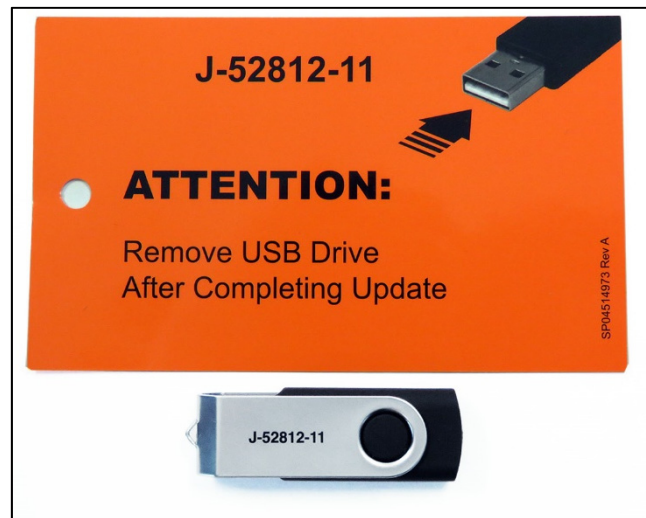
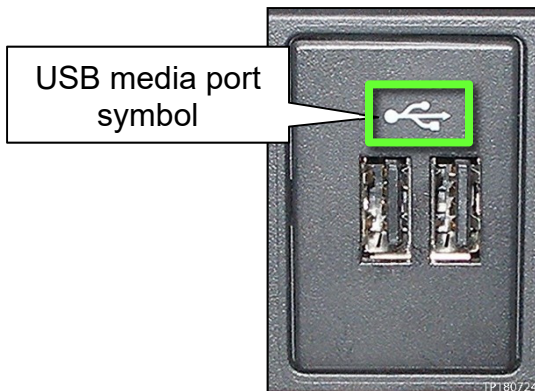
11. Insert special tool USB drive J-52812-11 into the vehicle's USB media port (see Figure 5 and Figure 6).
- DO NOT remove the USB drive during the software update until instructed.

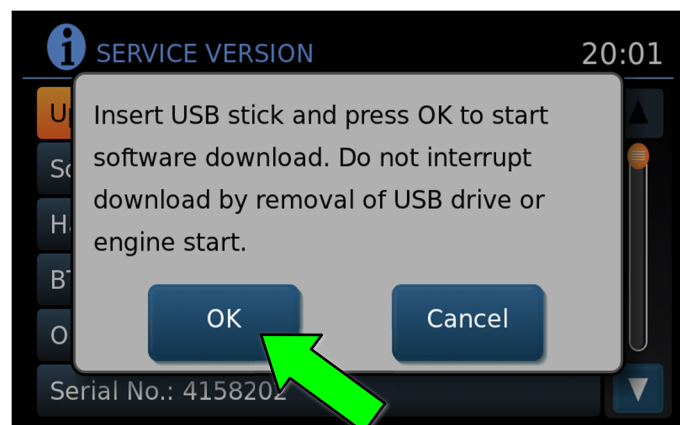
Figure 8

12. Select **OK**.

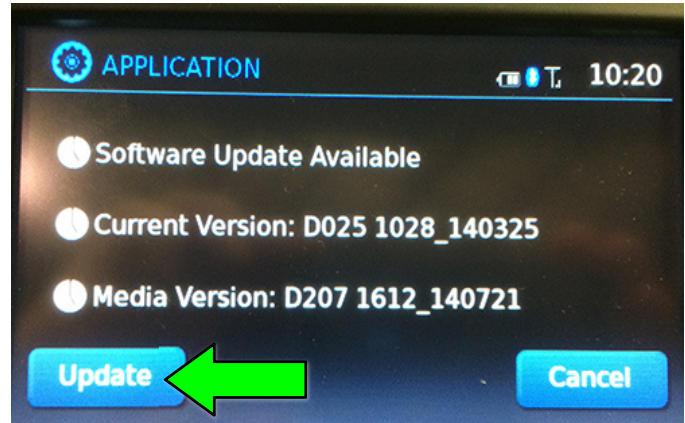
Figure 9

13. Wait for the **APPLICATION** screen to display (Figure 9).

14. Select **Update**.

HINT: After selecting **Update**, the screen will go black for up to 1 minute. **This is a normal part of the update.**

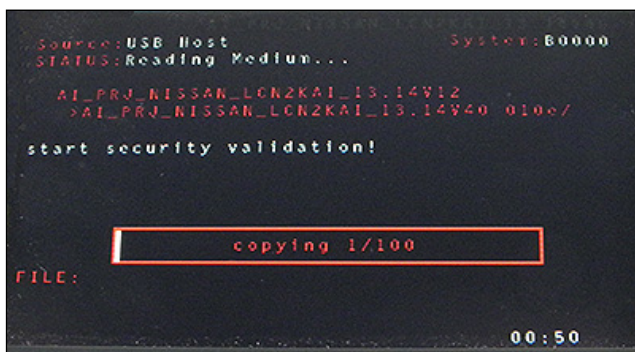
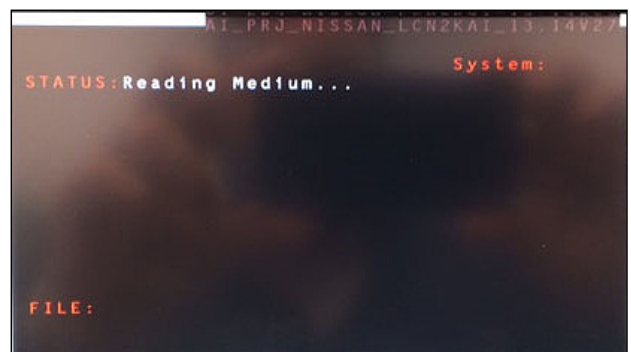
- The screen in Figure 10 will be displayed during the update.
- Figure 11 may display before the update begins. **DO NOT** remove the USB drive during the update.

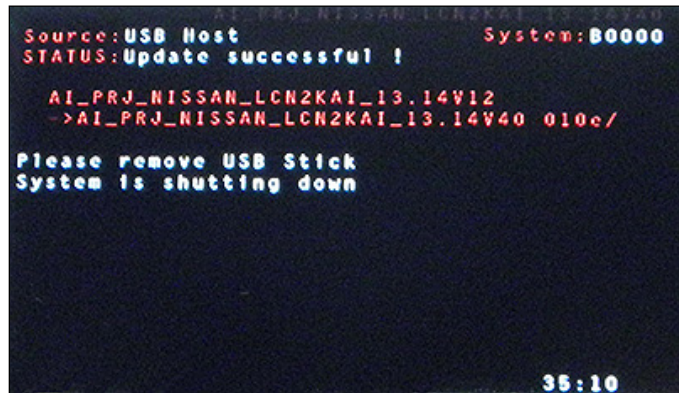
16. When Figure 12 is displayed, remove the USB drive to complete the update.

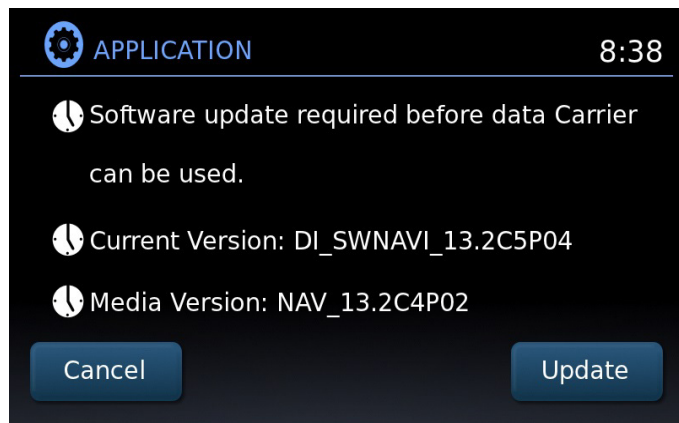
Figure 14

- If the **APPLICATION** screen is displayed (Figure 14), proceed to step 18 on page 9.

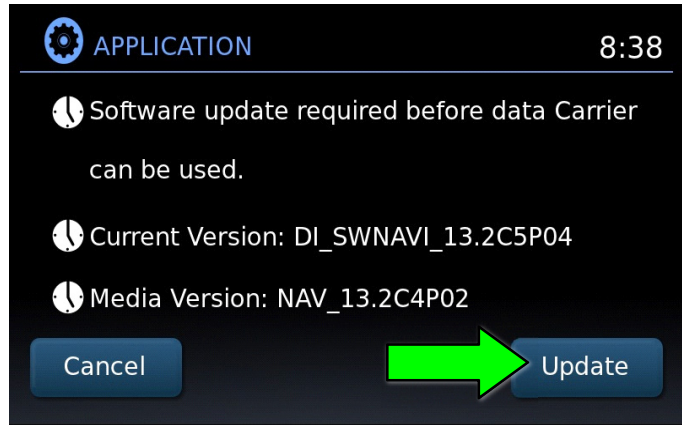
Figure 15

17. Remove and reinsert the map SD card from the card slot.
- After the map SD card is reinserted, the **APPLICATION** screen will display (Figure 15).

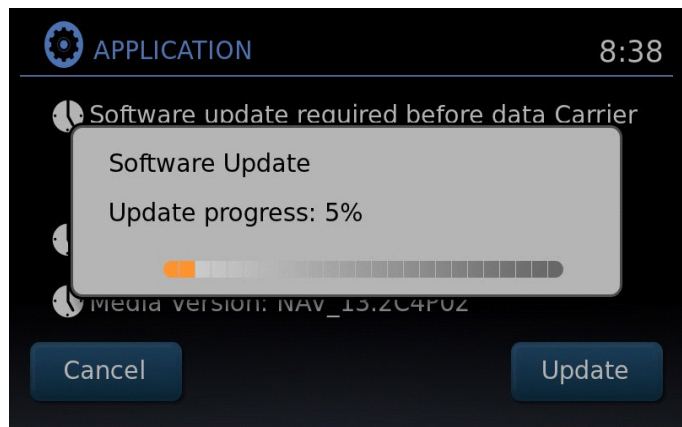
- The update will take about 1 minute to complete, and the screen in Figure 16 will display.

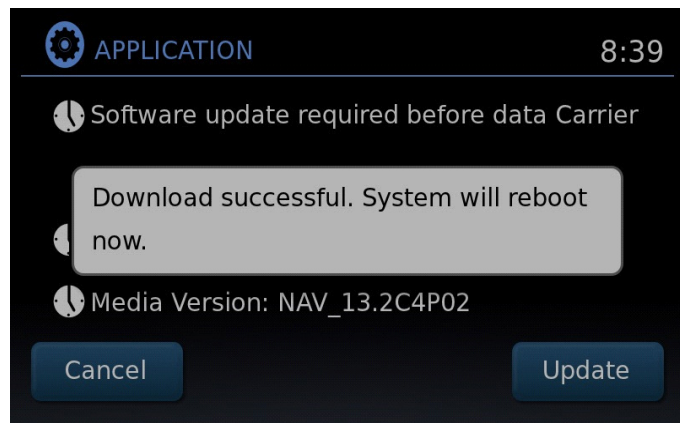
Figure 17

- The message “Download successful. System will reboot now” will display and the audio unit will reboot (Figure 17).
- After the system reboots, the update is complete.

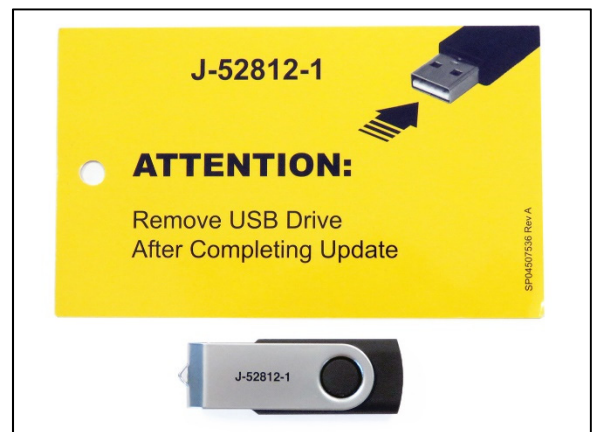
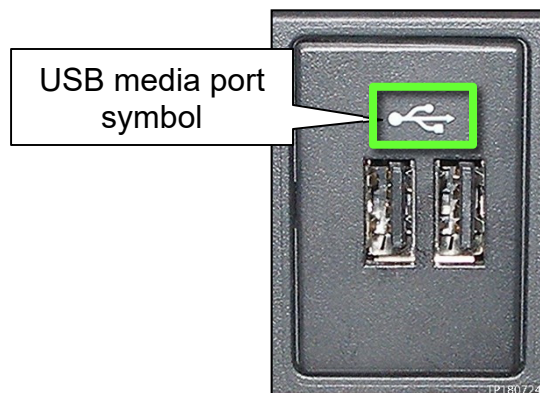
26. Turn the audio system OFF.
27. Insert special tool USB drive J-52812-1 into the vehicle's USB media port (see Figure 18 and Figure 19).

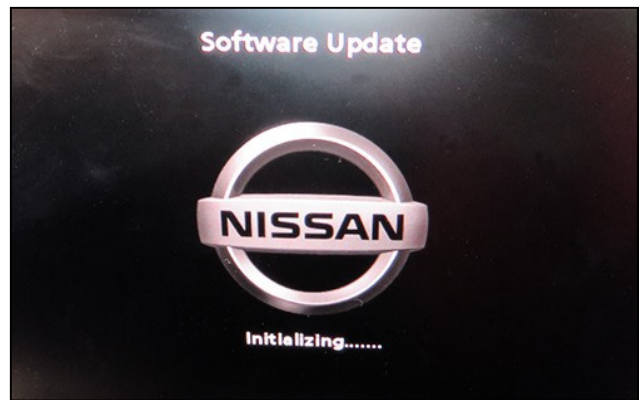
28. Wait approximately 10-30 seconds for the screen in Figure 21 to appear.

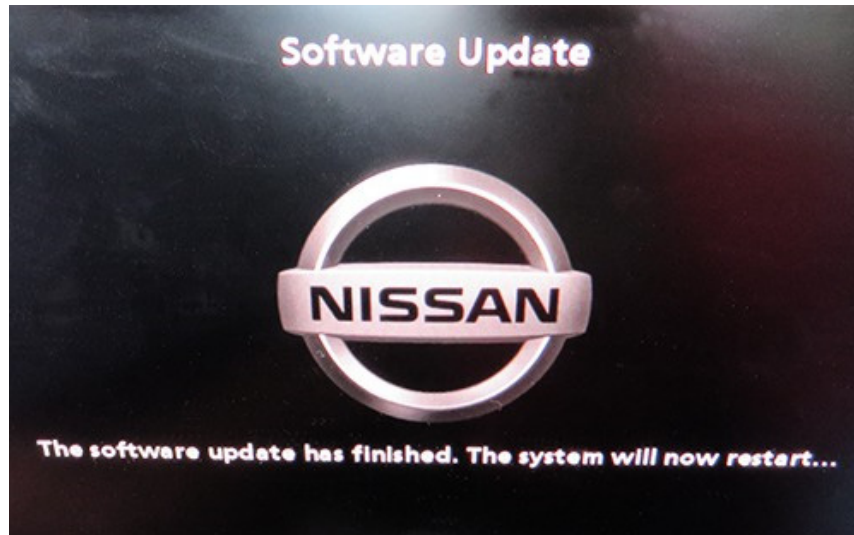
Figure 24

30. Once the software update is complete (Figure 24), remove special tool USB drive J-52812-1. The system will then reboot (restart).
