PRODUCT CAMPAIGN BULLETIN

APPLICABILITY: 2017-19MY Impreza
2018-19MY Crosstrek

NUMBER: WUQ-02R

SUBJECT: Ignition Coil Short Circuit

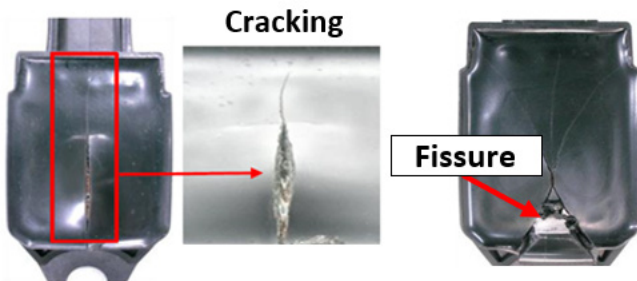
Ignition Coil Check Points

Step 4: Inspect all 4 ignition coils CLOSELY for any damage, cracking, fissures, etc. **Coil removal is NOT necessary as any damage will be external.** Were any cracks, fissures or other damage found on any of the 4 ignition coils?

NG

Cracks and Fissure

YES: Replace any damaged coil(s) (rare case) following the procedure in the applicable Service Manual then proceed to **Step 5** and using the SSM, check for any stored DTCs.
