December 9, 2019

**SUBJECT: NEW VEHICLE DEMONSTRATION / DELIVERY HOLD -
 Safety Recall 19S43 – Supplement #1**
 Certain 2019 Model Year Ranger Vehicles
 Rear Tail Lamps

CERTAIN 2019 MODEL YEAR RANGER VEHICLES — REAR TAIL LAMP WIRING

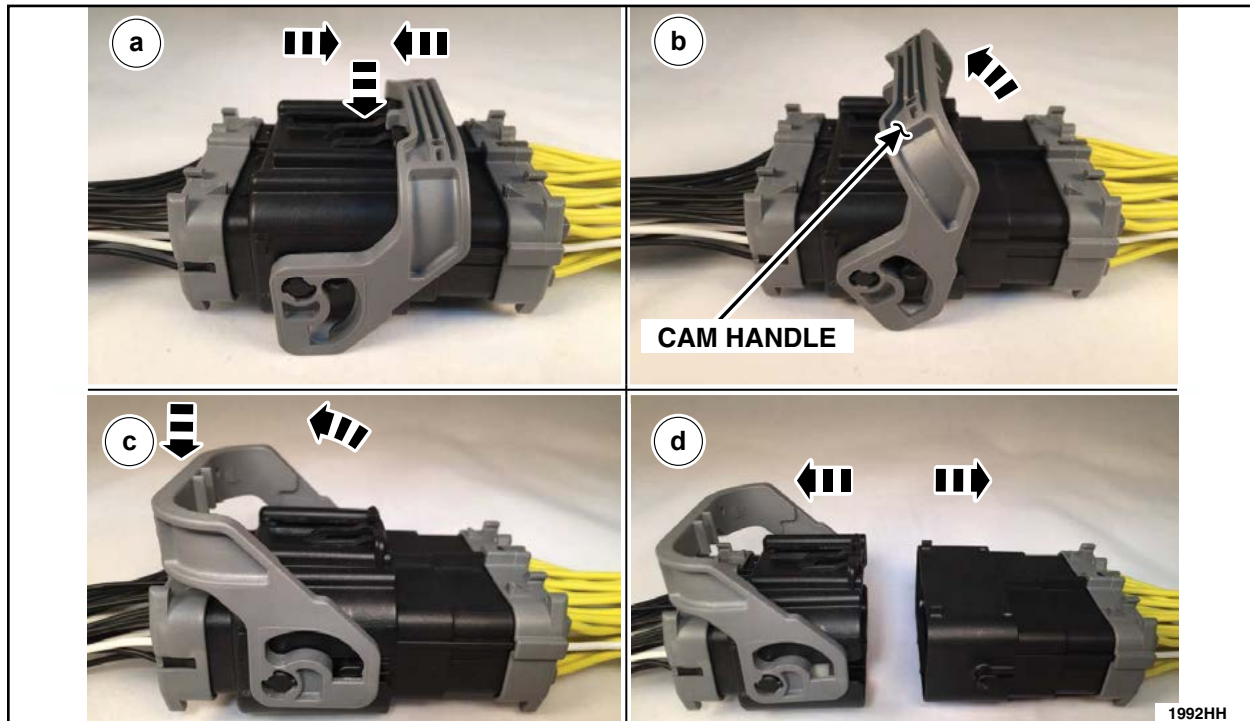
FIGURE 16

16. Release the connector lock and open the connector C422. See Figure 16.

- a. Push the connectors together and depress the primary lock.
- b. Once the primary lock releases the cam handle, rotate the cam handle as shown.
- c. Push the cam handle all the way back and seat the cam handle.
- d. Pull the male and female connectors apart.
