N412NAS1

# TECHNICAL BULLETIN

SAFETY RECALL: Headliner Metal Plate Retention

MODEL:	MODEL YEAR:	VIN:
New Range Rover Evoque (LZ)	2020	000181-025797

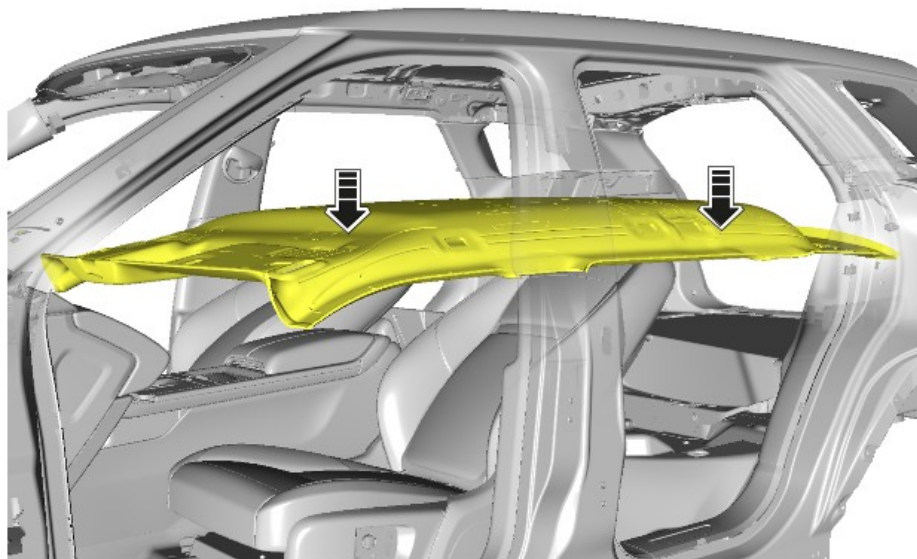
E256358

Vehicle with roof opening panel shown; vehicles with fixed roof similar.

Lower the headliner for access (see TOPIx Workshop Manual section: 501-05 Removal and Installation - Headliner Lower For Access.) Do NOT attempt to remove the headliner from the vehicle.
