SIB 65 23 19

2020-04-23

RECALL 19V-851: DRIVER'S FRONT AIR BAG (NADI) INFLATOR

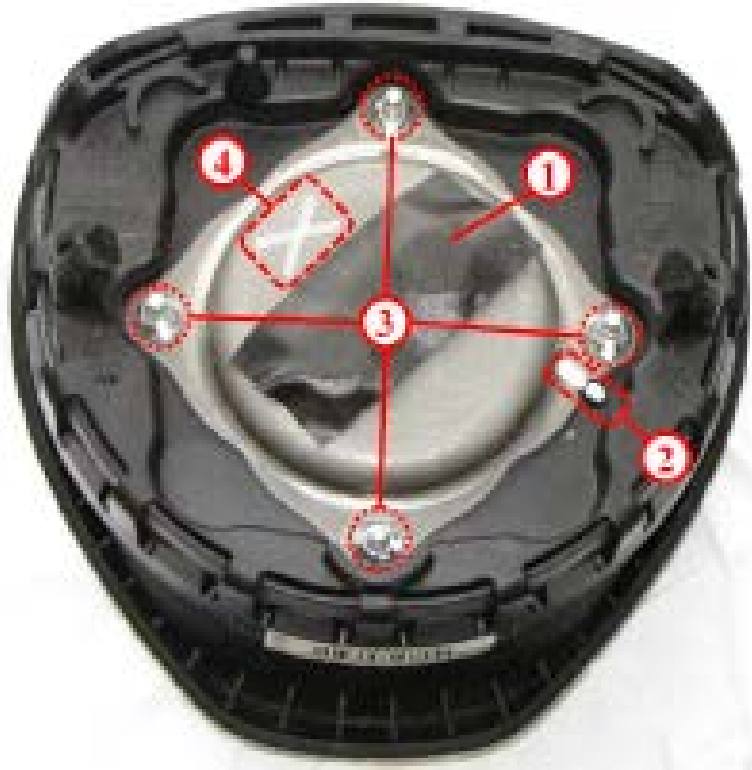
NOTE: – Picture above is an example and may not exactly match your Generator / air bag.

- Cover the connections on the old Generator with duct tape (1) so the contacts cannot be touched.
- Mark orientation (2) of the Generator in the Air Bag with the felt tip marker.
