**September 18, 2020**

## Safety Recall: 2017–20 Ridgeline Accessory Tonneau Cover Attachment Information

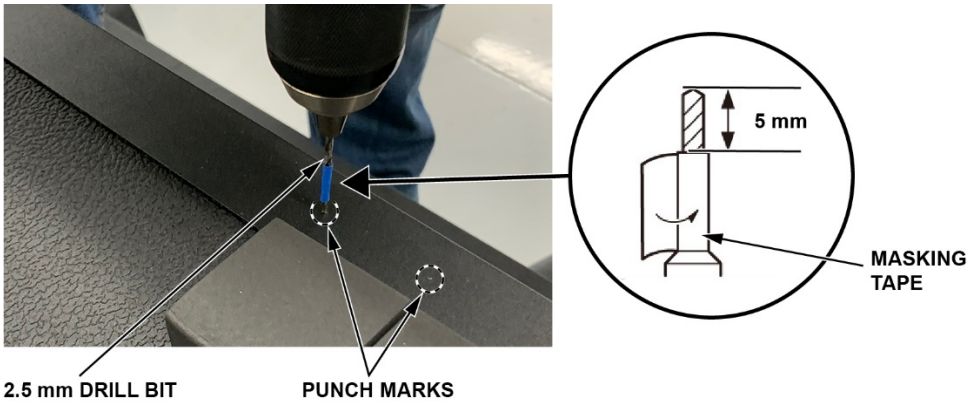
Use masking tape to serve as a drill stop at **5 mm**. If you drill too deep you can damage the hinge.

10. Use a 2.5 mm drill bit to drill holes on the four punch marks, then remove any burrs.

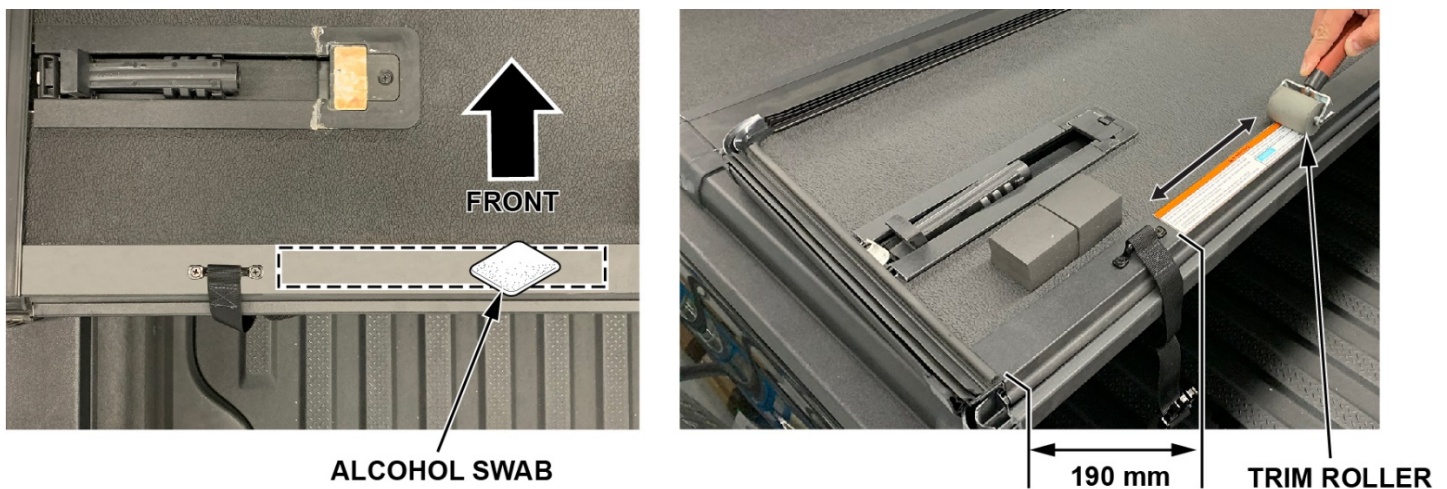
Make sure the warning label's orientation is correct. The orange should be facing toward the front of the vehicle.

13. Use isopropyl alcohol to thoroughly clean the surface of the rear panel where you will install the warning label. Make sure the alcohol is completely dry, then install the label as shown, and apply pressure to the entire surface of the label using a trim roller.
