Subject: 3 New Takata Recalls (Effective Today, January 16, 2020)

SIB 65 01 20

RECALL CAMPAIGN 20V-018: REPLACE PASSENGER'S FRONT AIR BAG MODULE

RE: Recall 20V-018: Replace Passenger's Front Air Bag Module – B65 01 20

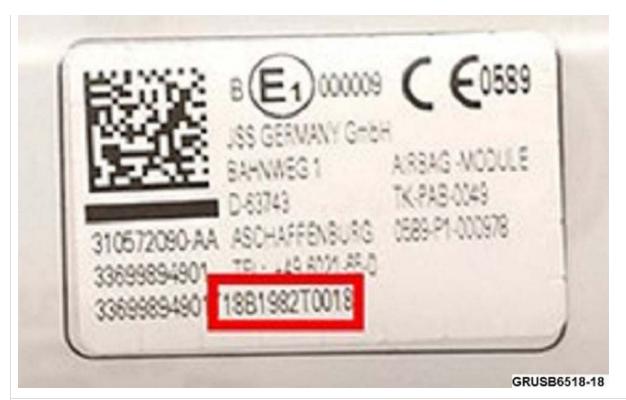
The replacement air bag module's serial number must be documented on the repair order so it can also be entered into the claim's comment section.

See Repair Instructions **REP 72 12 000**, Remove and refit/replace the air bag unit or follow the attached repair procedure.

<u>Warning!</u> Incorrect handling may result in triggering of the air bag module and thereby cause serious injury.
