CONDITION OF CONCERN

PARTS AND WARRANTY INFORMATION
Recall Campaign 4320A

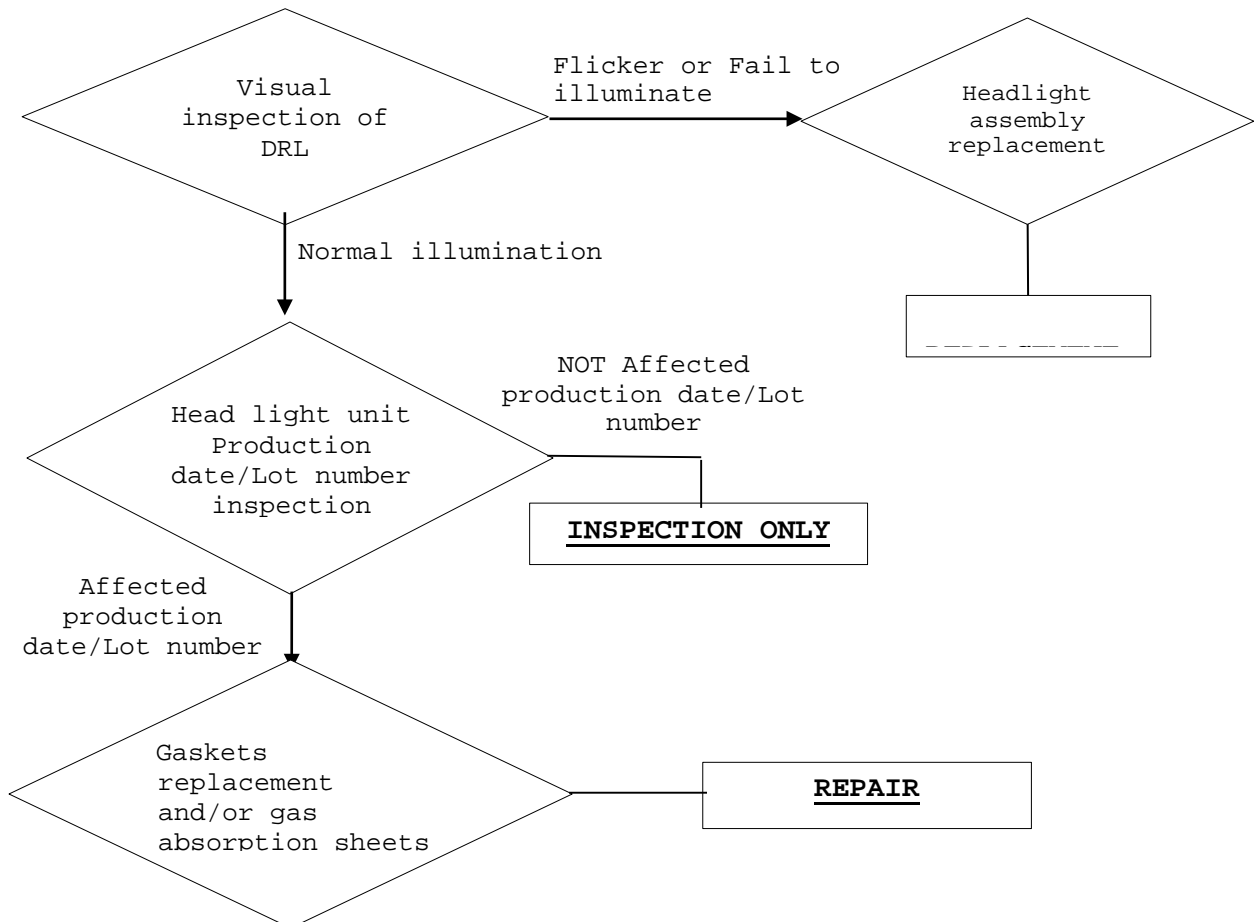
Flow Chart (Shows one side of headlight. Go through flow chart for RH and LH) the other side is the same.)

Submit applicable warranty claim according to the combination of repairs performed on each right and left headlight.
