## Safety Recall: Third Row Accessory Power Outlet

Supersedes 20-012, Dated February 7, 2020, to revise the information highlighted in **yellow**.

Year	Model	Trim	VIN Range
2018-20	Odyssey	EX-L, EX-L with Navigation and RES, Touring, and Elite	Check the iN VIN status for eligibility.

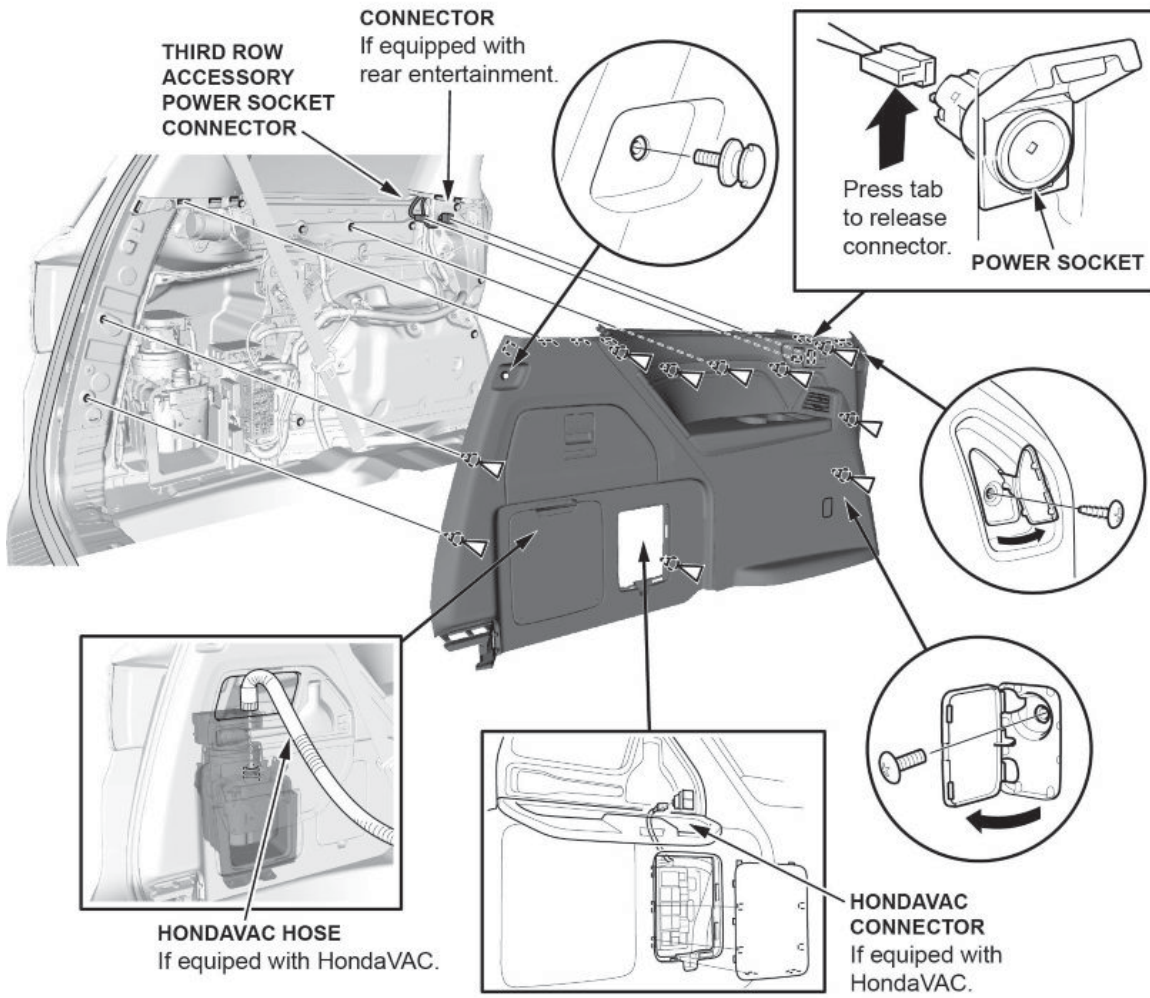
8. If the third row accessory power socket harness branch of the floor harness was improperly routed, the harness may be deformed. Inspect this part of the harness from the C-pillar trim to the third row accessory power socket connector for any exposed copper wiring. **Do not remove the electrical tape.**

7. Remove the left side rear trim panel. Disconnect the third row accessory power socket by pressing the lock that is located on the bottom of the connector to release it from the power socket. In addition, do the following if it applies to the vehicle:
- Remove the HondaVAC hose from the vacuum, and disconnect the connector.
  - Disconnect the rear entertainment connector.
