# Service Bulletin

20-012

# **Safety Recall: Third Row Accessory Power Outlet**

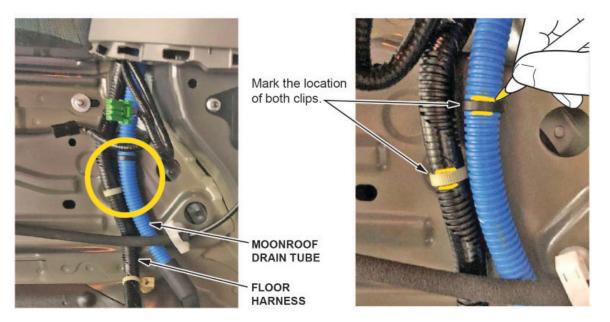
9. Mark the location of the clip on the floor harness corrugated tube and the moonroof drain tube.

- 9.1. To make sure the new clip is placed in the proper location on the floor harness, use a paint marker to mark the top and bottom edge of the band on the floor harness as shown.
- 9.2. To make sure the new clip is placed in the proper location on the moonroof drain tube, use a paint marker to mark the top and bottom edge of the band on the moonroof drain tube as shown.
- 10. Remove the clip on the moonroof drain tube.

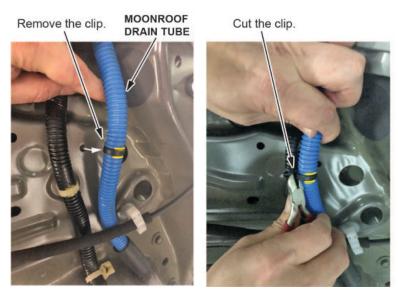
## MOONROOF DRAIN TUBE

Carefully remove the clip from the moonroof drain tube. If the drain is damaged, it must be replaced.

- 10.1. Remove the clip from the body.
- 10.2. Carefully cut the band with side cutters to remove the clip from the harness.
