Safety Recall Code: 47P8

Electronic Brake Booster Input Rod

March 24, 2020

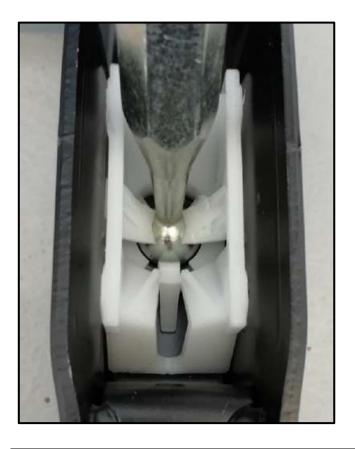
Inspect brake booster push rod installation.

Inspect and, if necessary, replace the electronic brake booster and mounting of the pressure rod OR the mounting of the pressure rod only, depending on the inspection results.
